Report: TAB Report
Function: Test, Adjust, & Balance
Date: 07/16/2025
Completed By: National TAB

PROJECT
07-14-25 WAWA #7211 MASON, OH

5450 KINGS MILLS RD

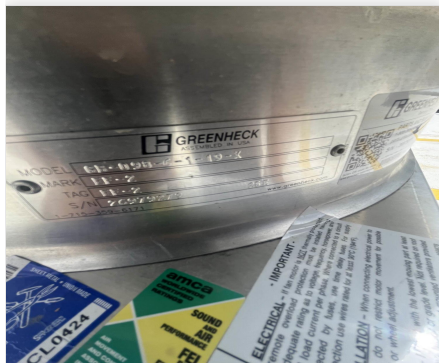
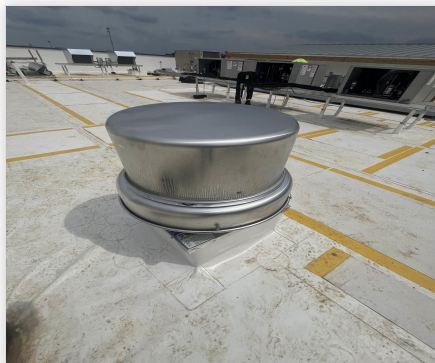
Issue Name : EF-2 not operational
Description : EF-2 fan is misaligned, when running fan wheel rubs against housing, could not balance in its current condition. Mechanical shut it down and a replacement fan has been ordered to correct this issue.
Created By : National TAB **Assigned To :** National TAB - Dylan Crisman
Status : Open
Priority : Urgent **Asset Tag :**
Originated Date : 07/16/2025 - Dylan Crisman - National TAB

Could not be balanced at time of TAB due to fan being misaligned and needing replacement. Replacement has been ordered.

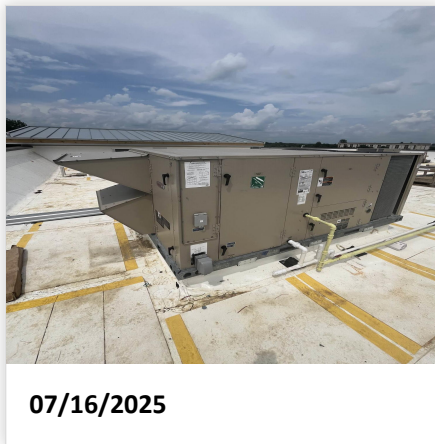
Issue Name : RTU-2 alarm
Description : RTU-2 has an alarm for “zone sensor” Recommend checking wiring to ensure it is landed properly at sensor as well as at unit.
Created By : National TAB **Assigned To :** National TAB - Dylan Crisman
Status : Open
Priority : High **Asset Tag :**
Originated Date : 07/16/2025 - Dylan Crisman - National TAB
