Report: TAB REPORT
Function: Test, Adjust, & Balance
Date: 08/19/2025
Completed By: National TAB

PROJECT
08-18-25 CAVA BURLINGTON, MA

Project: 08-18-25 CAVA BURLINGTON, MA

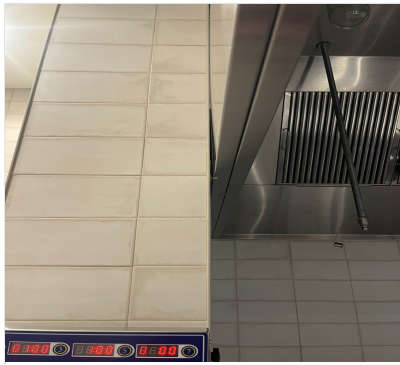
Kitchen Hoods are flush against the wall along the bottom and each of it's side walls.	Fail
--	------

Gap on left side of wall. Will allow for accumulation of grease and dirt. Recommend this is sealed.
