Report: TAB REPORT
Function: Test, Adjust, & Balance
Date: 08/19/2025
Completed By: National TAB

PROJECT
08-18-25 CAVA BURLINGTON, MA

Project: 08-18-25 CAVA BURLINGTON, MA

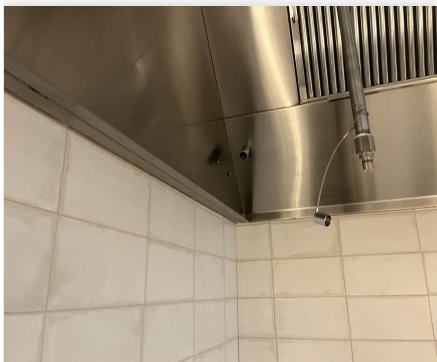
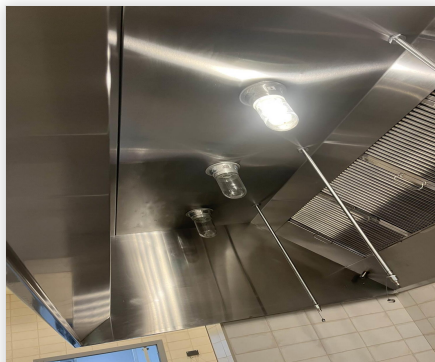
Issue Name : Hood Accessories not installed.
Description : Grease cups for the hood are not installed and could not be located. 2 hood lights do not have lightbulbs installed. Recommend they are intalled.
Created By : National TAB **Assigned To :** National TAB - Michael McDonnell
Status : Open
Priority : Low **Asset Tag :**
Originated Date : 08/19/2025 - Michael McDonnell - National TAB

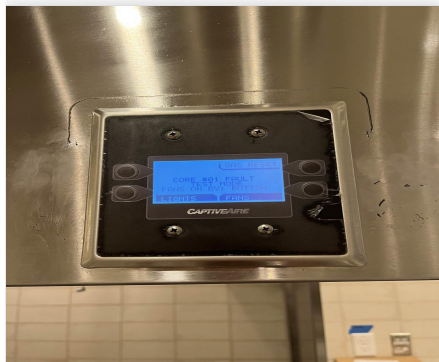
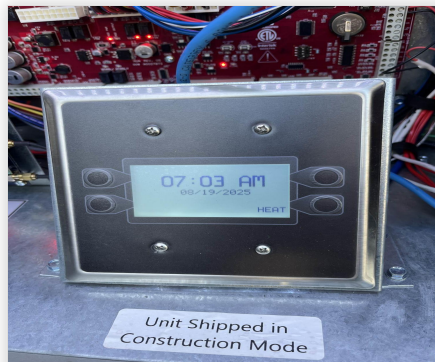
Issue Name : Hood Controls
Description : Supply motor not visible in hood controls. Appears configuration of hood setup is incorrect and needs review from Captive Aire tech. Adjusted MUA fan speed at unit by changing blower control to VFD Manual. Hood is also alarmed for CORE 1 fault. Switch is not on test but alarm remains, not impacting hood operation. Needs Service.
Created By : National TAB **Assigned To :** National TAB - Michael McDonnell
Status : Open
Priority : Medium **Asset Tag :**
Originated Date : 08/19/2025 - Michael McDonnell - National TAB

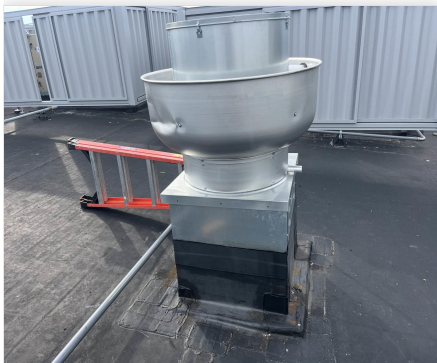
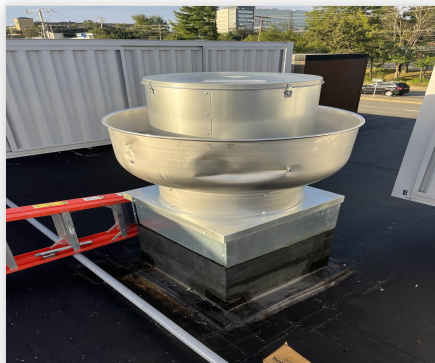
Issue Name : KEF-1: Hinge Kit
Description : Hood exhaust fan KEF-1 does not have hinge kit installed as specified in plans. Electrical conduit is not long enough to hinge fan back should it be installed. Fan also has large dent and is missing its grease cup. Plans also specify a viroguard, which is not installed.
Created By : National TAB **Assigned To :** National TAB - Michael McDonnell
Status : Open
Priority : High **Asset Tag :**
Originated Date : 08/19/2025 - Michael McDonnell - National TAB

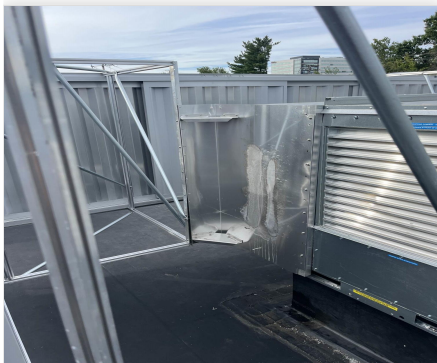
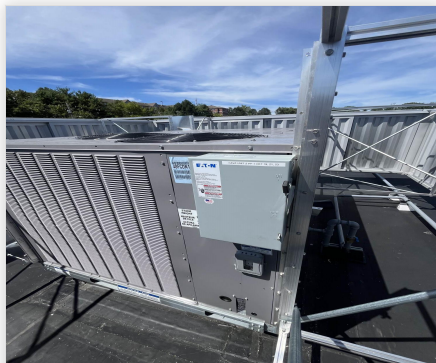
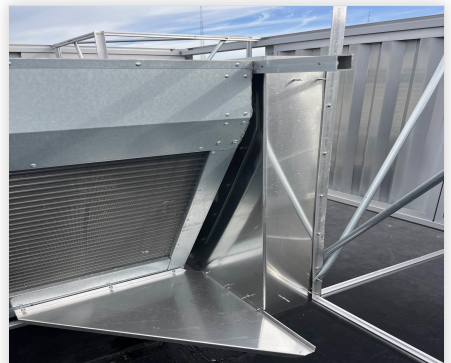
Issue Name : MUA: Compressor Compartment Blocked by Wind Screen
Description : Wind screen for unit was attached over the compressor compartment and can no longer be accessed. Needs correction. Wind screen installation also screwed into rtu panels damaging doors.
Created By : National TAB **Assigned To :** National TAB - Michael McDonnell
Status : Open
Priority : High **Asset Tag :**
Originated Date : 08/19/2025 - Michael McDonnell - National TAB

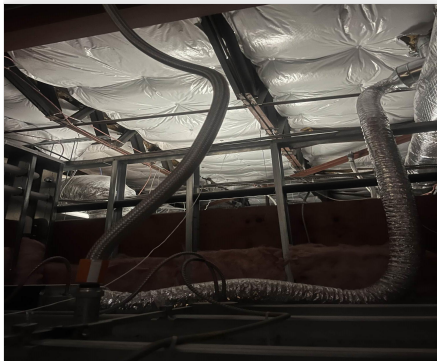
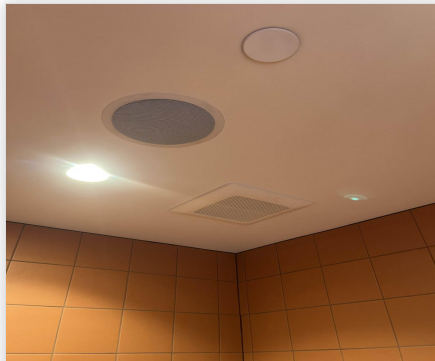
Issue Name : Restroom Exhaust Low: Backdraft Dampers
Description : Restroom exhaust fans are low on airflow. Suspect backdraft dampers are stuck shut. Additionally, excessive flex duct is use, likely further limiting airflow.
Created By : National TAB **Assigned To :** National TAB - Michael McDonnell
Status : Open
Priority : Medium **Asset Tag :**
Originated Date : 08/19/2025 - Michael McDonnell - National TAB

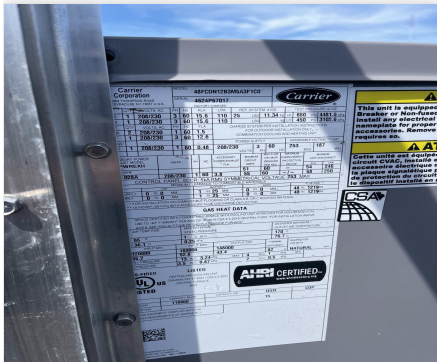
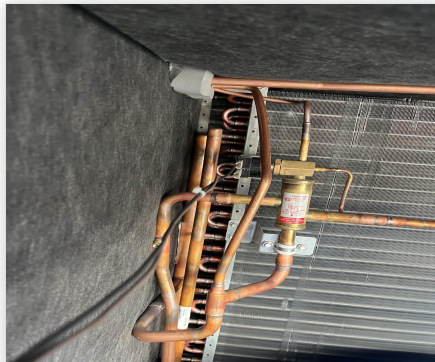
Issue Name : RTU Dehumidification
Description : RTU model numbers and reheat coil indicate units have dehumidification. No humidity sensors are installed or wired for either RTU. Recommend humidity sensors are installed so units can control space humidity.
Created By : National TAB **Assigned To :** National TAB - Brianna Biggs
Status : Open
Priority : High **Asset Tag :**
Originated Date : 08/19/2025 - Michael McDonnell - National TAB

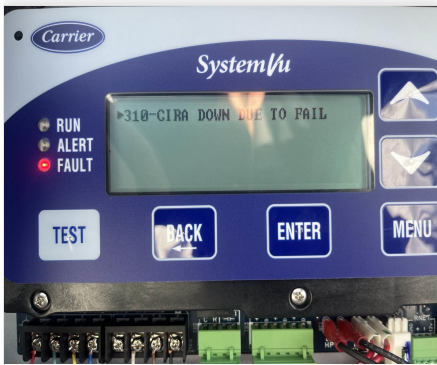
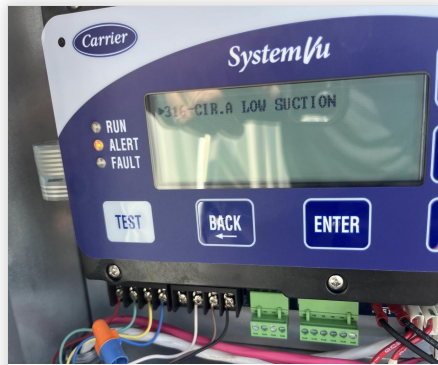
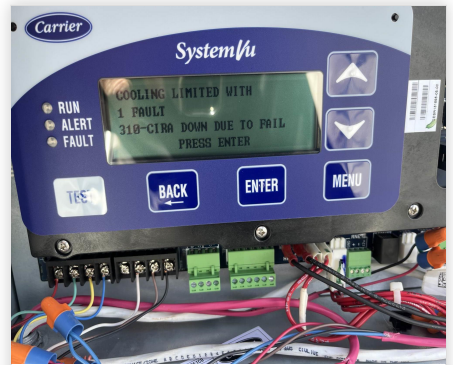
Issue Name : RTU-1 (KITCHEN): Cooling is not Functional
Description : Cooling is locked out on RTU-1 serving the kitchen. Suspect low pressure alarm. Unit needs service.
Created By : National TAB **Assigned To :** National TAB - Michael McDonnell
Status : Open
Priority : High **Asset Tag :**
Originated Date : 08/19/2025 - Michael McDonnell - National TAB

- **08/19/2025 National TAB - Michael McDonnell**
 - Gas valve at this unit in off position. Suggests unit has not been started up. Could not test heat.

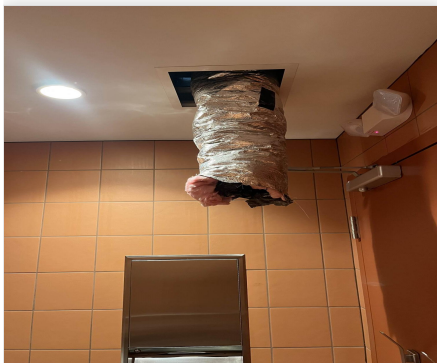
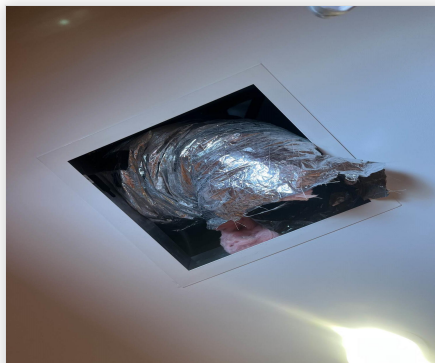
Issue Name : RTU-1 / RTU-2: Diffusers Not Installed
Description : Both RTUs do not have all diffusers installed. RTU-1 is missing office grille. RTU-2 is missing restroom supply diffusers. These grilles were roughly balanced based on traverse and velocity at outlet.
Created By : National TAB **Assigned To :** National TAB - Michael McDonnell
Status : Open
Priority : High **Asset Tag :**
Originated Date : 08/19/2025 - Michael McDonnell - National TAB

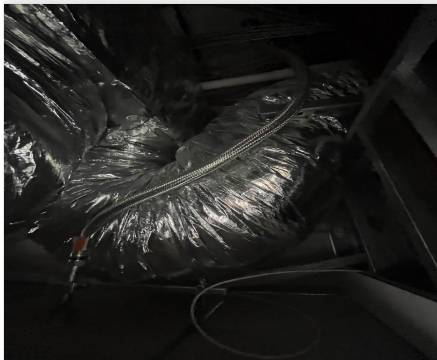
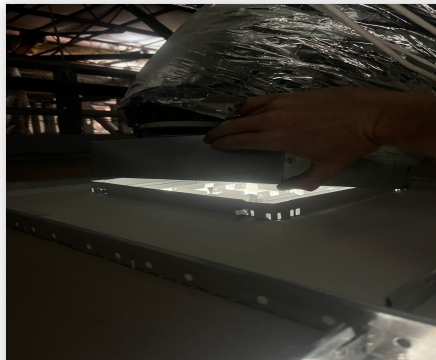
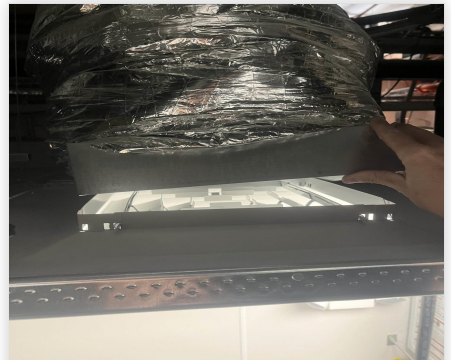
Issue Name : RTU-1 / RTU-2: Ductwork Installation
Description : Ductwork installation needs review. Excessive flex duct is used that exceeds 5ft in length. Run-outs make more than one transition and are pinched in some instances. RTU-1 return is pinched, restricting airflow. Ductwork is not attached to diffusers in most instances. RTU-1 grilles are 3 different sizes; not per plan.
Created By : National TAB **Assigned To :** National TAB - Michael McDonnell
Status : Open
Priority : High **Asset Tag :**
Originated Date : 08/19/2025 - Michael McDonnell - National TAB

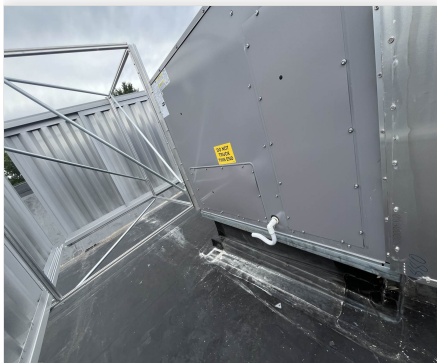
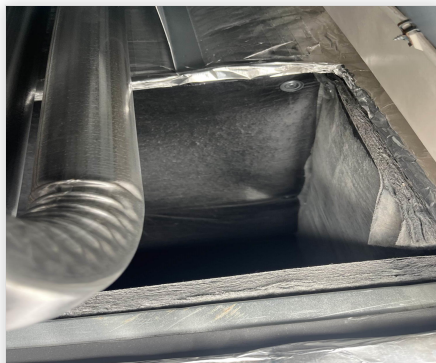
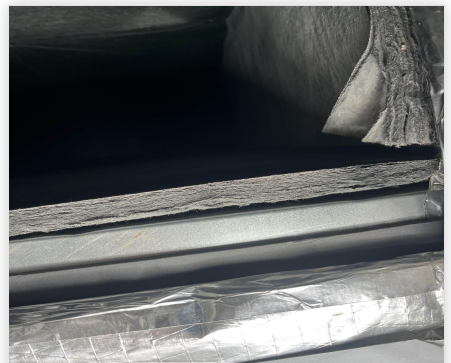
Issue Name : RTU-2: Misaligned on Curb; Leakage
Description : Unit is misaligned on the curb and leaking at the supply discharge along the edge of the curb. This needs correction. The discharge panel itself also needs to be secured / sealed as it is leaking.
Created By : National TAB **Assigned To :** National TAB - Michael McDonnell
Status : Open
Priority : High **Asset Tag :**
Originated Date : 08/19/2025 - Michael McDonnell - National TAB

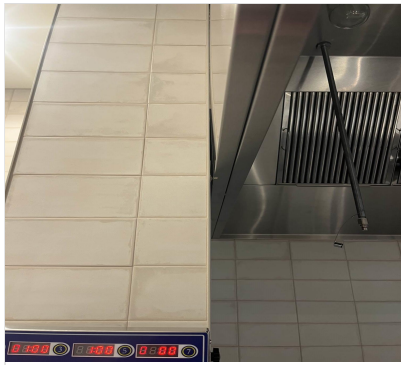
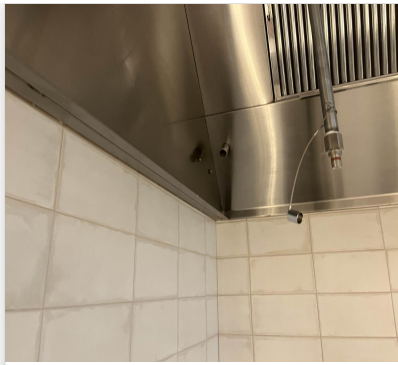
Kitchen Hoods are flush against the wall along the bottom and each of it's side walls.	Fail
--	------

Gap on left side of wall. Will allow for accumulation of grease and dirt. Recommend this is sealed.

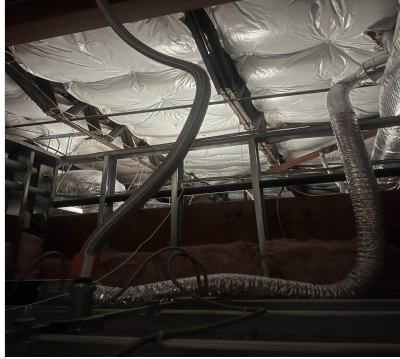
Restroom duct is properly supported

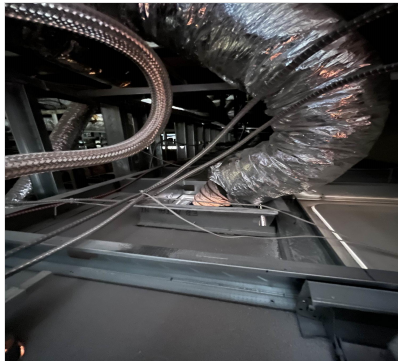
Ducts are securely insulated as per specificatins and foil taped to prevent air barrier from being breached

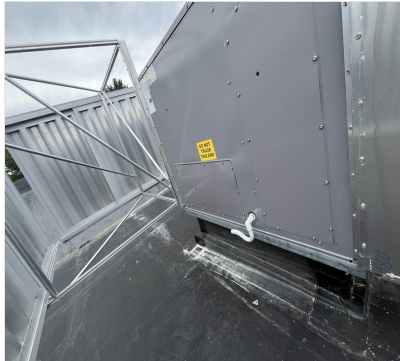
Not per specification.
