Report: TAB REPORT
Function: Test, Adjust, & Balance
Date: 08/19/2025
Completed By: National TAB

PROJECT
08-18-25 CAVA BURLINGTON, MA

Project: 08-18-25 CAVA BURLINGTON, MA

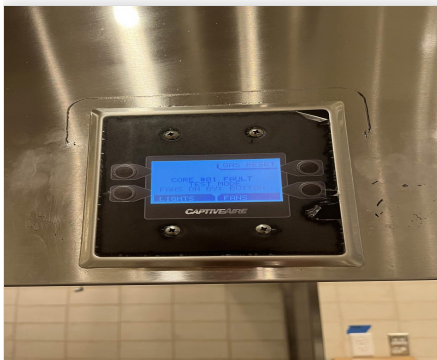
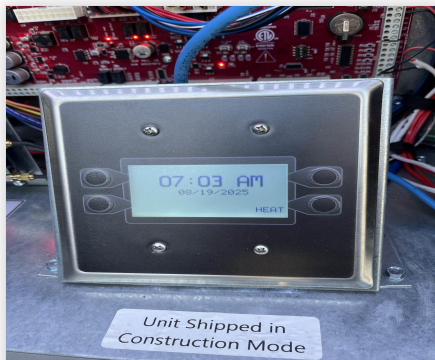
Issue Name : Hood Controls
Description : Supply motor not visible in hood controls. Appears configuration of hood setup is incorrect and needs review from Captive Aire tech. Adjusted MUA fan speed at unit by changing blower control to VFD Manual. Hood is also alarmed for CORE 1 fault. Switch is not on test but alarm remains, not impacting hood operation. Needs Service.
Created By : National TAB **Assigned To :** National TAB - Michael McDonnell
Status : Open
Priority : Medium **Asset Tag :**
Originated Date : 08/19/2025 - Michael McDonnell - National TAB

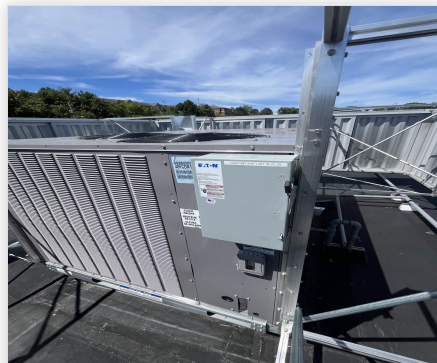
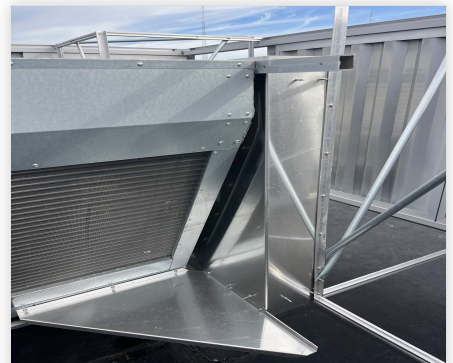
Issue Name : MUA: Compressor Compartment Blocked by Wind Screen
Description : Wind screen for unit was attached over the compressor compartment and can no longer be accessed. Needs correction. Wind screen installation also screwed into rtu panels damaging doors.
Created By : National TAB **Assigned To :** National TAB - Michael McDonnell
Status : Open
Priority : High **Asset Tag :**
Originated Date : 08/19/2025 - Michael McDonnell - National TAB

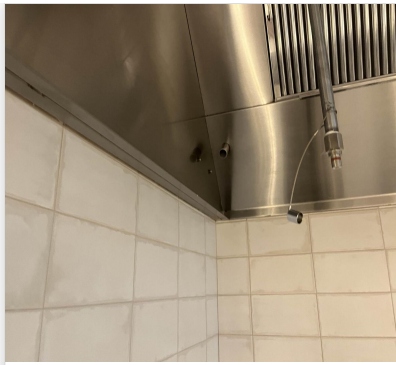
Kitchen Hoods are flush against the wall along the bottom and each of it's side walls.	Fail
--	------

Gap on left side of wall. Will allow for accumulation of grease and dirt. Recommend this is sealed.

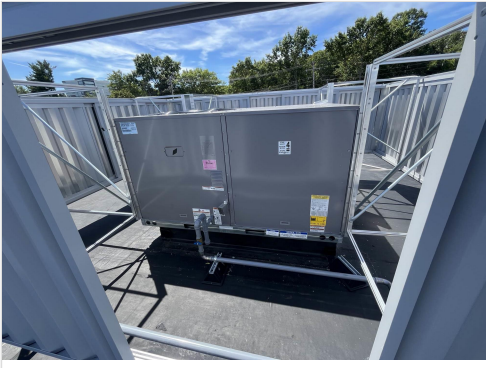
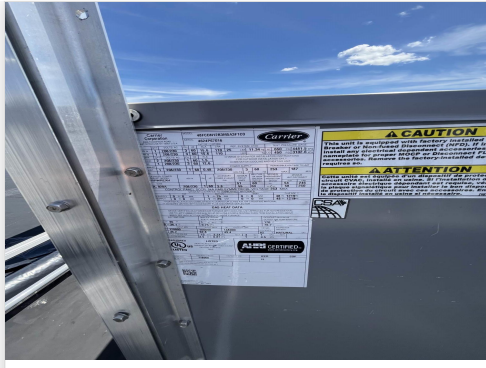
- [1] UNIT IS MISALINGED, LEAKING SUPPLY AIR INTO ATMOSPHERE ON ROOF.
- [2] SUPPLY GRILLES VARY IN SIZE AND ARE NOT INSTALLED PER PLAN.
- [3] RESTROOM DIFFUSERS NOT INSTALLED. TRAVERSED HALLWAY TOTAL AND USED VELOCITY TO VERIFY CFM AT THOSE OUTLETS.
