**Report: TAB REPORT**  
**Function: Test, Adjust, & Balance**  
**Date: 07/14/2023**

**06-05-23 SWEETGREEN - PEABODY, MA**  
**(TAB, IAQ)**

210 ANDOVER ST

PEABODY, MA 01960

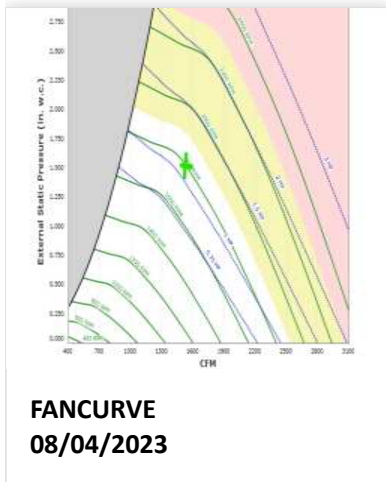
**Issue Name :** GX-1 AIRFLOW IS LOW  
**Description :** GX1 airflow is low (758 CFM out of 1200 CFM design). Initially a closed backdraft damper was found and was resolved. The fan is not fully accessible due to hard ceiling. Ductwork that was accessible looked to be installed properly. Recommend ensuring that the fan is rotating correctly and no other obstructions inside of the fan or at discharge.  
**Created By :** National TAB                      **Assigned To :** National TAB - Brianna Biggs  
**Status :** Open  
**Originated Date :** 06/29/2023 - Jordan Best - National TAB

- **08/04/2023 National TAB - Will Turnbough**
  - Fan curve indicates airflow should be closer to 1500 CFM.

Fan nearly inaccessible due to hard ceiling. Only able to adjust set point and view RPM. Flow was originally hindered by stuck backdraft damper, addressed this issue but was still unable to raise flow to design. Suspect leakage in duct work but could not verify due to hard ceiling throughout space.

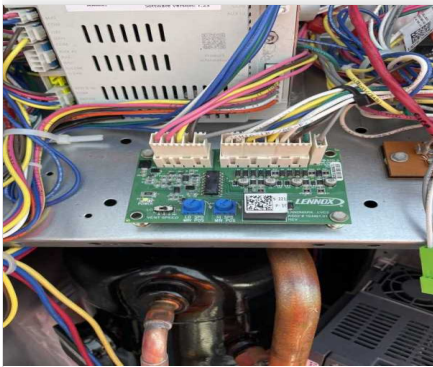
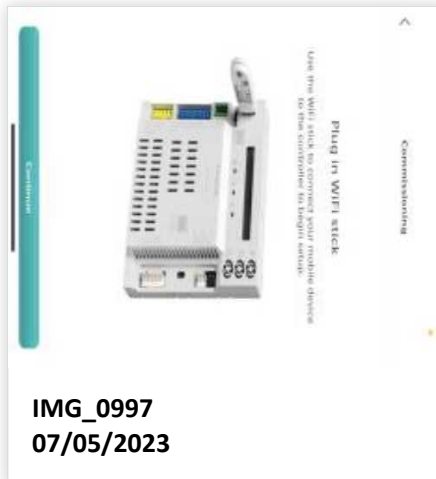
**Issue Name :** NO ECON CONTROLLER RTU-1  
**Description :** ECONOMIZER CONTROLLER FOR RTU-1 APPAERS TO REQUIRE WIFI STICK FOR SIEMENS MODULE. DAMPER DOES NOT RESPOND TO ADJUSTMENT WITH POTENTIOMETERS. UNABLE TO SET OA.

RTU1 ECON NOT FUNCTIONAL

UNABLE TO SET OA DUE TO LACK OF ACCESS TO SIEMENS CONTROL BOARD. WI-FI STICK COMPATIBLE WITH BOARD REQUIRED FOR ADJUSTING ECON.

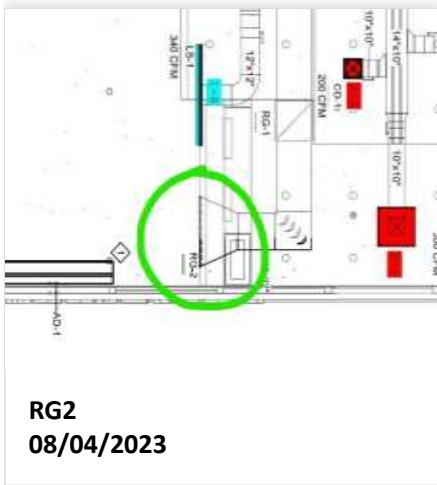
**Issue Name :** RG-2 NOT INSTALLED  
**Description :** RETURN GRILLE 2 LOCATED IN THE DINING AREA IS NOT INSTALLED. RECOMMEND INSTALLING.  
**Created By :** National TAB                      **Assigned To :** National TAB - Brianna Biggs  
**Status :** Open  
**Originated Date :** 06/27/2023 - Jordan Best - National TAB

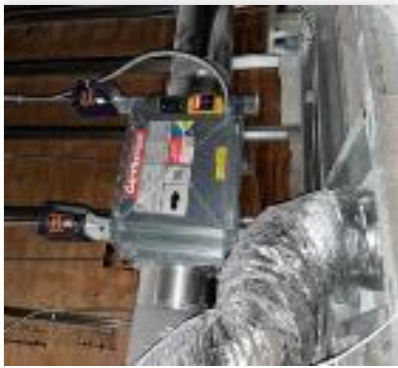
**IMG\_0956**  
**07/17/2023**

GX-1
