Report: TAB REPORT
Function: Test, Adjust, & Balance
Date: 07/14/2023

06-05-23 SWEETGREEN - PEABODY, MA
(TAB, IAQ)

210 ANDOVER ST

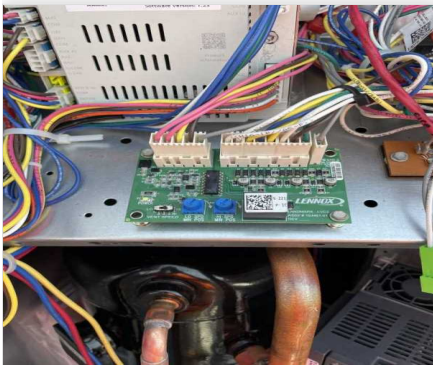
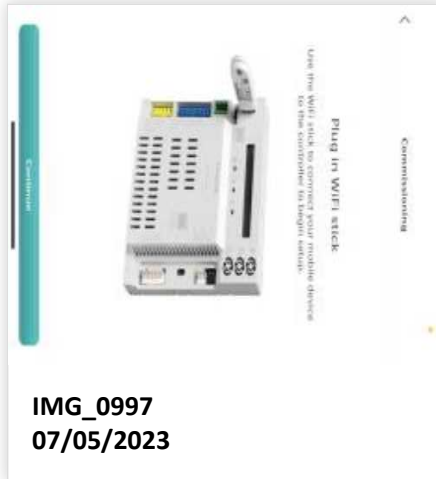
IMG_0998
07/05/2023

Issue Name : NO ECON CONTROLLER RTU-1
Description : ECON CONTROLLER FOR RTU-1 REQUIRES WIFI STICK FOR SIEMENS MODULE, DIALS ON UNIT DO NOT OPERATE ECON, UNABLE TO SET OA
Created By : National TAB **Assigned To :** National TAB - Brianna Biggs
Status : Open
Originated Date : 07/05/2023 - Jordan Best - National TAB

UNABLE TO SET OA DUE TO LACK OF ACCESS TO SIEMENS CONTROL BOARD. WI-FI STICK COMPATIBLE WITH BOARD REQUIRED FOR ADJUSTING ECON.
