TAB PUNCHLIST - CFA 05535 08/27/24

Aug 27, 2024

L05535_South Topeka Blvd (KS) FSU

3231 Southwest Topeka Boulevard, Topeka, Kansas

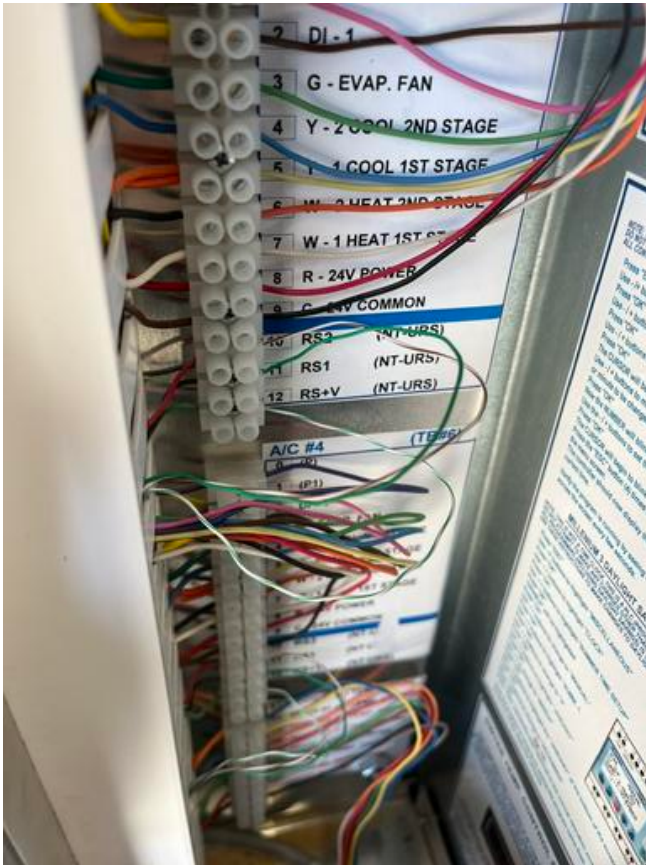
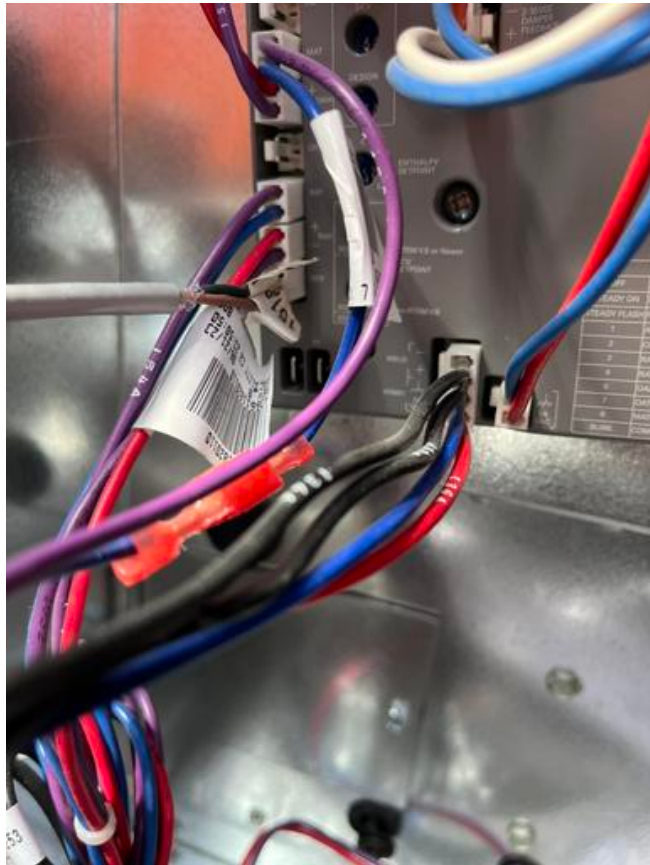
#189 [UNIT 999] [NEW] (MISC) P/P1 not connected to economizer module on AC4

Description
On AC4, P/P1 from the Suncoast panel should connect to P/P1 on the economizer module inside the unit.

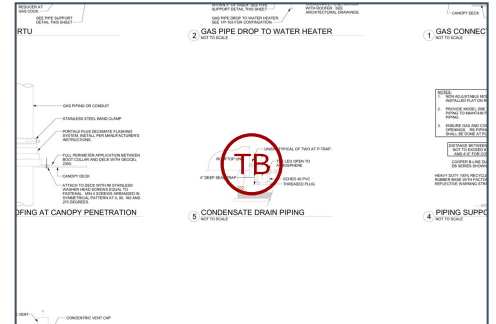
Sheet
M-502

Equipment condensate piping or p-trap is not constructed per normal CFA specifications.

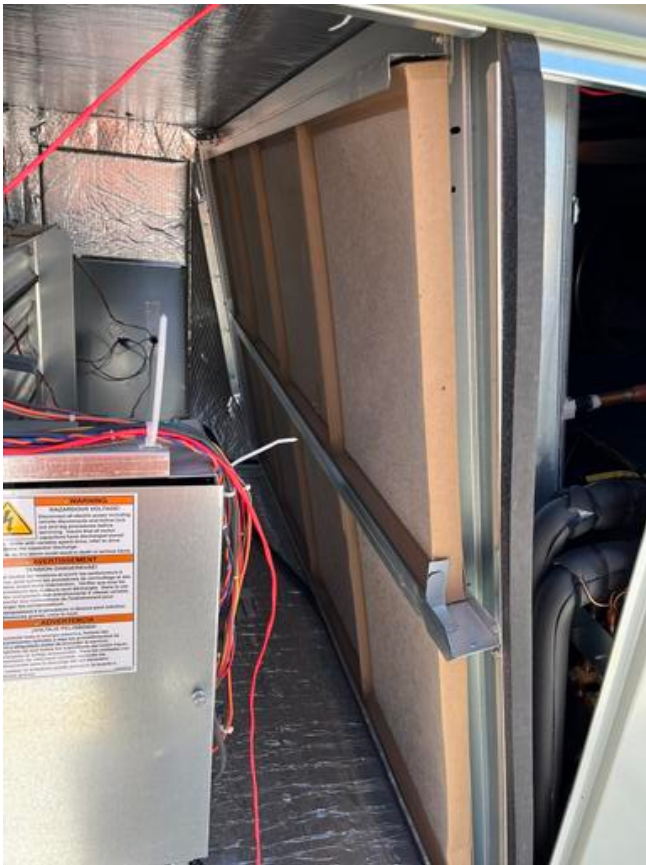
#185 [UNIT 522] [NEW] AC air filters.

Filters in AC3 are not pleated per design. The units are also missing extra set per specification.

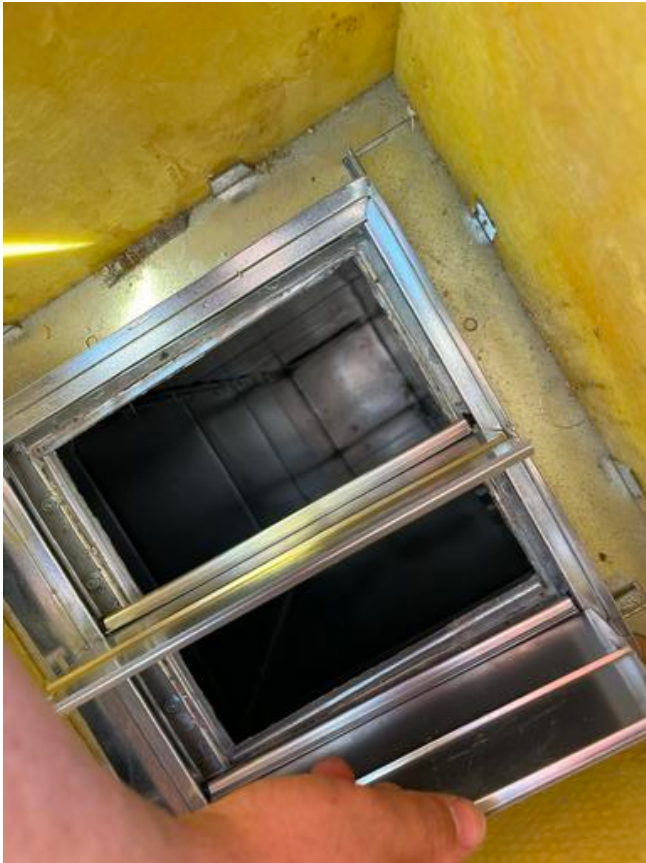
#183 [EXHA 500] [NEW] Restroom rectangular duct riser.

Restroom exhaust
rectangular duct riser not
correctly lined per
specification

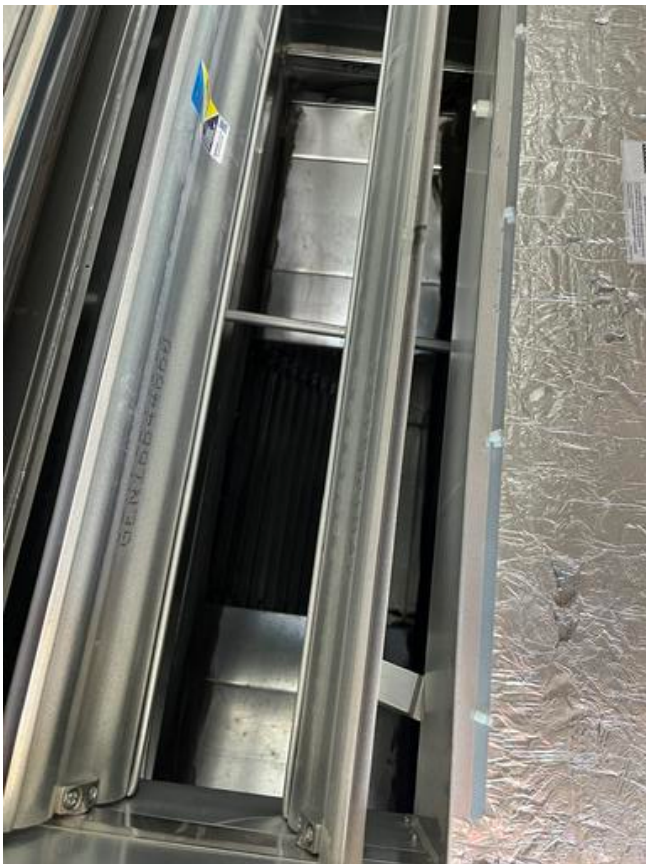
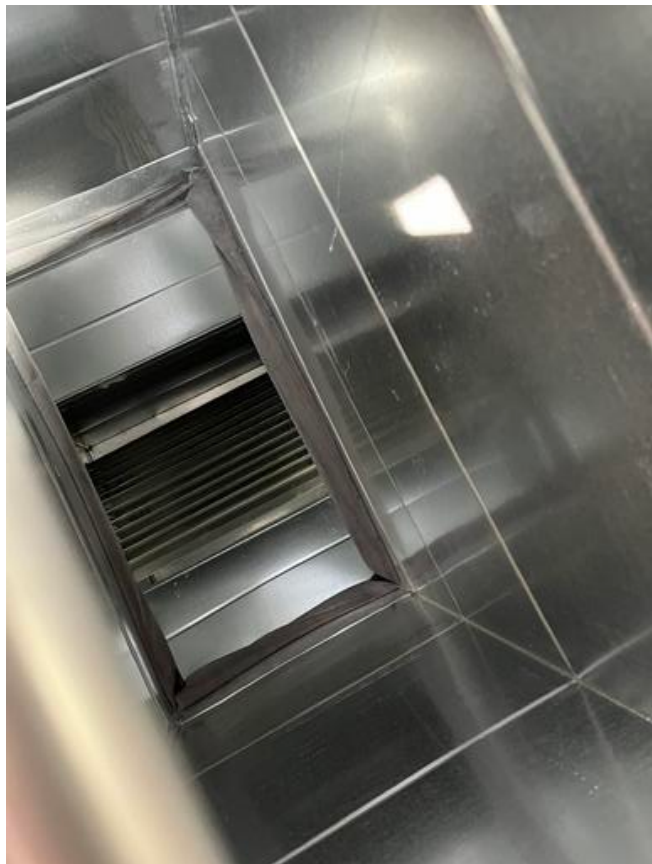
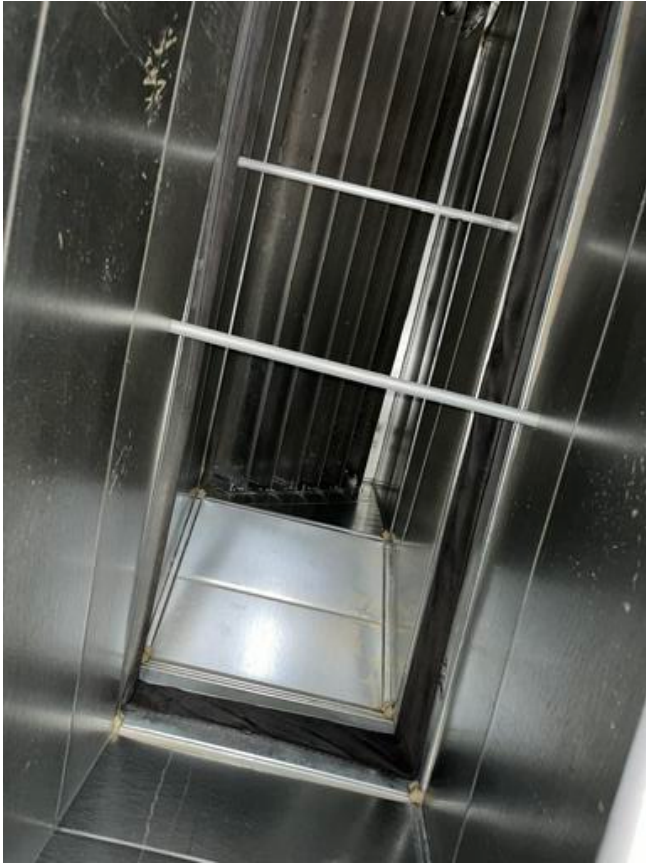
#182 [DUCT 002] [NEW] CRITICAL – Turning vanes in return duct.

Turning vanes are present in the return duct and need to be removed per specification. Present in return ducts of AC1, AC2, and AC3

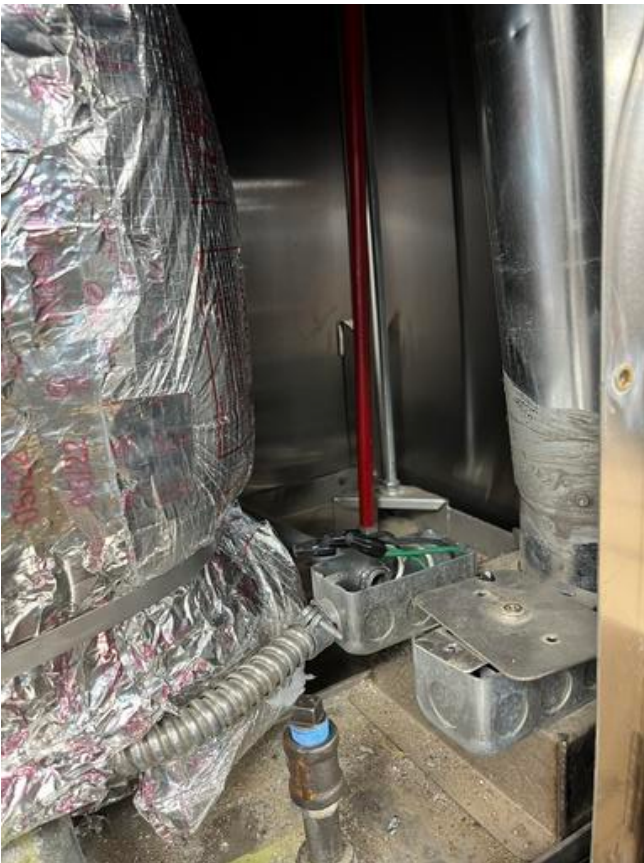
#181 [HOOD 499] [NEW] CRITICAL (MISC) – Capture Jet Fan not wired

Capture jet fans are not wired currently for operation.

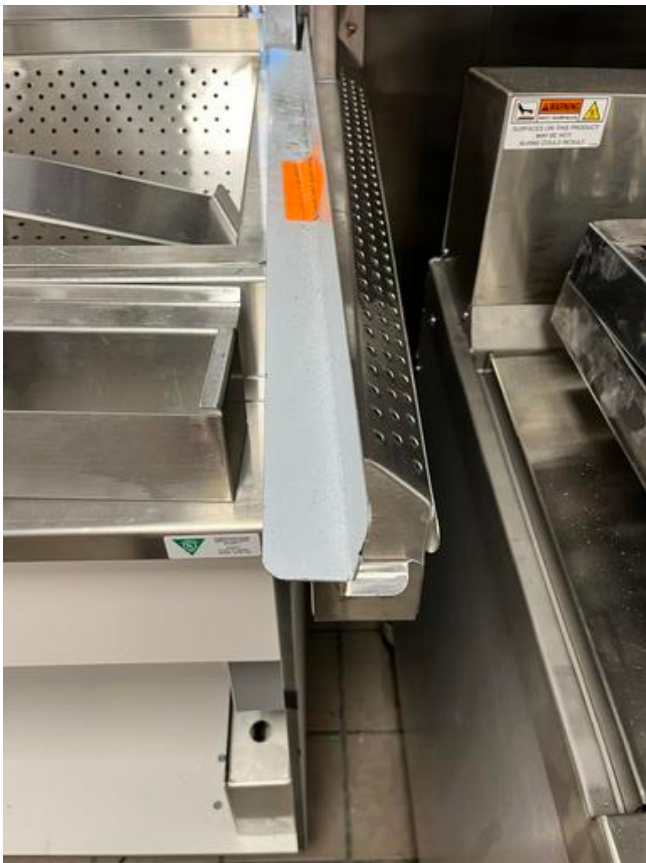
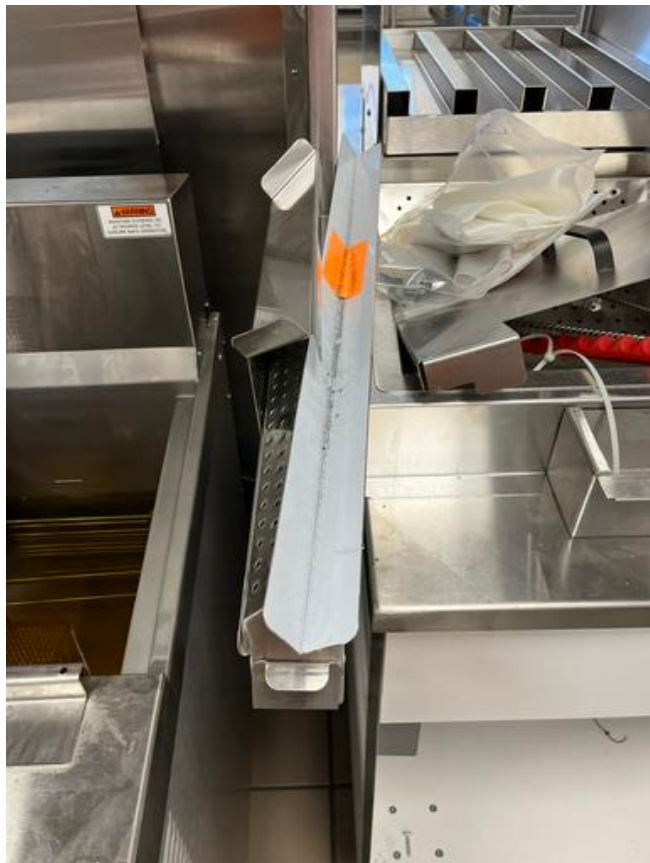
#180 [HOOD 508] [NEW] Sidejet arm angle bracket.

The Halton supplied angle bracket that connects the integral sidejet arm to the counter is missing or not installed correctly. Secure bracket to arm and bracket to counter underneath removeable fry dump via stainless steel rivets.

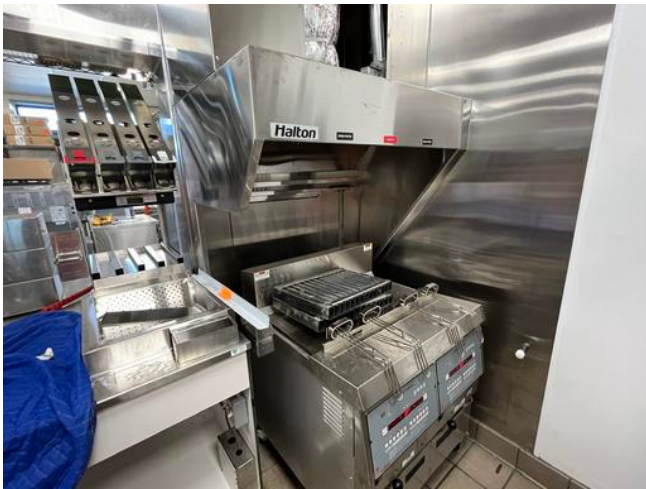
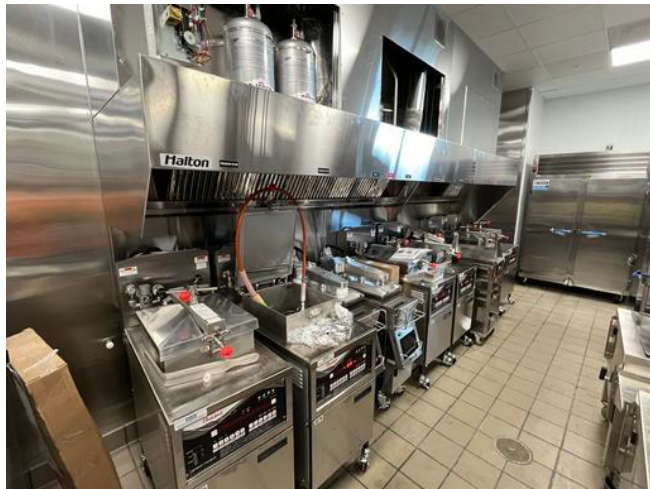
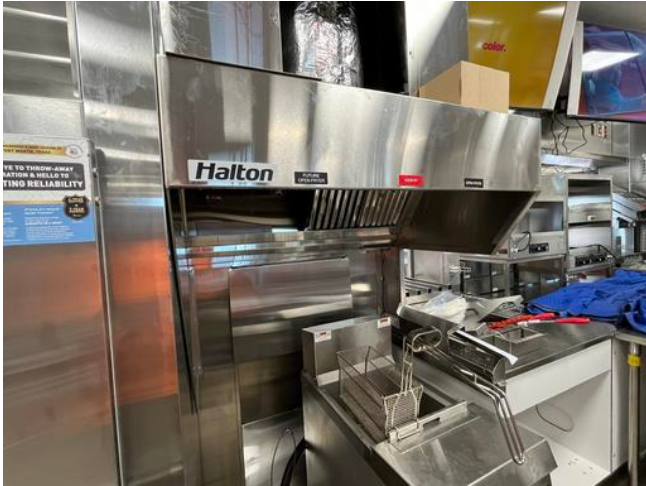
#179 [HOOD 500] [NEW] Hood lighting.

Hood has lighting not energized properly with exhaust fans on or light(s) is flickering.
