**All State Fire Midwest
1030 W. 23rd, Suite G
Independence, MO 64055**

**Report: Sierra Grill Duct Integrity Test
Function: Life Safety
Date: 12/29/2022**

**PROJECT
Sierra Grill**

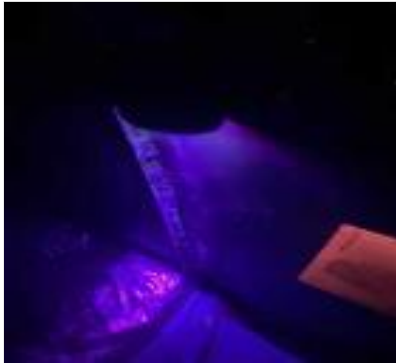
Pressurized Water Test section 1 duct work - Main Cook Line. Exhaust duct meets NFPA 17a and 96 standard. Fail

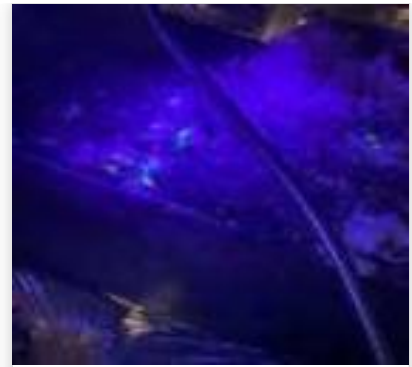
Pressurized Water Test Section 2 duct work - Main Cook Line. Exhaust duct meets NFPA 17a and 96 standard. Fail

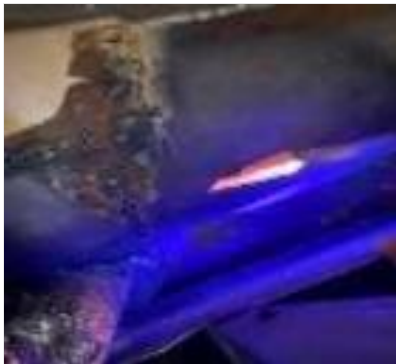
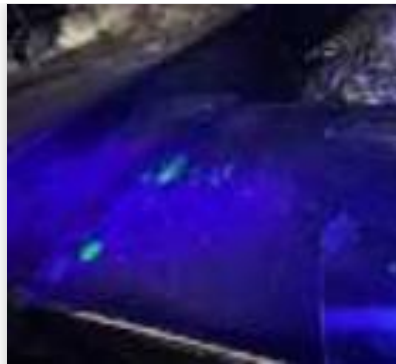
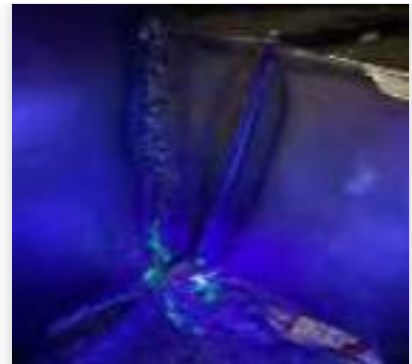
Pressurized Water Test Section 3 ductwork - Main Cook Line. Exhaust duct meets NFPA 17a and 96 standard.

Fail

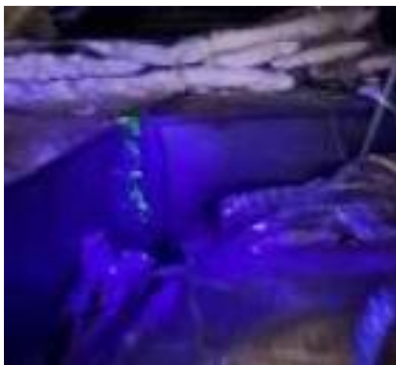
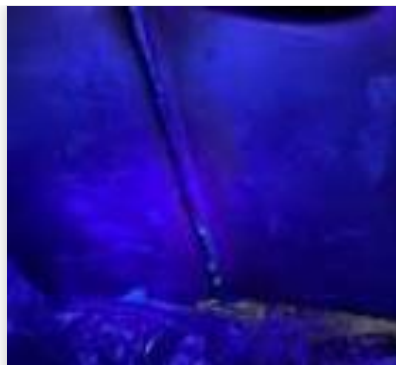
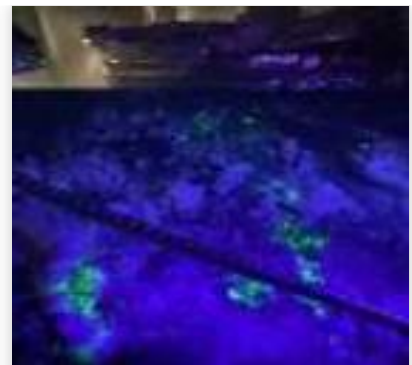
Pressurized Water Test Section 4 ductwork - Main Cook Line. Exhaust duct meets NFPA 17a and 96 standard.

Fail

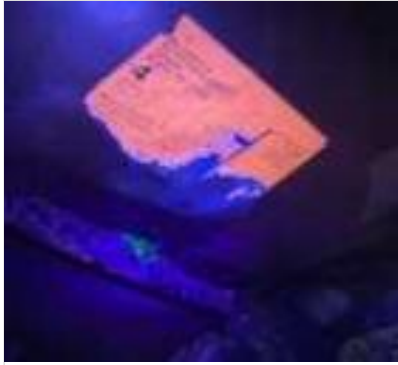
Pressurized Water Test Section 5 ductwork - Main Cook Line. Exhaust duct meets NFPA 17a and 96 standard.

Fail

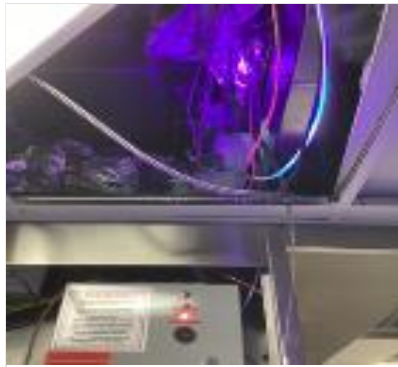
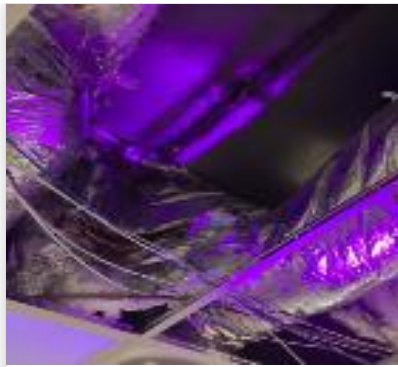
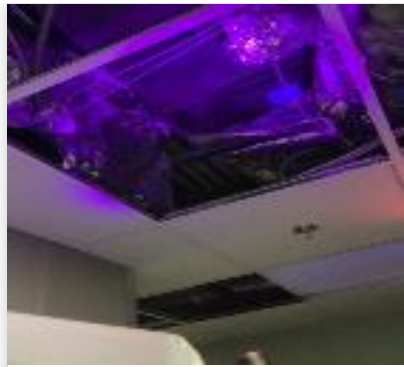
Pressurized Water Test - Main Cook line- Misc Photos

Fail

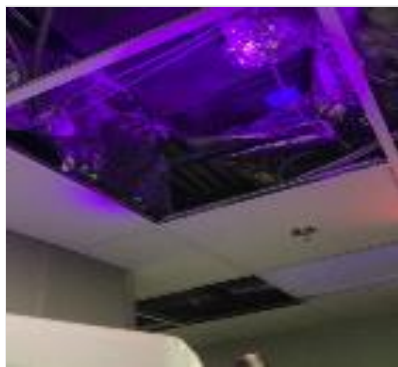
Pressurized Water Test - Main Cook Line Misc Video

Fail
