Sierra Grill

Name : Sierra Grill Exhaust pressurized water test **Status :** NotSubmitted
Assigned Organization : All State Fire Midwest **Asset :**
Requesting Organization : All State Fire Midwest

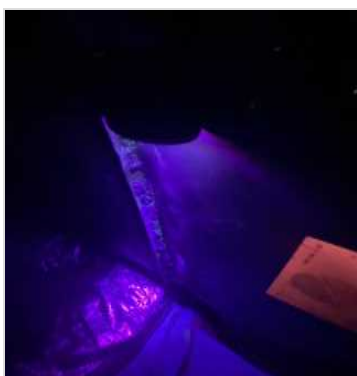
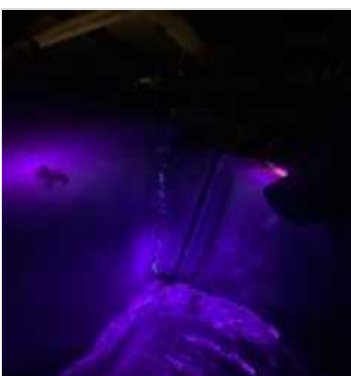
Pressurized Water Test section 1 duct work - Main Fail
Cook Line. Exhaust duct meets NFPA 17a and 96
standard.

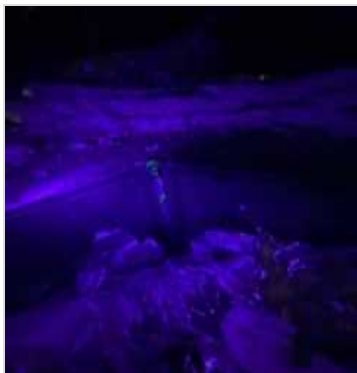
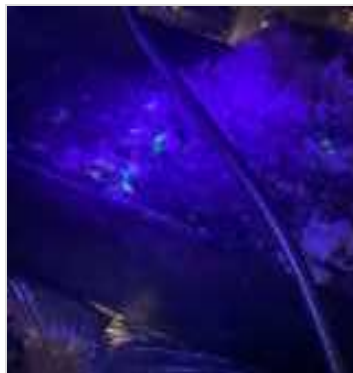
Pressurized Water Test Section 2 duct work - Main Fail
Cook Line. Exhaust duct meets NFPA 17a and 96
standard

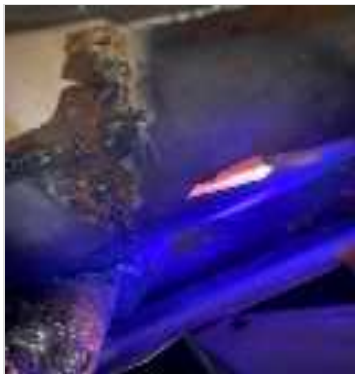
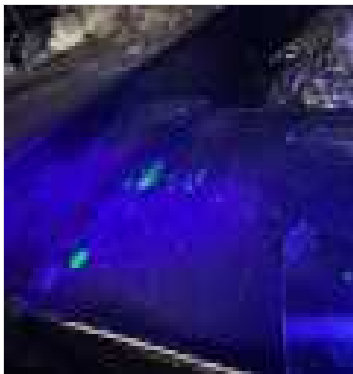
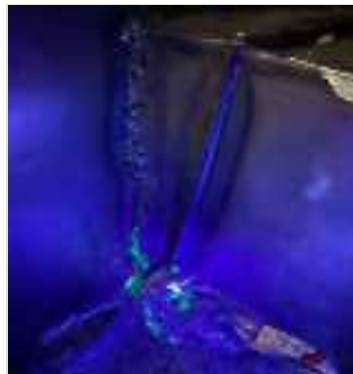
Pressurized Water Test Section 3 ductwork - Main Fail
Cook Line. Exhaust duct meets NFPA 17a and 96
standard.

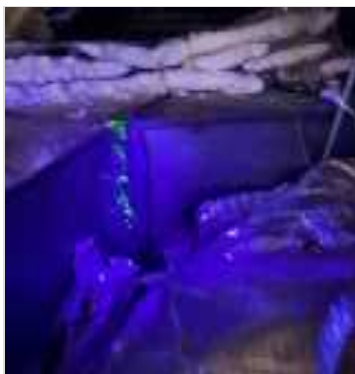
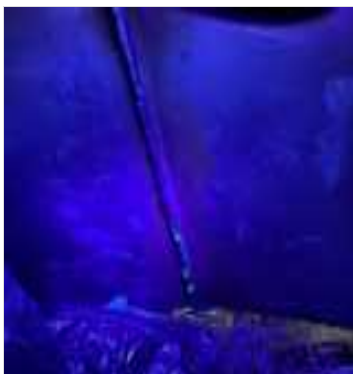
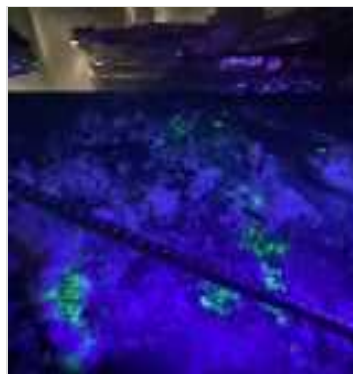
Pressurized Water Test Section 4 ductwork - Main Cook Line. Exhaust duct meets NFPA 17a and 96 standard. Fail

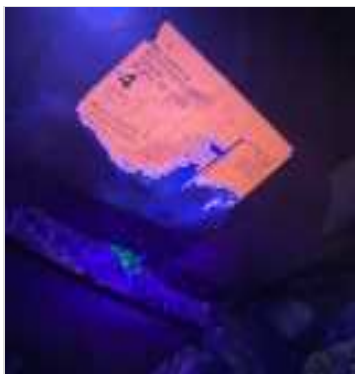
Pressurized Water Test Section 5 ductwork - Main Cook Line. Exhaust duct meets NFPA 17a and 96 standard. Fail

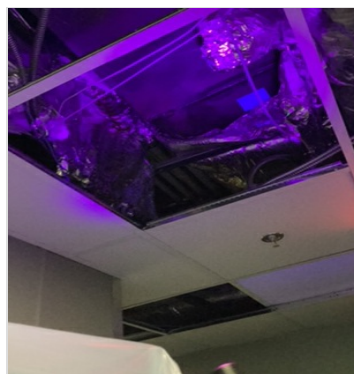
Pressurized Water Test - Main Cook line- Misc Photos Fail
