# Sierra Grill

**Name :** Sierra Grill Exhaust pressurized water test      **Status :** NotSubmitted  
**Assigned Organization :** All State Fire Midwest      **Asset :**  
**Requesting Organization :** All State Fire Midwest

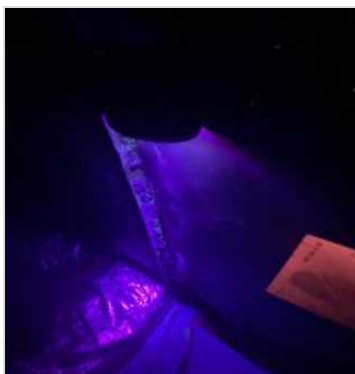
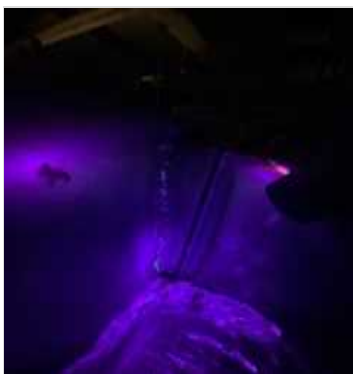
Pressurized Water Test section 1 duct work - Main      Fail  
Cook Line. Exhaust duct meets NFPA 17a and 96  
standard.

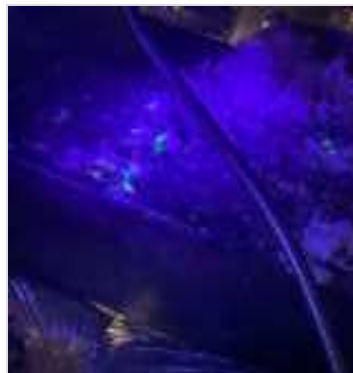
Pressurized Water Test Section 2 duct work - Main      Fail  
Cook Line. Exhaust duct meets NFPA 17a and 96  
standard

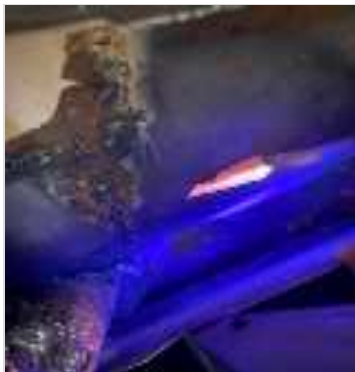
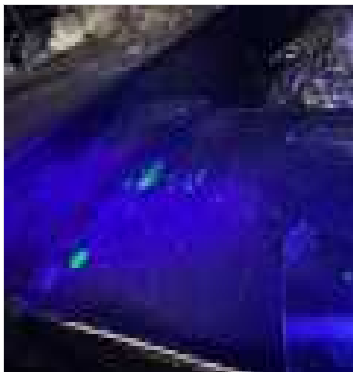
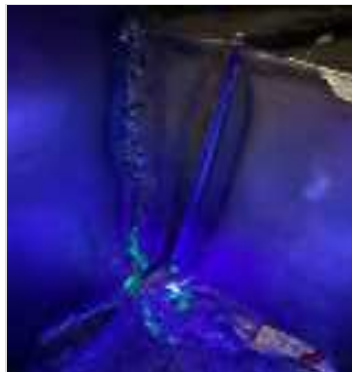
Pressurized Water Test Section 3 ductwork - Main      Fail  
Cook Line. Exhaust duct meets NFPA 17a and 96  
standard.

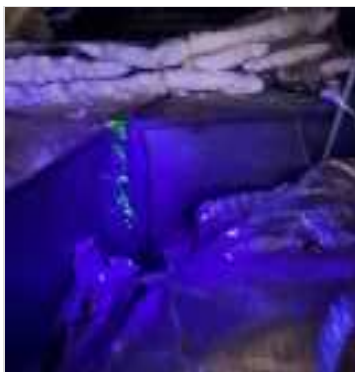
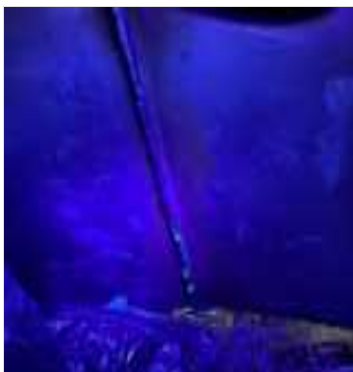
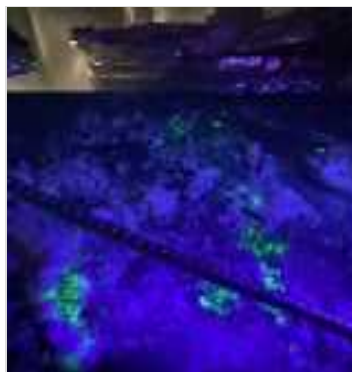
Pressurized Water Test Section 4 ductwork - Main Cook Line. Exhaust duct meets NFPA 17a and 96 standard. Fail

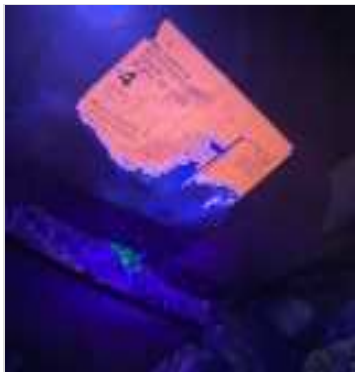
Pressurized Water Test Section 5 ductwork - Main Cook Line. Exhaust duct meets NFPA 17a and 96 standard. Fail

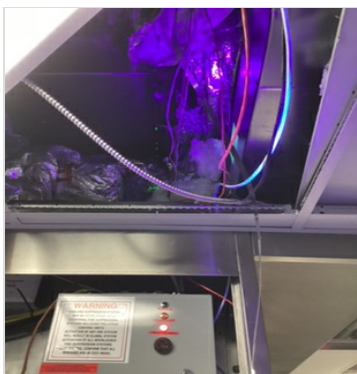
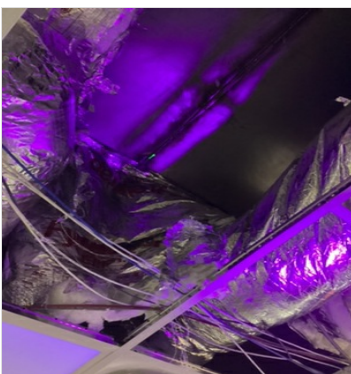
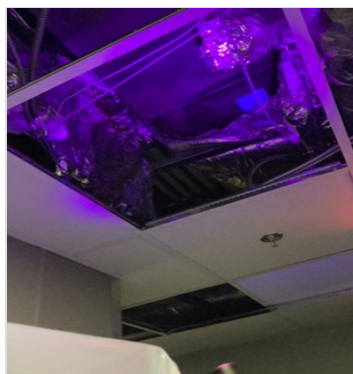
Pressurized Water Test - Main Cook line- Misc Photos Fail

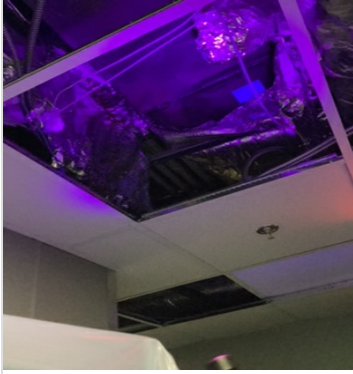
Pressurized Water Test - Main Cook Line Misc Video Fail
