## Sierra Grill

**Name :** Sierra Grill Exhaust pressurized water test      **Status :** NotSubmitted  
**Assigned Organization :** All State Fire Midwest      **Asset :**  
**Requesting Organization :** All State Fire Midwest

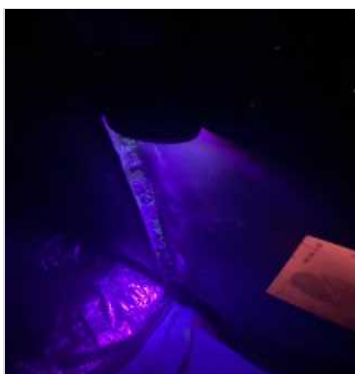
IMG\_7407\_1\_.jpg

Pressurized Water Test section 1 duct work - Main      Fail  
 Cook Line. Exhaust duct meets NFPA 17a and 96  
 standard.

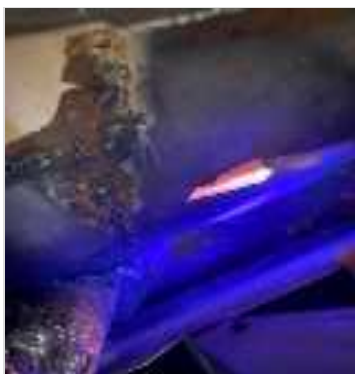
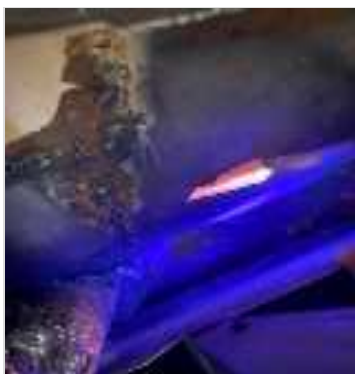
**IMG\_7414\_1.jpg**

Pressurized Water Test Section 3 ductwork - Main Cook Line. Exhaust duct meets NFPA 17a and 96 standard.

Fail

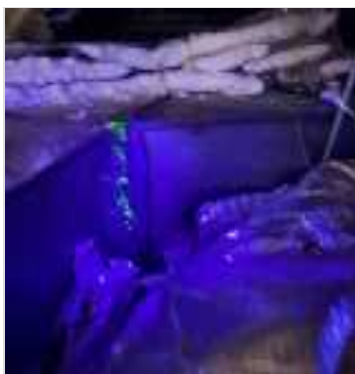
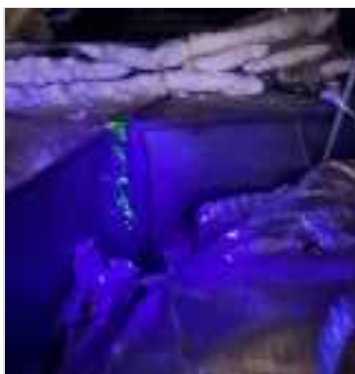
**IMG\_7417\_1.jpg**

Pressurized Water Test Section 4 ductwork - Main Cook Line. Exhaust duct meets NFPA 17a and 96 standard.

Fail

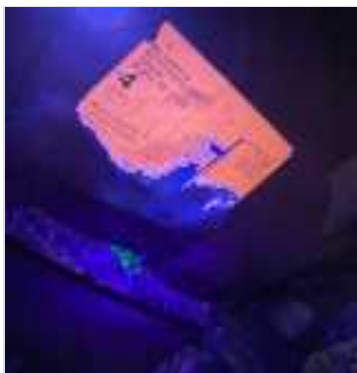
IMG\_7422\_1\_.jpg

Pressurized Water Test Section 5 ductwork - Main Cook Line. Exhaust duct meets NFPA 17a and 96 standard.

Fail

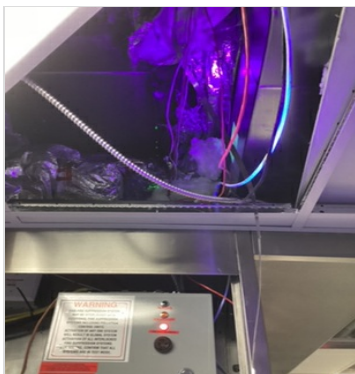
**Leaktestipad1main.jpeg**

Pressurized Water Test - Main Cook line- Misc Photos

Fail

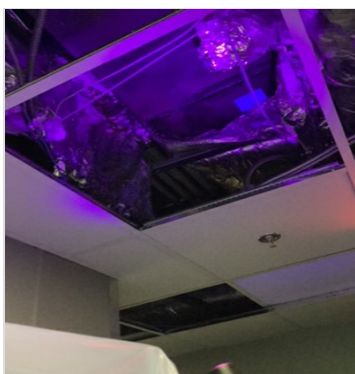
**Leaktestmain.jpeg**

Pressurized Water Test - Main Cook Line Misc  
Video

Fail
