Sierra Grill

CheckList Information

Name : Sierra Grill Exhaust pressurized water test **Status :** NotSubmitted
Assigned Organization : All State Fire Midwest **Asset :**
Requesting Organization : All State Fire Midwest

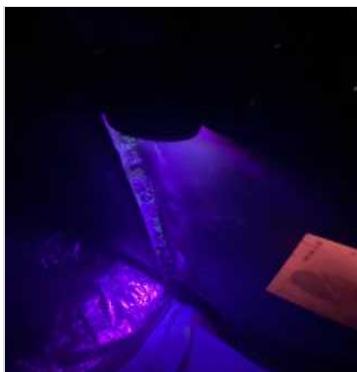
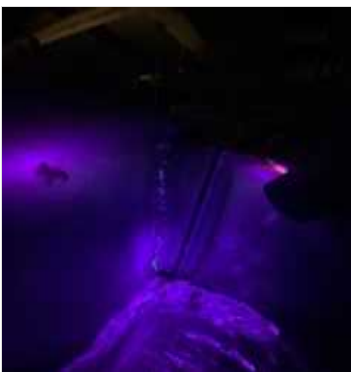
Pressurized Water Test section 1 duct work - Main Fail
Cook Line. Exhaust duct meets NFPA 17a and 96 standard.

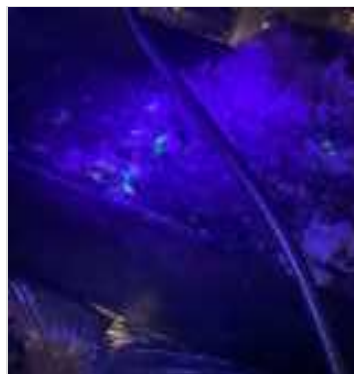
Pressurized Water Test Section 2 duct work - Main Fail
Cook Line. Exhaust duct meets NFPA 17a and 96 standard

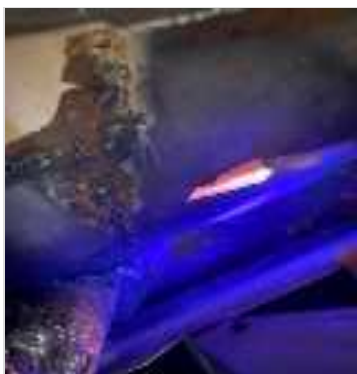
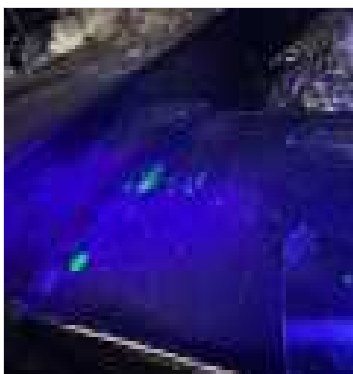
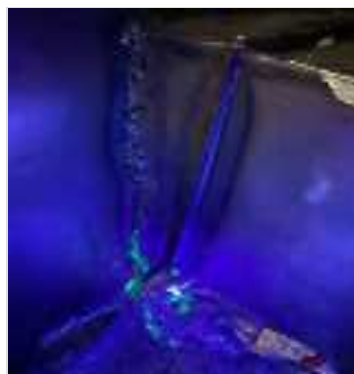
Pressurized Water Test Section 3 ductwork - Main Cook Line. Exhaust duct meets NFPA 17a and 96 standard. Fail

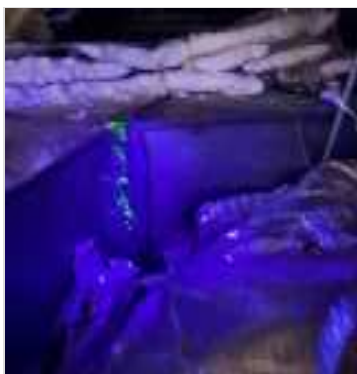
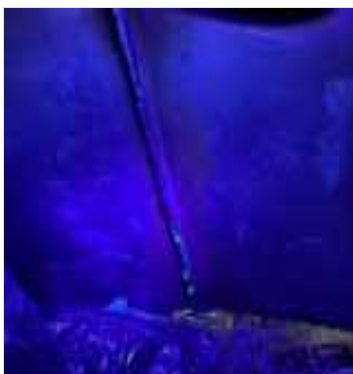
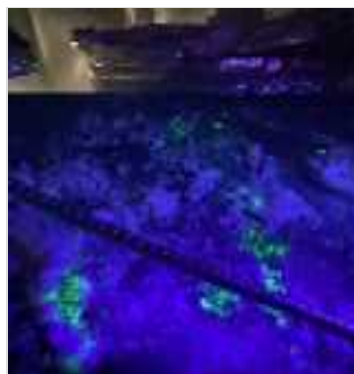
Pressurized Water Test Section 4 ductwork - Main Cook Line. Exhaust duct meets NFPA 17a and 96 standard. Fail

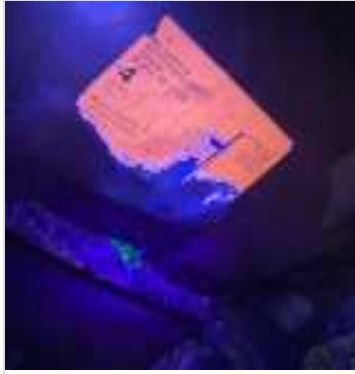
Pressurized Water Test Section 5 ductwork - Main Cook Line. Exhaust duct meets NFPA 17a and 96 standard.

Fail

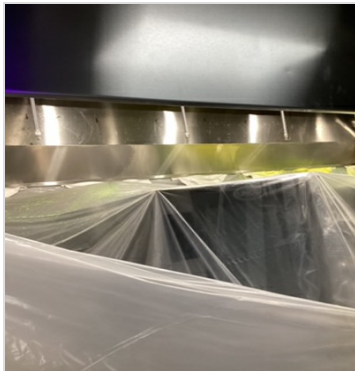
Processpressuretest1.jpg

Method-process for pressure testing. 1600 psi pressurize water jet utilizing photo-lumencent amplifier and UV Light test at all joints in the main cook line.

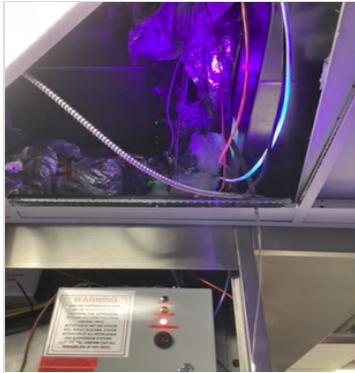
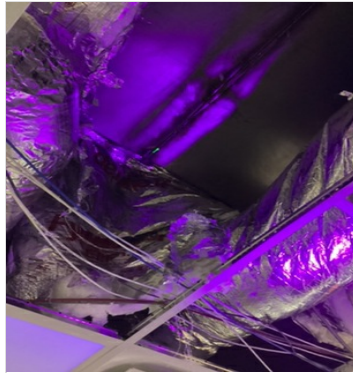
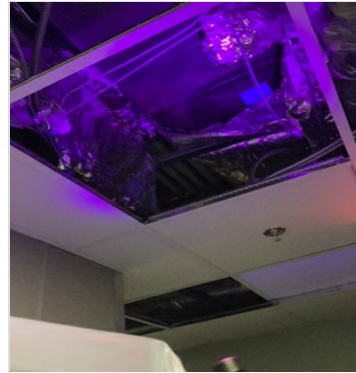
Pressurized Water Test - Main Cook line- Misc Photos

Fail

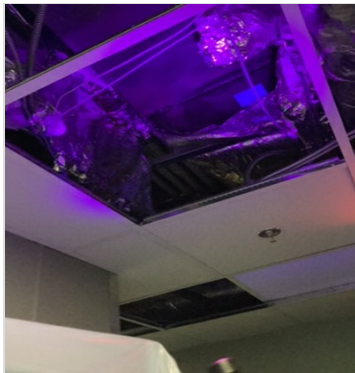
Pressurized Water Test - Main Cook Line Misc Fail
Video
