Report: TAB REPORT
Function: Test, Adjust, & Balance
Date: 12/12/2024
Completed By: National TAB

PROJECT
12-09-24 CULVERS PRINCETON, MN

Project: 12-09-24 CULVERS PRINCETON, MN

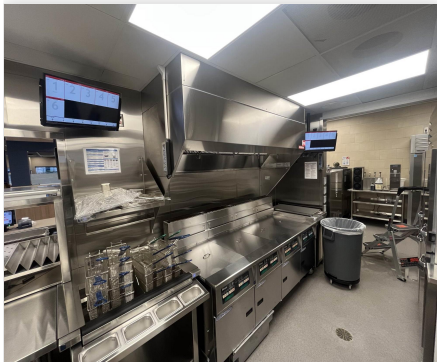
Issue Name : HOOD SMOKE CAPTURE
Description : Due to incorrect diffuser placement, deviation from duct design, and missing dampers; smoke capture was poor on HD-1. Adjusted diffuser values on Cookline to improve hood capture. Individual diffusers not balanced to design as a result, however, smoke capture is much improved.

- **12/12/2024 National TAB - Will Turnbough**
 - Diffuser placement fixed per GC pictures and missing dampers are now installed.

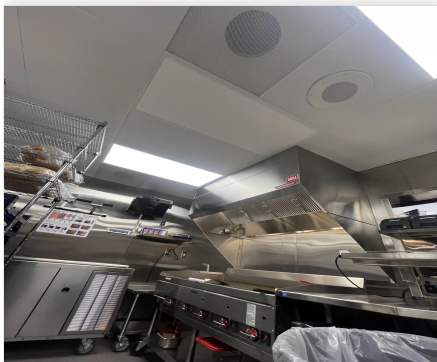
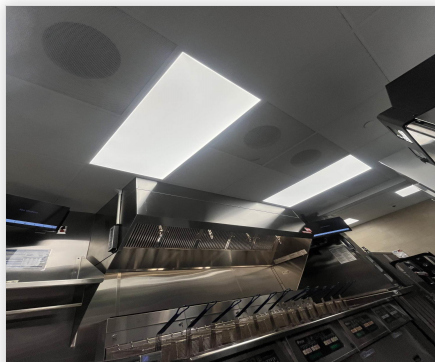
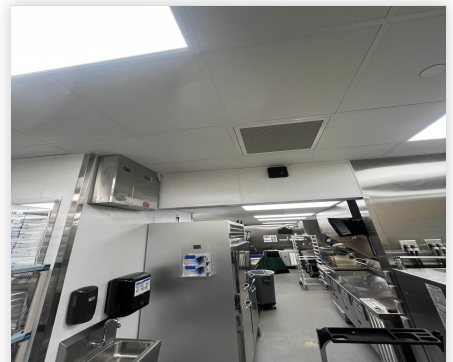
Issue Name : RTU-2: Cookline Diffusers
Description : Cookline Diffuser 1-7 is not in correct position per plans. It's important cookline diffusers are installed per plan for hood capture. Several kitchen diffusers are also missing dampers. MC came to install missing dampers, but only brought 2 dampers. Several still missing. Additionally, return in incorrect location per plans.

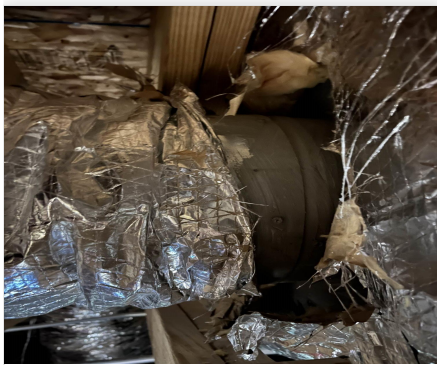
Issue Name : RTU-2: Missing Dampers
Description : Kitchen unit is missing dampers on several diffusers. Where necessary, flex was banded with drawband to reduce airflow. See issue regarding smoke capture; diffusers not balanced to design.
Created By : National TAB **Assigned To :** National TAB - Dan Hertenstein
Status : Closed
Priority : High **Asset Tag :** RTU2
Originated Date : 12/10/2024 - Michael McDonnell - National TAB
