Report: Preliminary TAB
Function: Test, Adjust, & Balance
Date: 08/18/2024

08-12-24 WAWA #5446 MERRITT ISLAND, FL

Wawa
260 West Baltimore Pike
Wawa, PA 19063

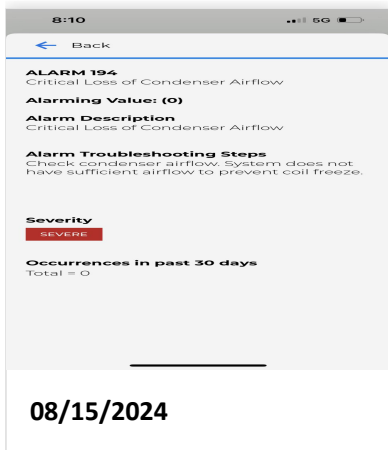
Issue Name : RTU 1 - Alarm 194
Description : Alarm 194 - Critical loss of condenser airflow. Water is dripping into the discharge duct and from the supply diffusers. Recommend HVAC inspection.
Created By : National TAB **Assigned To :** National TAB - Will Turnbough
Status : Open
Priority : Urgent **Asset Tag :** RTU1
Originated Date : 08/15/2024 - Mark Johnson - National TAB

- **08/16/2024 National TAB - Mark Johnson**
 - Resolved after setting OA to design.

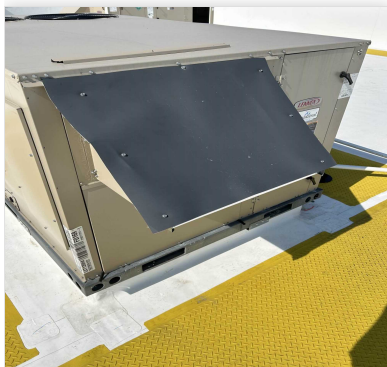
Issue Name : RTU 2 - Incorrect OA Hood Cover
Description : RTU 2 is missing the metal cover for the OA intake hood. A vinyl sheet has been fastened in its place. Recommend repairing with metal plate.
Created By : National TAB **Assigned To :** National TAB - Will Turnbough
Status : Open
Priority : Medium **Asset Tag :** RTU2
Originated Date : 08/15/2024 - Mark Johnson - National TAB

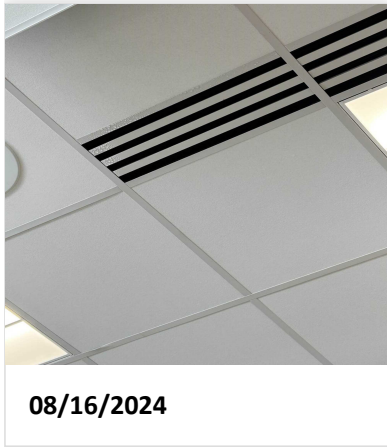
Issue Name : RTU 3 - Water Leaking From Diffusers
Description : There is excess moisture leaking around the discharge compartment in RTU 3. Water droplets are leaking from most diffusers served by this unit. No Core alarms present. Recommend HVAC inspection.
Created By : National TAB **Assigned To :** National TAB - Will Turnbough
Status : Open
Priority : Urgent **Asset Tag :** RTU3
Originated Date : 08/15/2024 - Mark Johnson - National TAB

- **08/16/2024 National TAB - Mark Johnson**
 - May be due to unit adjusting to new OA setting. Observe for the next several days to determine if the issue resolves or persists.
