Project Summary

The purpose of the testing was to evaluate cause of hot conditions at the cookline. Limited design information was provided so target airflows were made based on previous design documents, equipment size and application, and typical 5 Guys Designs.

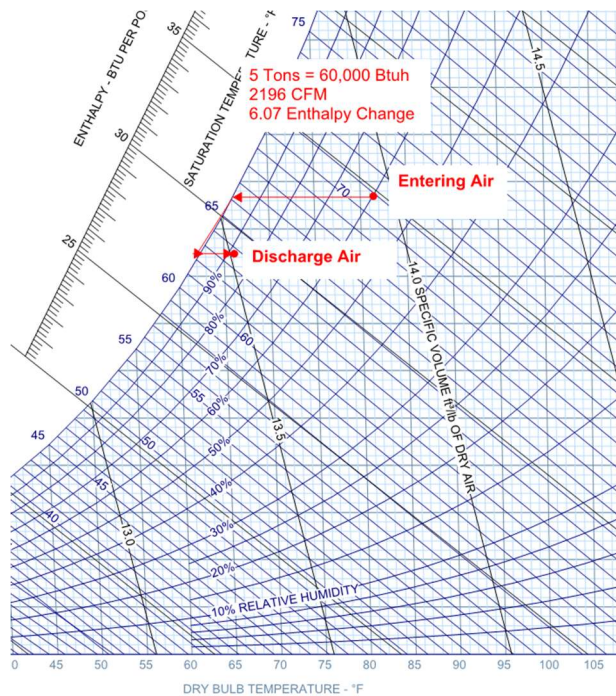
Airflow for RTU-4 on the cookline was initially 1704 CFM (341 CFM/ton) and was increased to 2196 CFM (439 CFM/ton) to increase airflow on the cookline. The temperature on the cookline was in the 70's in the morning but as the day progressed it increased to around 85 degrees. The measured temperature at the temp sensor matched what was being displayed on the thermostat which indicates it is sensing an accurate temperature. During peak cooking times entering and leaving temperatures on the evaporator coil were measured as 81 EAT and 66 LAT which is a 15 degree drop. A quick check was done on a psychrometric chart and it appears this is a reasonable discharge temperature, however it is recommended that the refrigeration of this unit be checked to ensure it is adequately charged and operating properly.

1. Ensure that refrigeration for RTU-4 on the cookline is adequately charged and operating properly. Appears that it is based on the entering air conditions even though the discharge temp was measured as 66 degrees.
