**Report: Brightview-DOAS1 Analysis**

**Function: Test, Adjust, & Balance**

## BVE - Brightview Senior Living (Eatontown, NJ)

Project: BVE - Brightview Senior Living (Eatontown, NJ)

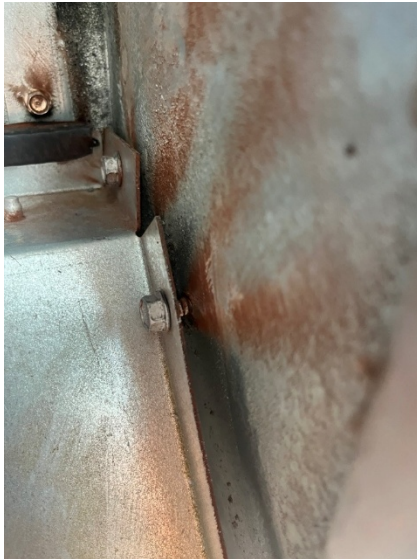
Per DJW DOAS filters have been replaced and Heat Wheel cleaned and serviced by facility staff prior to our testing. New filters were found inside the unit at time of testing. All doors have had additional foam added to seal gaps and to prevent leakage. No air supply/exhaust leakage could be felt around any access doors indicating the unit is well sealed. The only spot we're there could be some short cycling is a bracket piece on the inside of the unit that is located in the coil/filter compartment. There was about a 1/8" gap (picture below) which most likely is

negligible leakage.

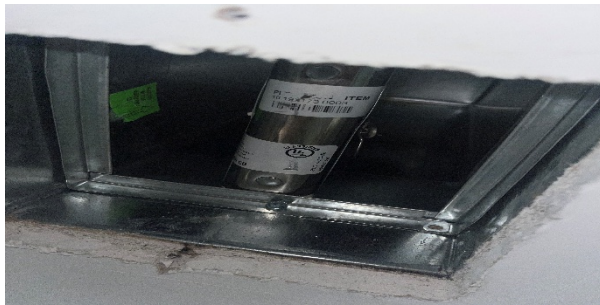
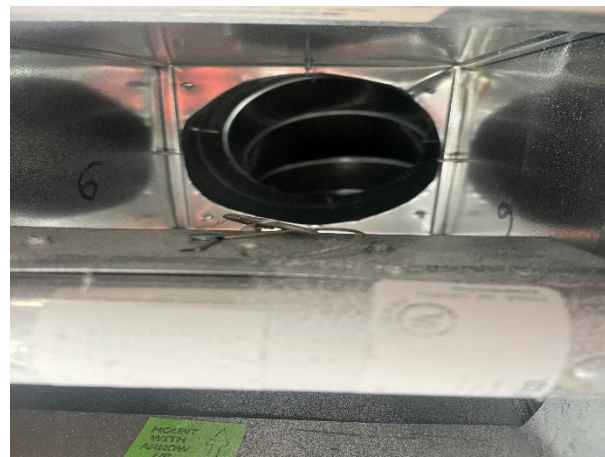
The reason to perform additional duct traverses is to develop a correction factor (K Factor) to be used as a multiplier to the flow-hood value. All modern flow-hoods are designed with back pressure analysis that will calculate a corrected airflow (k factor) for every reading. However, it is only accurate typically with settle pressure and velocity patterns changes at the supply or exhaust grills. When you have erratic readings (inconsistency) or possibility of velocity profile at the orifice of the velocity grid located at the bottom of the utilized flow hood it will have impact on the recorded CFM value that the built in back pressure factor does not work. This will cause

the inconsistency in readings that the team has experienced from different testing firms. It is NEBB guidelines and Flow-Hood Manufacturers recommendations to develop your own K factor when experiencing these issues in the field. For example, in extreme circumstances if you have uneven velocity across your flow-hood grid that is 5 times higher on one side versus the other side you will have an error of 20x. See pictures below. We pulled off several of the grills to inspect the duct configuration at the grills. The arrangement would create uneven exhaust or discharge at the grill. Larger plenum boxes had to be fabricated to allow for the fire dampers to be inserted inside the box just above the rated ceiling. Then the duct was cut in at the top of the plenum box either on the left, right, or center of box. This configuration would cause higher pressures on one side of the grill & lower on the other side with the compact arrangement. Our traverses taken did develop different K factors. So, we utilized an Average K factor of 1.27 for all flow-hood readings. Per flow-hood manufacturer recommendations we use a low-flow hood for any GRD measured at 150 CFM or less and a normal flow-hood for any devices of 150 CFM or more for better accuracy.

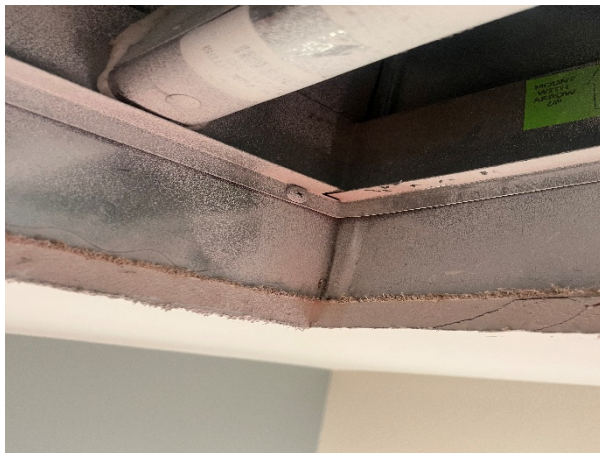
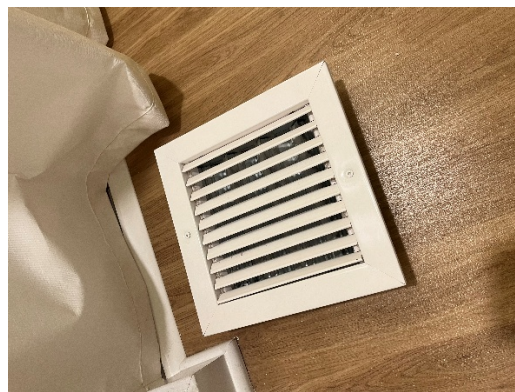
We also inspected the duct system above the hard ceiling as much as access would allow from traverse location to the exhaust grilles and found no sources of potential leakage. When we removed several of the exhaust grilles it was evident in each case that the fire rated sheetrock ceiling was sandwiched tight between the grill and the plenum box.

We pulled the insulation off the duct system where it tied to the top of the plenum boxes & found the duct was installed tight to the plenum box. Visually there was no evidence of duct construction that would allow for any significant leakage for a low pressure duct system.

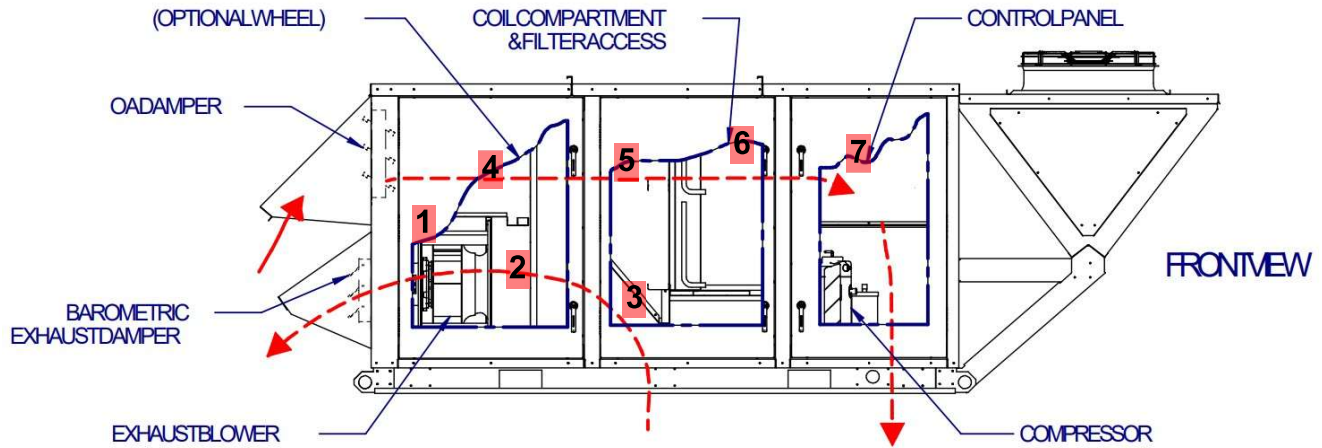
- 1. 0.44" EF DISCHARGE
- 2. -1.15" EF SUCTION
- 3. -0.60" PRESSURE AT EXHAUST DUCT (.55" WHEEL/PREFILTER DROP)
- 4. -0.08" OA INTAKE
- 5. -0.82" PRECOIL
- 6. -1.07" SUPPLY FAN INTAKE
- 7. 0.52" SUPPLY DISCHARGE

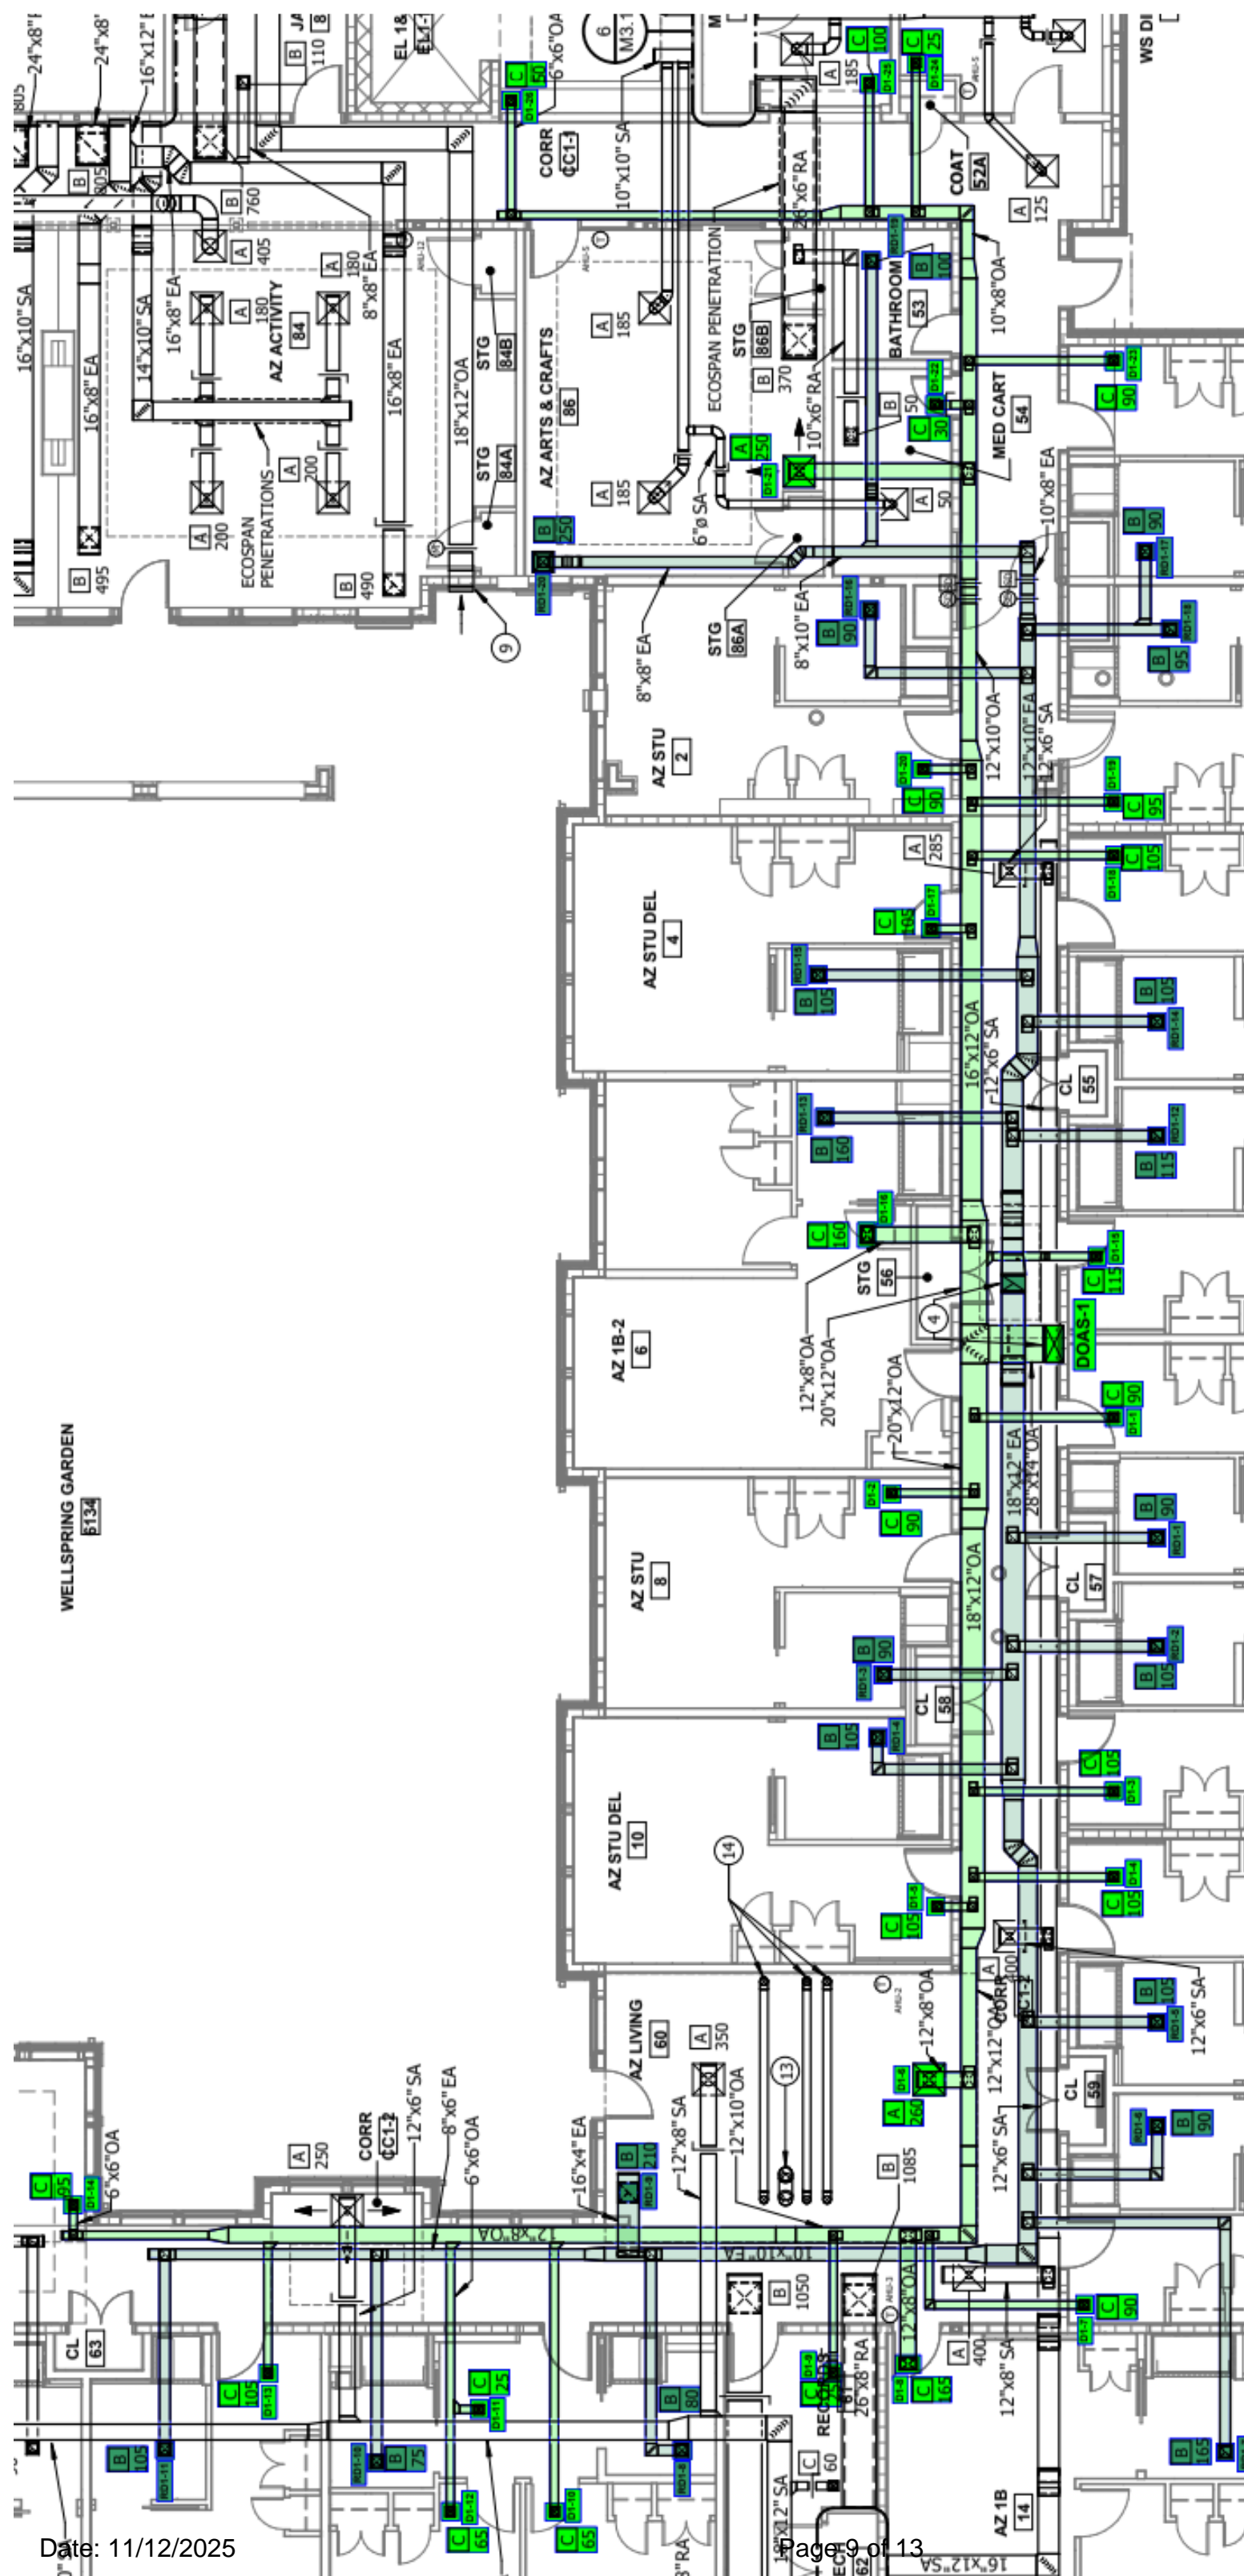
Asset	Notes	Date	Written By
EGRD19	[1] NOT REACHING DESIGN. EXHAUST GRD 17&18 DUCT WORK IS TAPPED OFF AT THE 10X8" DUCT POST FIRE DAMPER. 10X8 CANNOT HANDLE LOAD OF EGRDS-17/18/19/20 COMBINED.	11/05/2025	Tyler Youells
EGRD20	[1] NOT REACHING DESIGN. EXHAUST GRD 17&18 DUCT WORK IS TAPPED OFF AT THE 10X8" DUCT POST FIRE DAMPER. 10X8 CANNOT HANDLE LOAD OF EGRDS-17/18/19/20 COMBINED.	11/05/2025	Tyler Youells
