Report: Brightview-DOAS1 Analysis

Function: Test, Adjust, & Balance

Date: 09/22/2025

BVE - Brightview Senior Living (Eatontown, NJ)

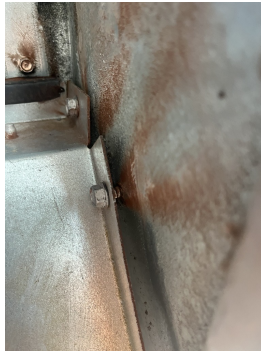
Per DJW DOAS filters have been replaced and Heat wheel cleaned and serviced by Facility staff. Fresh filters were found inside the unit at time of testing. All doors have had additional foam to seal gaps and to prevent leakage. No air supply/exhaust can be felt around any access doors showing the unit is well sealed. The only spot where there could be some short cycling is a bracket piece on the inside of the unit. Pictured:

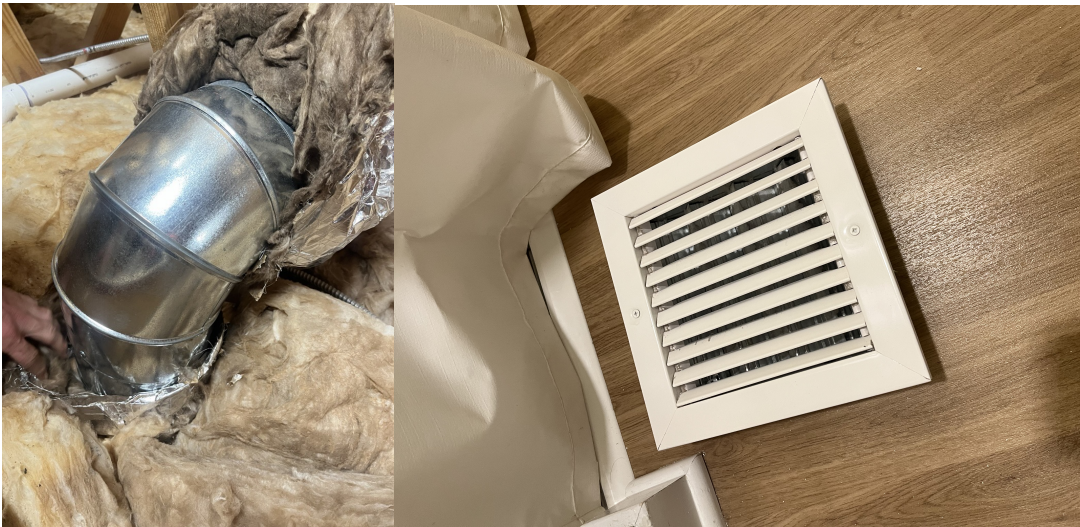
It was not possible to obtain a traverse of any part of the trunkline for the supply side of DOAS-1 due to the location of the duct above hard ceiling in the hallway and clearance needed to insert the pitot tube. Flow hood readings were taken on the supply side with three hood configurations types and it was found that there is no consistency and ability to triangulate hood readings or traverses. The hood readings on the supply side we deem as inaccurate. The reason for the discrepancy/inconsistency in readings is from the 1. Supply grille type, and 2. how the supply grille is connected to ductwork with an elbow directly on top of the plenum box. the configuration is creating turbulence across the flow hood grid where the flow hood requires laminar flow in order to read supply air accurately as you would see with a typical 4 way throw diffuser.

A total traverse of the DOAS supply was not possible so for further testing it would be recommended to read the total intake on the roof via alternative methods.

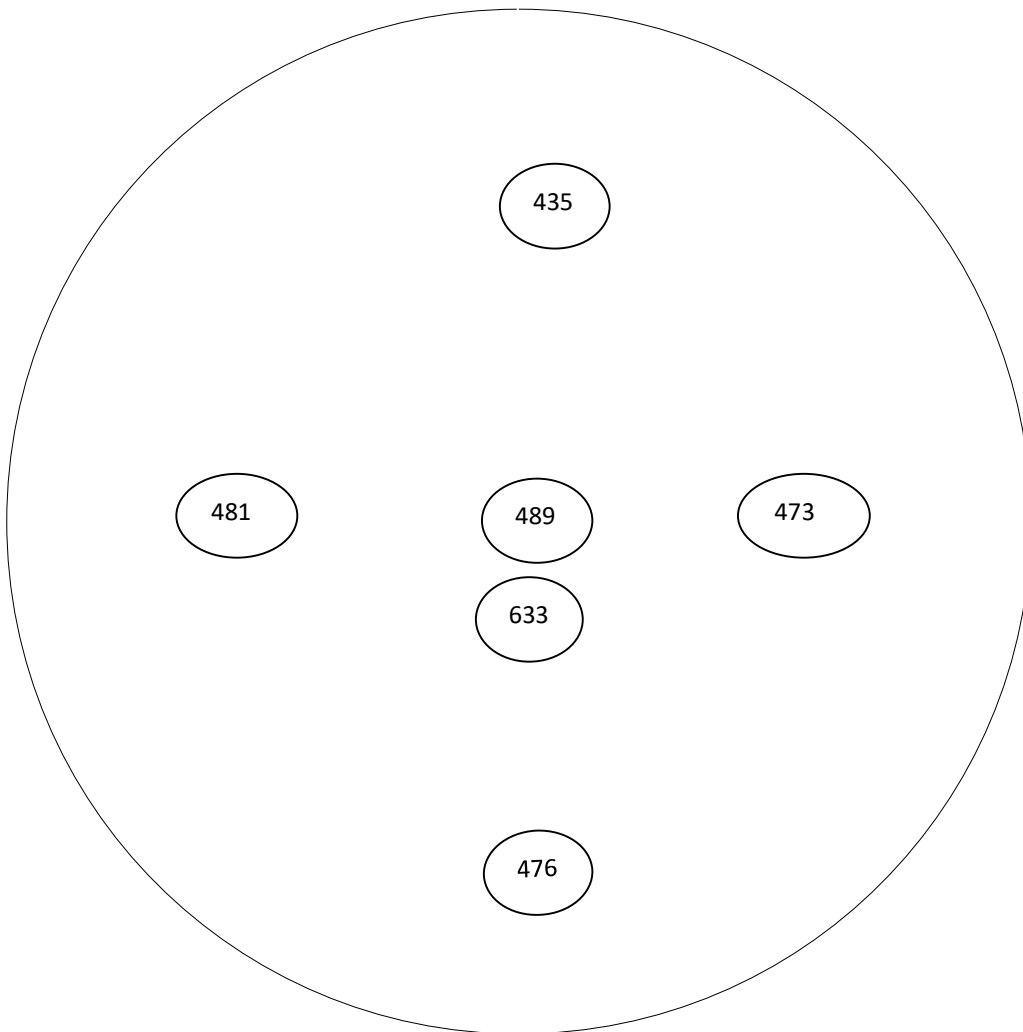
PROJECT:	Brightview Senior Living	SYSTEM:	DOAS 1
LOCATION - ZONE:	Attic	SERVICE:	Supply Register 11/12
ALTITUDE:		DENSITY:	
		FACTOR:

DUCT	REQUIRED	ACTUAL
S.P.: 0.14"	SCFM:	SCFM:
SIZE: 6"	FPM: 450	FPM: 498
AREA: 0.35Ft^2	CFM: 90	CFM: 100
TEMP:

REMARKS:
[1] Accessed in attic space

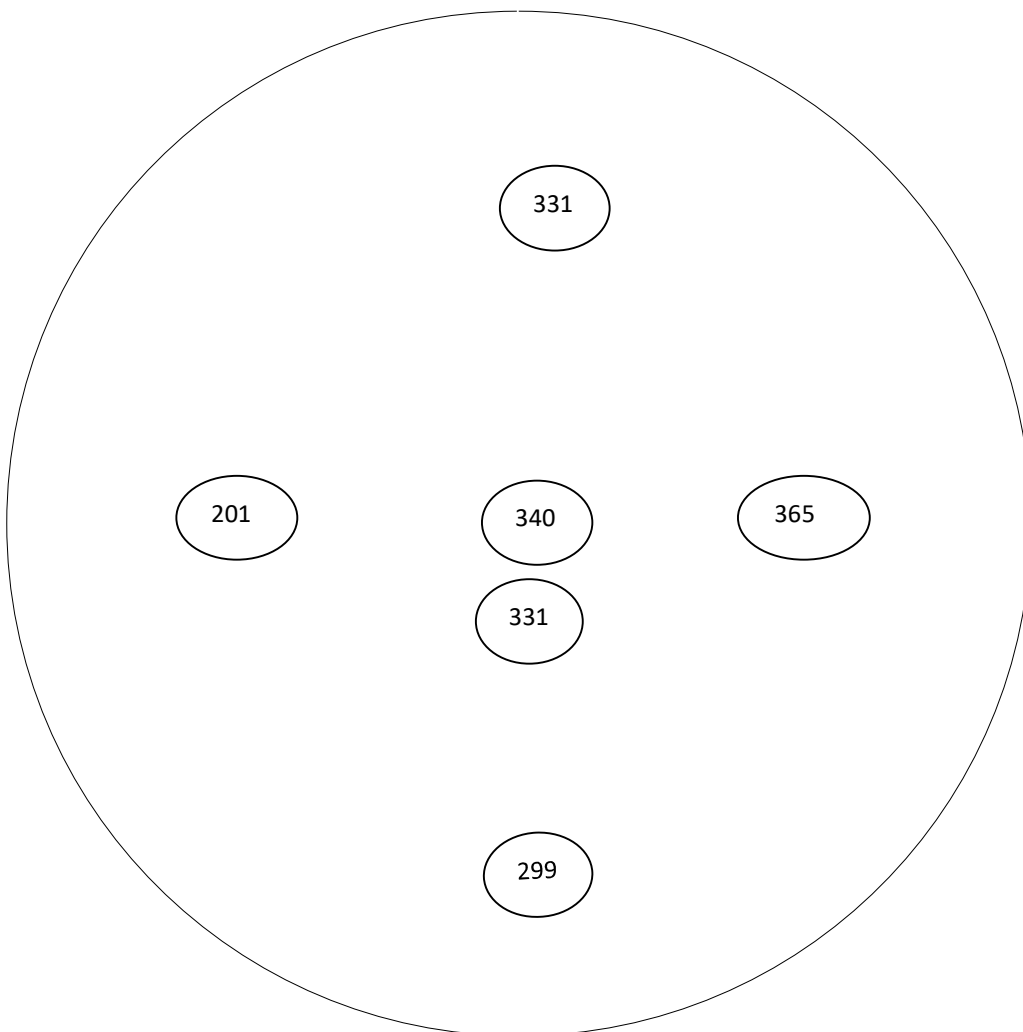
PROJECT:	Brightview Senior Living	SYSTEM:	DOAS 1
LOCATION - ZONE:	Attic	SERVICE:	Supply Register 10
ALTITUDE:		DENSITY:	
		FACTOR:

DUCT	REQUIRED	ACTUAL
S.P.: 0.14"	SCFM:	SCFM:
SIZE: 6"	FPM: 326	FPM: 311
AREA: 0.35Ft^2	CFM: 65	CFM: 61
TEMP:

REMARKS:
[1] Accessed in attic space

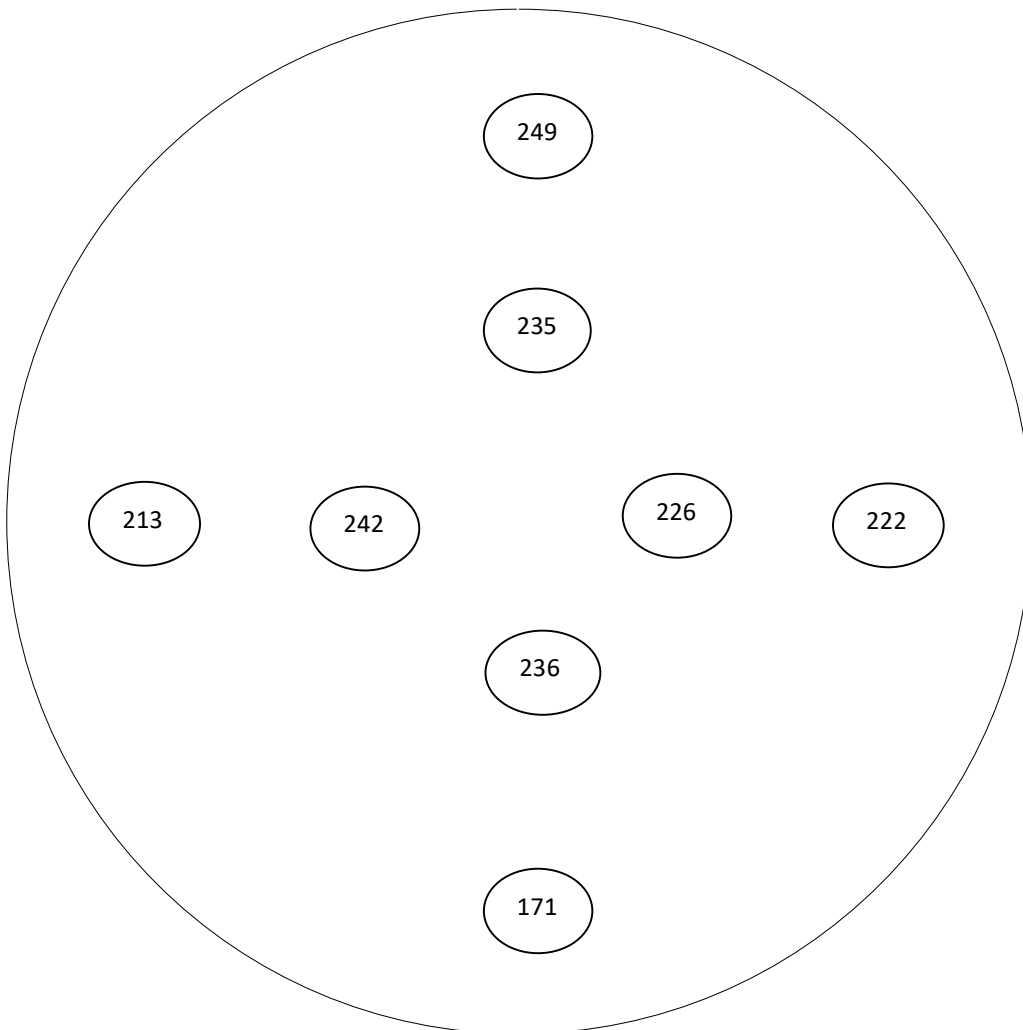
PROJECT:	Brightview Senior Living	SYSTEM:	DOAS-1
LOCATION - ZONE:	Attic	SERVICE:	Exhaust Register 7
ALTITUDE:		DENSITY:	
		FACTOR:

DUCT	REQUIRED	ACTUAL
S.P.: 0.02"	SCFM:	SCFM:
SIZE: 8"	FPM: 229	FPM: 223
AREA: 0.35Ft^2	CFM: 80	CFM: 78
TEMP:

REMARKS:
[1] Accessed in attic space

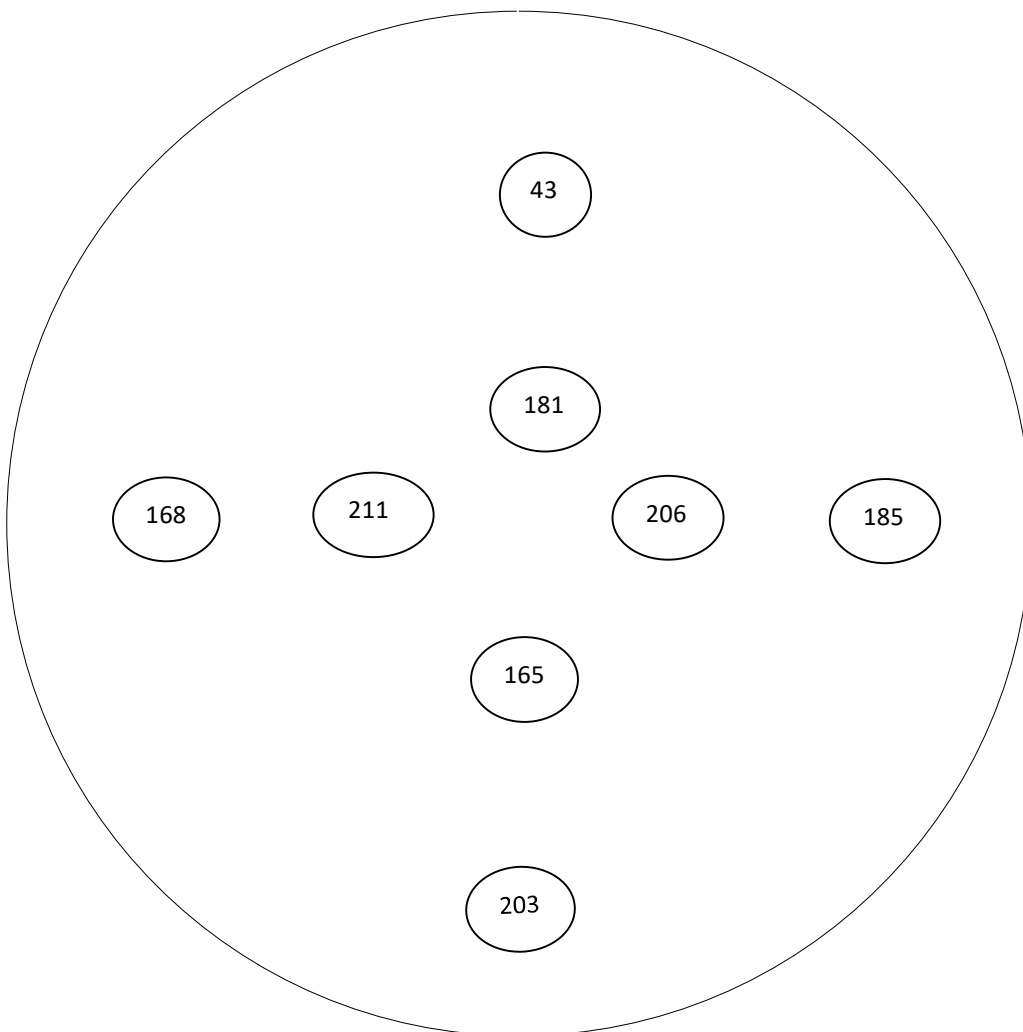
PROJECT:	Brightview Senior Living	SYSTEM:	DOAS 1
LOCATION - ZONE:	Attic	SERVICE:	Exhaust Register 10
ALTITUDE:		DENSITY:	
		FACTOR:

DUCT	REQUIRED	ACTUAL
S.P.: 0.008"	SCFM:	SCFM:
SIZE: 8"	FPM: 214	FPM: 170
AREA: 0.35Ft^2	CFM: 75	CFM: 59
TEMP:

REMARKS:
[1] Accessed in attic space
