Report: Brightview-DOAS1 Analysis

Function: Test, Adjust, & Balance

Date: 09/22/2025

BVE - Brightview Senior Living (Eatontown, NJ)

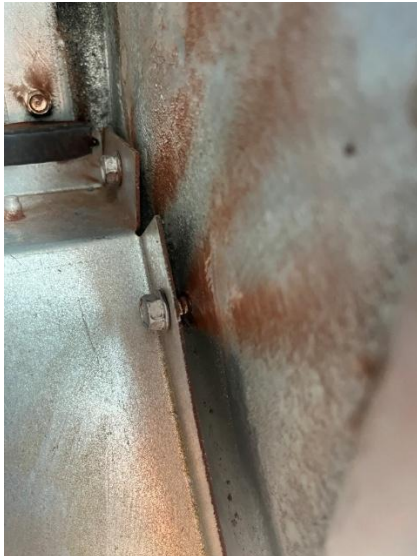
Per DJW DOAS filters have been replaced and Heat Wheel cleaned and serviced by facility staff prior to our testing. New filters were found inside the unit at time of testing. All doors have had additional foam added to seal gaps and to prevent leakage. No air supply/exhaust leakage could be felt around any access doors indicating the unit is well sealed. The only spot we're there could be some short cycling is a bracket piece on the inside of the unit that is located in the coil/filter compartment. There was about a 1/8" gap (picture below) which most likely is negligible leakage.

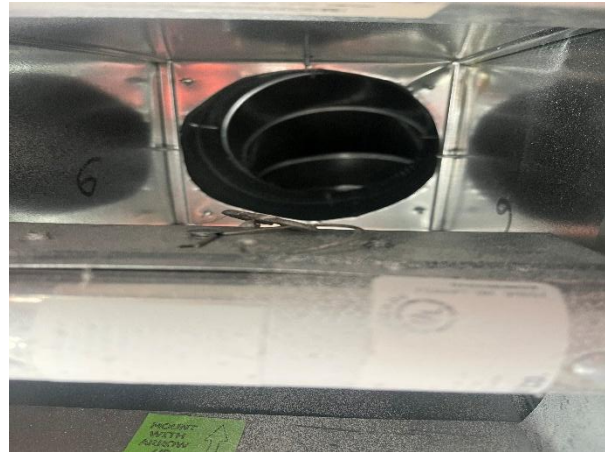
flow-hood grid that is 5 times higher on one side versus the other side you will have an error of 20x. See pictures below. We pulled off several of the grills to inspect the duct configuration at the grills. The arrangement would create uneven exhaust or discharge at the grill. Larger plenum boxes had to be fabricated to allow for the fire dampers to be inserted inside the box just above the rated ceiling. Then the duct was cut in at the top of the plenum box either on the left, right, or center of box. This configuration would cause higher pressures on one side of the grill & lower on the other side with the compact arrangement. Our traverses taken did develop different K factors. So, we utilized an Average K factor of 1.27 for all flow-hood readings. Per flow-hood manufacturer recommendations we use a low-flow hood for any GRD measured at 150 CFM or less and a normal flow-hood for any devices of 150 CFM or more for better accuracy.

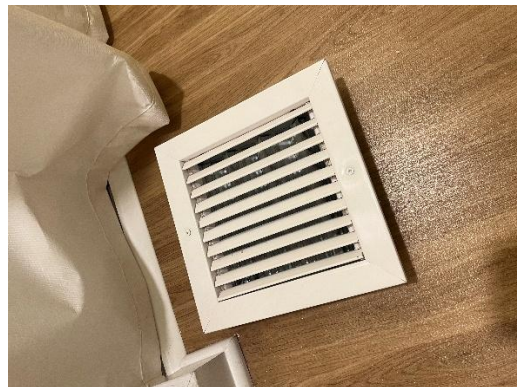
We also inspected the duct system above the hard ceiling as much as access would allow from traverse location to the exhaust grilles and found no sources of potential leakage. When we removed several of the exhaust grilles it was evident in each case that the fire rated sheetrock ceiling was sandwiched tight between the grill and the plenum box.
