**Report: Brightview-DOAS1 Analysis**

**Function: Test, Adjust, & Balance**

## BVE - Brightview Senior Living (Eatontown, NJ)

Included in the Report below is data and analysis of DOAS-1 at the Brightview Senior living facility located in Eatontown NJ. The purpose of this analysis was to determine if the unit is meeting design and performance expectations on the Supply and exhaust side of the DOAS.

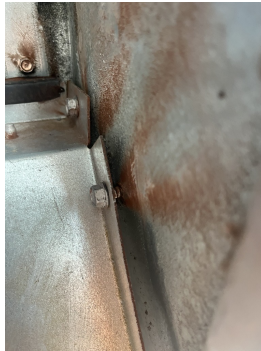
Per DJW DOAS filters have been replaced and Heat wheel cleaned and serviced by Facility staff. Fresh filters were found inside the unit at time of testing. All doors have had additional foam to seal gaps and to prevent leakage. No air supply/exhaust can be felt around any access doors showing the unit is well sealed. The only spot where there could be some short cycling is a bracket piece on the inside of the unit. Pictured:

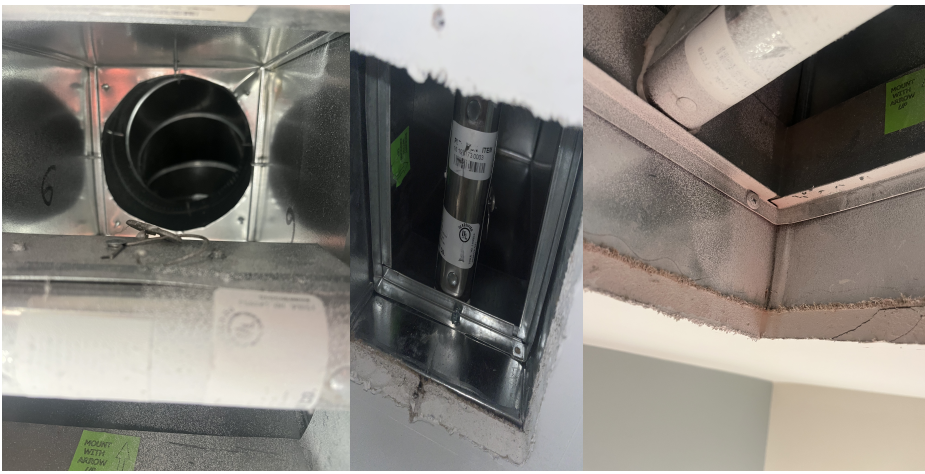
Due to site access restrictions it was impossible to obtain a traverse of the entire exhaust duct prior to any hits or runouts. The only point for a traverse of multiple hits/runouts was through an access of a supply diffuser in the hallway that has all exhaust runs for Grilles 5-11. The traverse came to 629CFM (@0.07" Static). Summation of Flow hood readings for Exhaust grilles 5-11 came to 472CFM.

Next it was important to triangulate Data in order to confirm that the flow hood is reading airflow correctly. Per the Flow hood manufacturers recommendation hood airflow readings should always be compared to a traverse(s) and K-factor established as needed for correction. Three separate exhaust hit traverses along with the main trunk traverse of Grilles 5-11 came to an average of 129.5% difference in flow hood readings vs Traverse readings with the flow hood reading 30% less than traverse.

The ductwork was inspected from traverse location to the Exhaust grilles and found no sources of potential leakage and Exhaust grilles faces were removed and connection to drywall and plenum box was inspected with no gaps for potential leakages found. It was determined that at such low static pressure it is not possible to have 30% leakage from the traverse points to the grilles and a K-factor of 1.295 is justified for the flow hood readings.

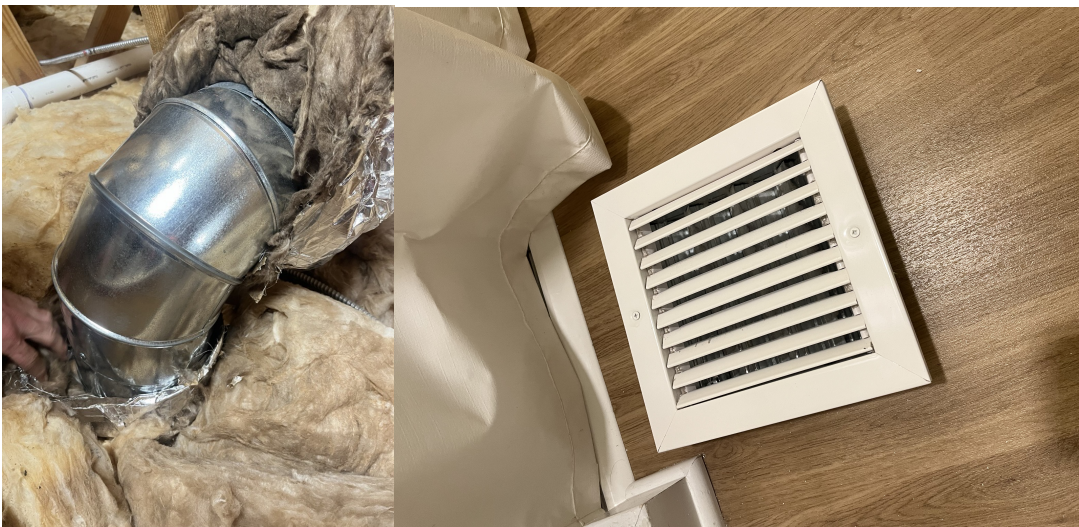
It was not possible to obtain a traverse of any part of the trunkline for the supply side of DOAS-1 due to the location of the duct above hard ceiling in the hallway and clearance needed to insert the pitot tube. Flow hood readings were taken on the supply side with three hood configurations types and it was found that there is no consistency and ability to triangulate hood readings or traverses. The hood readings on the supply side we deem as inaccurate. The reason for the discrepancy/inconsistency in readings is from the 1. Supply grille type, and 2. how the supply grille is connected to ductwork with an elbow directly on top of the plenum box. the configuration is creating turbulence across the flow hood grid where the flow hood requires laminar flow in order to read supply air accurately as you would see with a typical 4 way throw diffuser.

A total traverse of the DOAS supply was not possible so for further testing it would be recommended to read the total intake on the roof via alternative methods.
