Report: Brightview-DOAS1 Analysis

Function: Test, Adjust, & Balance

Date: 09/22/2025

BVE - Brightview Senior Living (Eatontown, NJ)

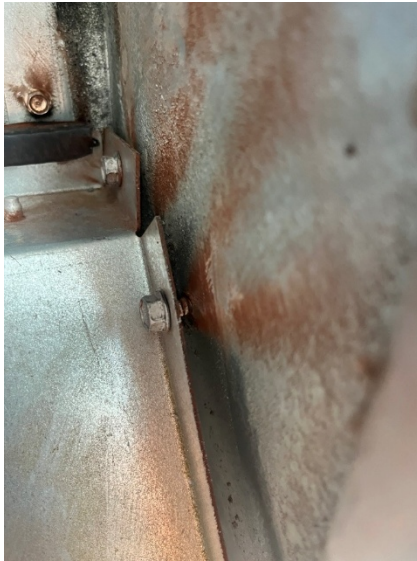
Per DJW DOAS filters have been replaced and Heat Wheel cleaned and serviced by facility staff prior to our testing. New filters were found inside the unit at time of testing. All doors have had additional foam added to seal gaps and to prevent leakage. No air supply/exhaust leakage could be felt around any access doors indicating the unit is well sealed. The only spot we're there could be some short cycling is a bracket piece on the inside of the unit that is located in the coil/filter compartment. There was about a 1/8" gap (picture below) which most likely is

negligible leakage.

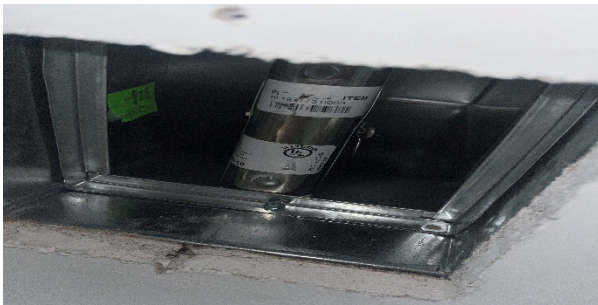
The reason to perform additional duct traverses is to develop a correction factor (K Factor) to be used as a multiplier to the flow-hood value. All modern flow-hoods are designed with back pressure analysis that will calculate a corrected airflow (k factor) for every reading. However, it is only accurate typically with settle pressure and velocity patterns changes at the supply or exhaust grills. When you have erratic readings (inconsistency) or possibility of velocity profile at the orifice of the velocity grid located at the bottom of the utilized flow hood it will have impact on the recorded CFM value that the built in back pressure factor does not work. This will cause

the inconsistency in readings that the team has experienced from different testing firms. It is NEBB guidelines and Flow-Hood Manufacturers recommendations to develop your own K factor when experiencing these issues in the field. For example, in extreme circumstances if you have uneven velocity across your flow-hood grid that is 5 times higher on one side versus the other side you will have an error of 20x. See pictures below. We pulled off several of the grills to inspect the duct configuration at the grills. The arrangement would create uneven exhaust or discharge at the grill. Larger plenum boxes had to be fabricated to allow for the fire dampers to be inserted inside the box just above the rated ceiling. Then the duct was cut in at the top of the plenum box either on the left, right, or center of box. This configuration would cause higher pressures on one side of the grill & lower on the other side with the compact arrangement. Our traverses taken did develop different K factors. So, we utilized an Average K factor of 1.27 for all flow-hood readings. Per flow-hood manufacturer recommendations we use a low-flow hood for any GRD measured at 150 CFM or less and a normal flow-hood for any devices of 150 CFM or more for better accuracy.

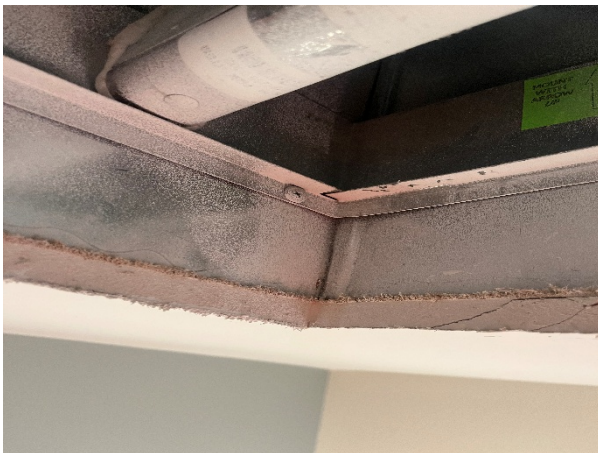
We also inspected the duct system above the hard ceiling as much as access would allow from traverse location to the exhaust grilles and found no sources of potential leakage. When we removed several of the exhaust grilles it was evident in each case that the fire rated sheetrock ceiling was sandwiched tight between the grill and the plenum box.

We pulled the insulation off the duct system where it tied to the top of the plenum boxes & found the duct was installed tight to the plenum box. Visually there was no evidence of duct construction that would allow for any significant leakage for a low pressure duct system.
