The Brightview Senior Living Facility consists of qty (4) DOAS systems. Each system has a heat wheel with supply & exhaust fans. Our focus for our analysis was DOAS-1, which serves the 1st floor Wing A area. There have been multiple testing agencies on site to evaluate the system each time returning data with conflicting information. The purpose of this analysis was to provide data that could have more conclusive results and a possible understanding of why different results were measured by different testing firms.

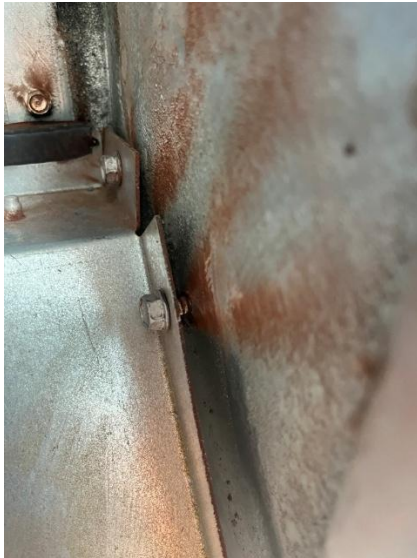
Per DJW DOAS filters have been replaced and Heat Wheel cleaned and serviced by facility staff prior to our testing. New filters were found inside the unit at time of testing. All doors have had additional foam added to seal gaps and to prevent leakage. No air supply/exhaust leakage could be felt around any access doors indicating the unit is well sealed. The only spot we're there could be some short cycling is a bracket piece on the inside of the unit that is located in the coil/filter compartment. There was about a 1/8" gap (picture below) which most likely is negligible leakage.

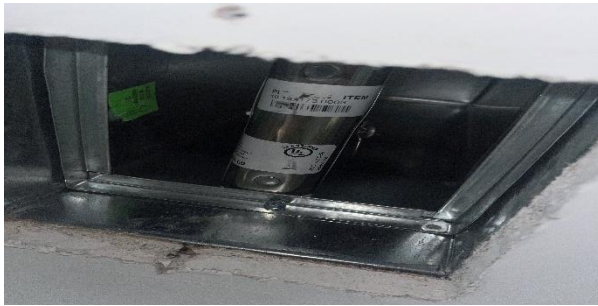
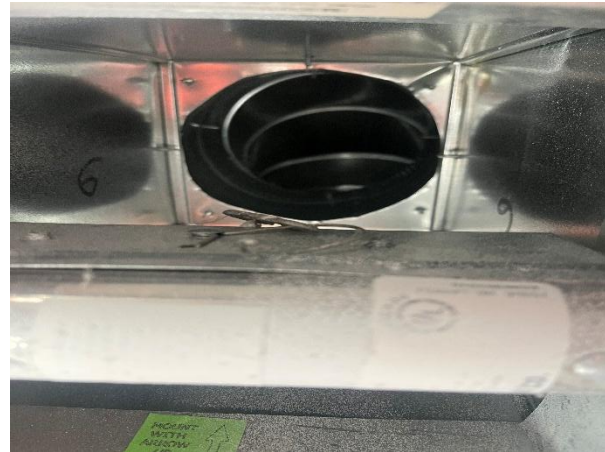
flow-hood grid that is 5 times higher on one side versus the other side you will have an error of 20x. See pictures below. We pulled off several of the grills to inspect the duct configuration at the grills. The arrangement would create uneven exhaust or discharge at the grill. Larger plenum boxes had to be fabricated to allow for the fire dampers to be inserted inside the box just above the rated ceiling. Then the duct was cut in at the top of the plenum box either on the left, right, or center of box. This configuration would cause higher pressures on one side of the grill & lower on the other side with the compact arrangement. Our traverses taken did develop different K factors. So, we utilized an Average K factor of 1.27 for all flow-hood readings. Per flow-hood manufacturer recommendations we use a low-flow hood for any GRD measured at 150 CFM or less and a normal flow-hood for any devices of 150 CFM or more for better accuracy.

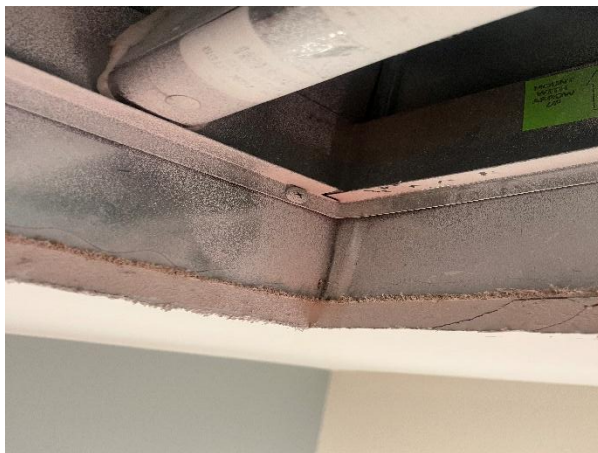
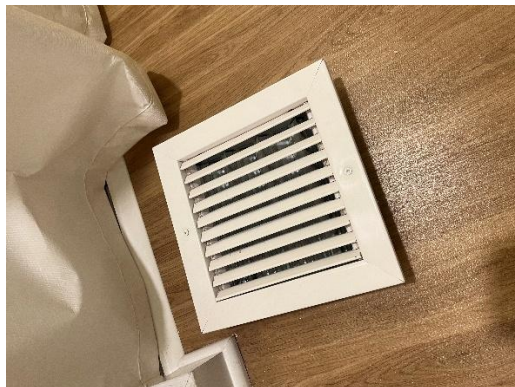
We also inspected the duct system above the hard ceiling as much as access would allow from traverse location to the exhaust grilles and found no sources of potential leakage. When we removed several of the exhaust grilles it was evident in each case that the fire rated sheetrock ceiling was sandwiched tight between the grill and the plenum box.
