**Report: TAB Report**  
**Function: Test, Adjust, & Balance**  
**Date: 10/23/2025**  
**Completed By: National TAB**

**PROJECT**  
**03-09-26 QT #0588 OMAHA, NE**

QUIKTRIP  
4705 SOUTH 129TH EAST AVENUE  
TULSA, OK 74134

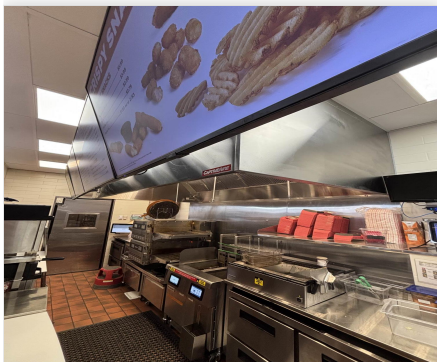
**Issue Name :** HOOD1: Smoke Capture  
**Description :** Hood 1 is losing approximately 10% of smoke along the perimeter at the back left portion of the hood above the pizza ovens. Unable to test with RT-3 off due to interlock with EF-2. Recommend fixing air leakage at the base of EF-2 and installing rigid risers or elbows in the necks of the supply grilles to prevent turbulence in the space.  
**Created By :** National TAB                      **Assigned To :** National TAB - Dan Hertenstein  
**Status :** Open  
**Priority :** Medium                                      **Asset Tag :** HD1  
**Originated Date :** 03/24/2026 - Kalen Kemp - National TAB

90% Smoke Capture (Lost smoke at back 2 feet on left side of hood above pizza ovens)

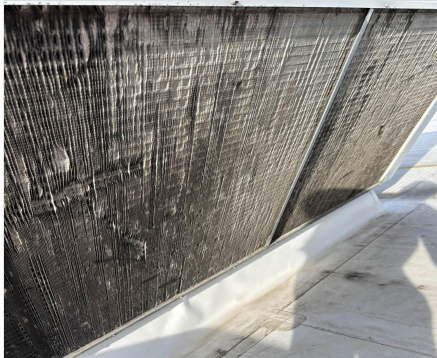
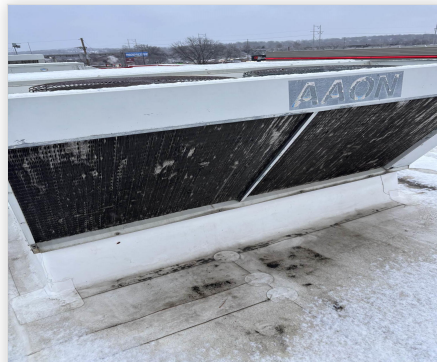
**Issue Name :** RT-1 and RT-2: Condenser Coil  
**Description :** The condenser coils for RT-1 and RT-2 are damaged. Recommend service.  
**Created By :** National TAB                      **Assigned To :** National TAB - Dan Hertenstein  
**Status :** Open  
**Priority :** **Medium**                                      **Asset Tag :**  
**Originated Date :** 03/11/2026 - Kalen Kemp - National TAB

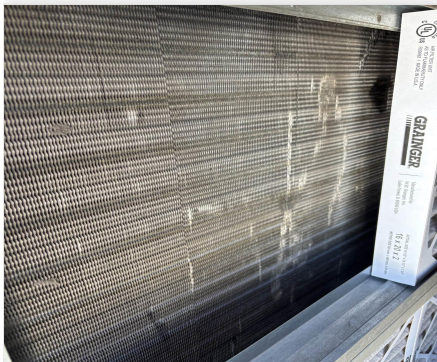
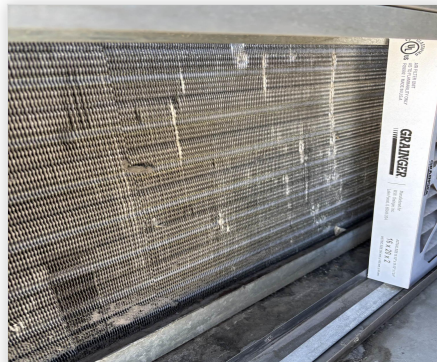
**Issue Name :** RT-1: Coil  
**Description :** The evaporator coil for RT-1 has minor damage.  
**Created By :** National TAB                      **Assigned To :** National TAB - Dan Hertenstein  
**Status :** Open  
**Priority :** Low                                      **Asset Tag :** RT-1  
**Originated Date :** 03/10/2026 - Kalen Kemp - National TAB

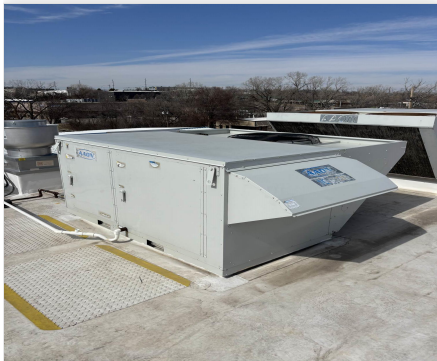
**Issue Name :** RT-3: No Heat  
**Description :** RT-3 is not going into heating. The RTU is designed for 100% outside air. This is causing the RTU to dump cold air from the outside down into the space making it uncomfortable for workers and food to get cold quicker. Recommend service.  
**Created By :** National TAB                      **Assigned To :** National TAB - Dan Hertenstein  
**Status :** Open  
**Priority :** High                                      **Asset Tag :** RT-3  
**Originated Date :** 03/11/2026 - Kalen Kemp - National TAB

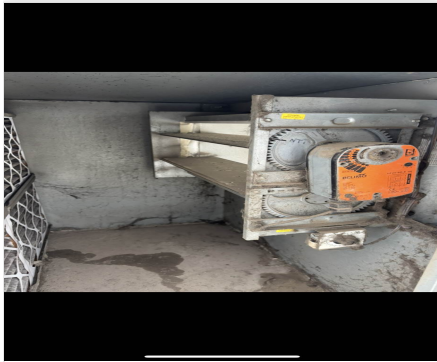
**Issue Name :** RT-3: OA Damper  
**Description :** OA damper is not controlled by Emerson. Damper position set manually. Left in hood on position.  
**Created By :** National TAB                      **Assigned To :** National TAB - Dan Hertenstein  
**Status :** Open  
**Priority :** Medium                                      **Asset Tag :** RT-3  
**Originated Date :** 03/24/2026 - Kalen Kemp - National TAB

- EMERSON DOES NOT CONTROL OA DAMPER POSITION. OA DAMPER POSITION SET MANUALLY. LEFT IN HOOD ON POSITION (100% OPEN)
- UNIT IS NOT ACTIVATING HEAT MODE. SET TO OFF ON EMERSON. RECOMMEND SERVICE.

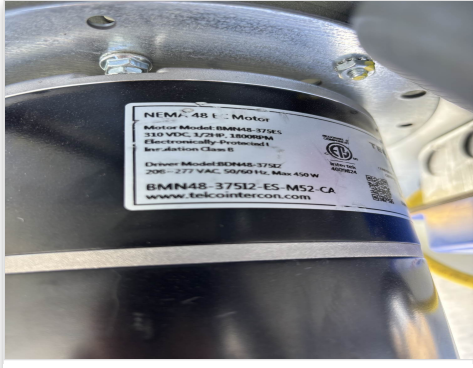
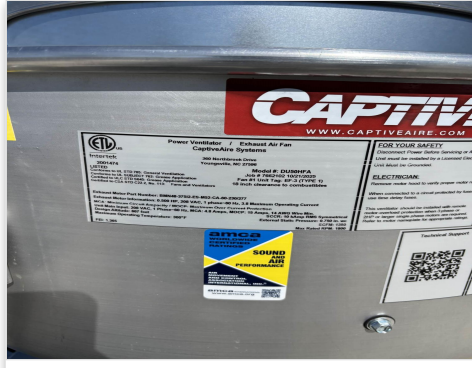
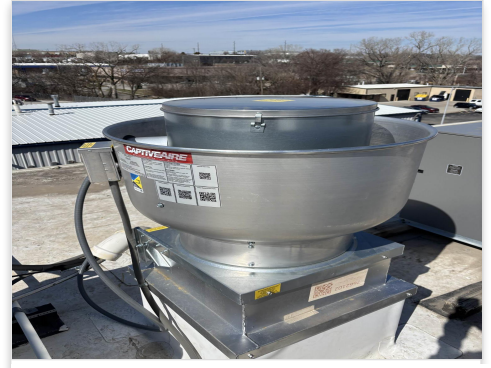
Notes:  
 -RPM DATA RETRIEVED FROM MOTOR SPEED CONTROLLER IN MOTOR COMPARTMENT.  
 -MINOR AIR LEAKAGE AT FAN BASE. CAUSING PERFORMANCE AND EFFICIENCY ISSUES.  
 RECOMMEND RESEALING CONNECTION AT FAN BASE.

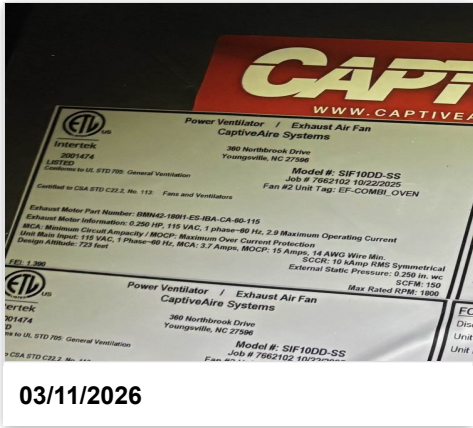
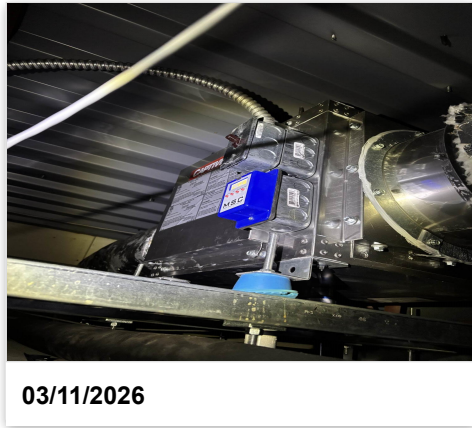
Notes:  
 -COULD NOT ACCESS MOTOR. MOTOR DATA RETRIEVED FROM UNIT TAG.  
 -COULD NOT SAFELY ACCESS VOLTAGE/AMPERAGE READING. WE DO NOT ANTICIPATE ANY AMPERAGE ISSUES BASED ON THE MOTOR SPEED SET POINT.
