Report: TAB Report
Function: Test, Adjust, & Balance
Date: 10/23/2025
Completed By: National TAB

PROJECT
03-09-26 QT #0588 OMAHA, NE

QUIKTRIP
4705 SOUTH 129TH EAST AVENUE
TULSA, OK 74134

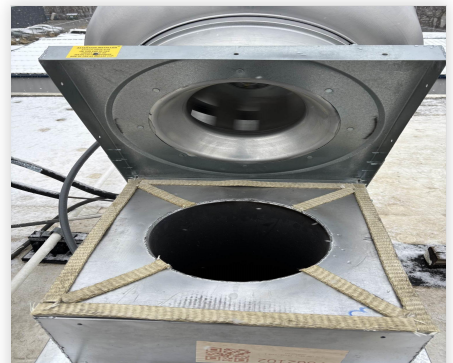
Issue Name : EF-2: Air Leakage
Description : There is air leakage at the base of EF2. The inlet of the fan slightly overhangs the curb cap. This is affecting fan performance and efficiency. Recommend reworking curb or installing new curb cap to properly seal fan base.
Created By : National TAB **Assigned To :** National TAB - Dan Hertenstein
Status : Open
Priority : High **Asset Tag :** EF2
Originated Date : 03/10/2026 - Kalen Kemp - National TAB

There is minor leakage at the base of the fan. Causing the fan speed to be set higher to achieve design airflow.

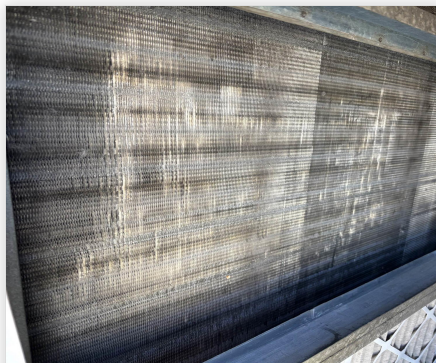
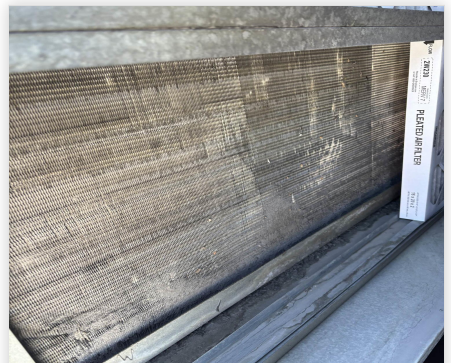
Issue Name : RT-2: Evaporator Coil
Description : The evaporator coil is dirty on the filter side. There is also some damage on the fan side of this coil. This is affecting unit performance and efficiency. Recommend service.
Created By : National TAB **Assigned To :** National TAB - Dan Hertenstein
Status : Open
Priority : Medium **Asset Tag :** RT-2
Originated Date : 03/10/2026 - Kalen Kemp - National TAB

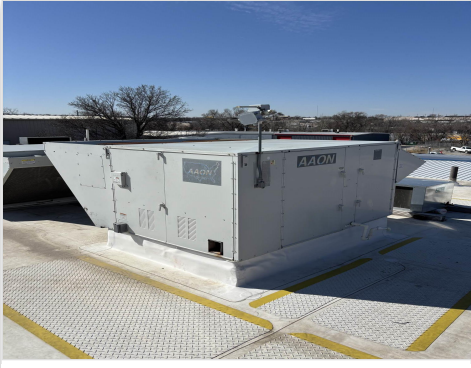
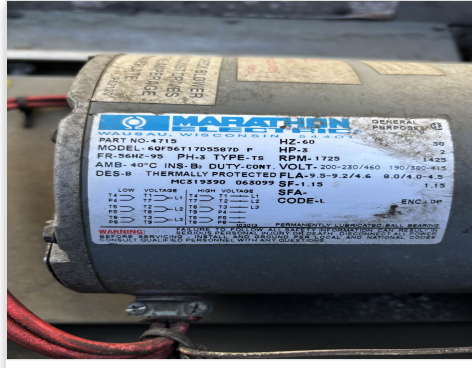
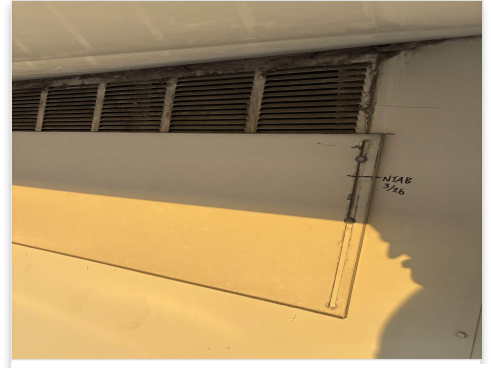
Unit Data - PHOTO LOG

- DIRTY EVAPORATOR COIL. RECOMMEND CLEANING.
- DISCONNECT SWITCH IS BYPASSED.
