Report: TAB Report
Function: Test, Adjust, & Balance
Date: 10/23/2025
Completed By: National TAB

PROJECT
03-09-26 QT #0588 OMAHA, NE

QUIKTRIP
4705 SOUTH 129TH EAST AVENUE
TULSA, OK 74134

Project: 03-09-26 QT #0588 OMAHA, NE

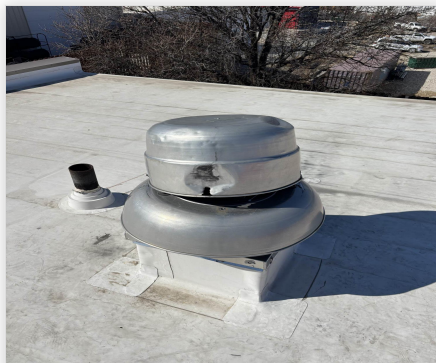
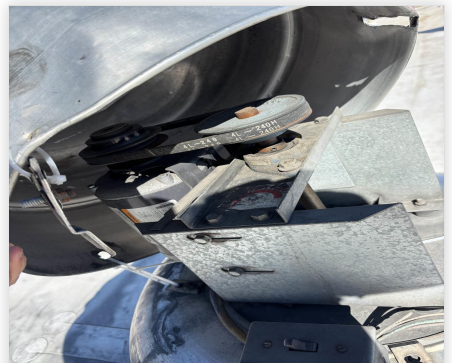
Issue Name : EF-1: Damage
Description : EF-1 was found off upon arrival. Drive belt is cracked and missing chunks out of it. The cover is also heavily damaged and being held on with zip ties. Recommend replacing drive belt and cover. Unit left turned off.
Created By : National TAB **Assigned To :** National TAB - Dan Hertenstein
Status : Open
Priority : Urgent **Asset Tag :** EF1
Originated Date : 03/10/2026 - Kalen Kemp - National TAB

- Notes:
- UNIT FOUND OFF UPON ARRIVAL.
 - FAN COVER IS HEAVILY DAMAGED. CONNECTED TO THE BASE WITH ZIP TIES.
 - DRIVE BELT IS WORN AND CRACKED. MISSING CHUNKS OUT OF IT.

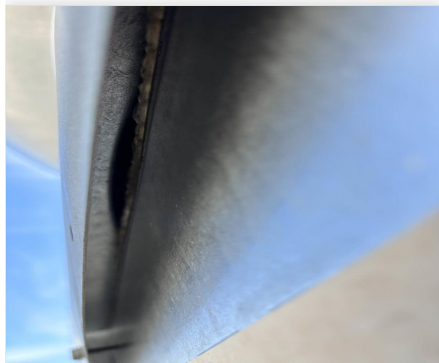
Issue Name : EF-2: Air Leakage
Description : There is air leakage at the base of EF2. The inlet of the fan slightly overhangs the curb cap. This is affecting fan performance and efficiency. Recommend reworking curb or installing new curb cap to properly seal fan base.
Created By : National TAB **Assigned To :** National TAB - Dan Hertenstein
Status : Open
Priority : High **Asset Tag :** EF2
Originated Date : 03/10/2026 - Kalen Kemp - National TAB

There is minor leakage at the base of the fan. Causing the fan speed to be set higher to achieve design airflow.
