Report: PUNCHLIST
Function: Test, Adjust, & Balance
Date: 03/10/2026
Completed By: National TAB

PROJECT
03-09-26 QT #0588 OMAHA, NE

QUIKTRIP
4705 SOUTH 129TH EAST AVENUE
TULSA, OK 74134

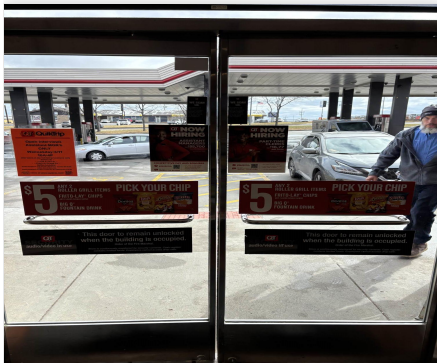
Issue Name : Doors
Description : The front doors of the store are not well sealed. This may affect the accuracy of the building pressure readings. Noting for clarity and awareness.
Created By : National TAB **Assigned To :** National TAB - Dan Hertenstein
Status : Open
Priority : InfoOnly **Asset Tag :**
Originated Date : 03/11/2026 - Kalen Kemp - National TAB

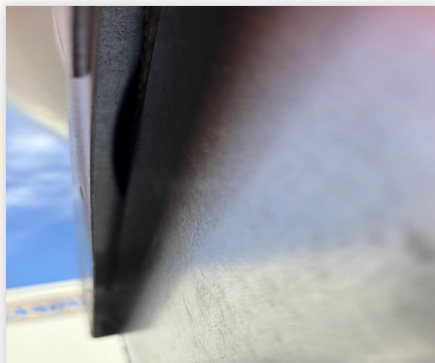
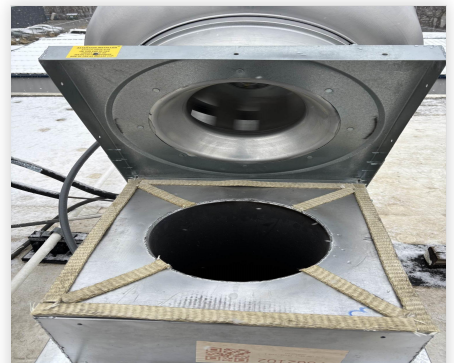
Issue Name : EF-2: Air Leakage
Description : There is air leakage at the base of EF2. The inlet of the fan slightly overhangs the curb cap. This is affecting fan performance and efficiency. Recommend reworking curb or installing new curb cap to properly seal fan base.
Created By : National TAB **Assigned To :** National TAB - Dan Hertenstein
Status : Open
Priority : High **Asset Tag :** EF2
Originated Date : 03/10/2026 - Kalen Kemp - National TAB

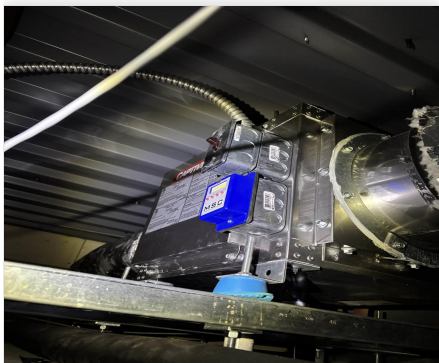
Issue Name : EF-3: Voltage/Amperage
Description : Could not safely access amperage/voltage measurements for EF-3. We do not anticipate any amperage issues based on fan speed set point and performance on similar fans. Noting for clarity and awareness.
Created By : National TAB **Assigned To :** National TAB - Dan Hertenstein
Status : Open
Priority : InfoOnly **Asset Tag :** EF3
Originated Date : 03/11/2026 - Kalen Kemp - National TAB
