**Report: TAB Report**  
**Function: Test, Adjust, & Balance**  
**Date: 10/23/2025**  
**Completed By: National TAB**

**PROJECT**  
**03-09-26 QT #0588 OMAHA, NE**

QUIKTRIP  
4705 SOUTH 129TH EAST AVENUE  
TULSA, OK 74134

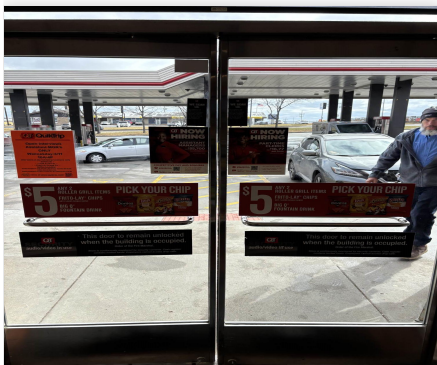
**Issue Name :** Doors  
**Description :** The front doors of the store are not well sealed. This may affect the accuracy of the building pressure readings. Noting for clarity and awareness.  
**Created By :** National TAB                      **Assigned To :** National TAB - Dan Hertenstein  
**Status :** Open  
**Priority :** InfoOnly                                      **Asset Tag :**  
**Originated Date :** 03/11/2026 - Kalen Kemp - National TAB

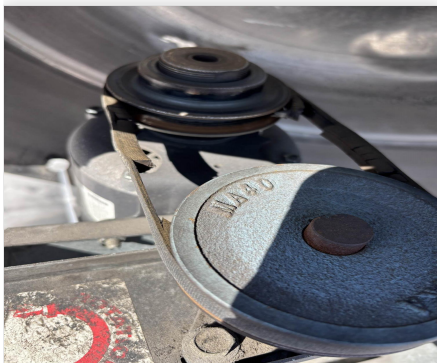
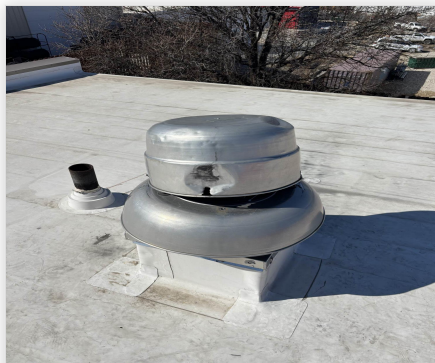
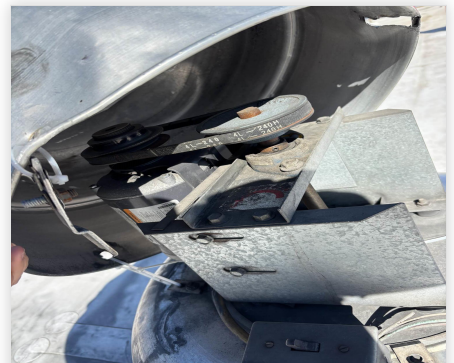
**Issue Name :** EF-1: Damage  
**Description :** EF-1 was found off upon arrival. Drive belt is cracked and missing chunks out of it. The cover is also heavily damaged and being held on with zip ties. Recommend replacing drive belt and cover. Unit left turned off.  
**Created By :** National TAB                      **Assigned To :** National TAB - Dan Hertenstein  
**Status :** Open  
**Priority :** Urgent                                      **Asset Tag :** EF1  
**Originated Date :** 03/10/2026 - Kalen Kemp - National TAB

- Notes:
- UNIT FOUND OFF UPON ARRIVAL.
  - FAN COVER IS HEAVILY DAMAGED. CONNECTED TO THE BASE WITH ZIP TIES.
  - DRIVE BELT IS WORN AND CRACKED. MISSING CHUNKS OUT OF IT.

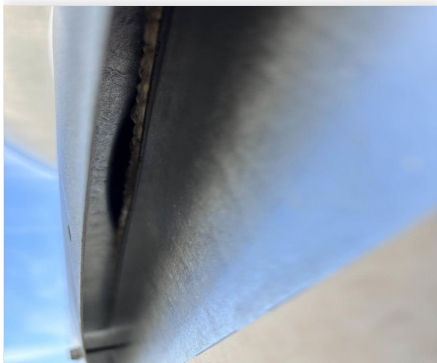
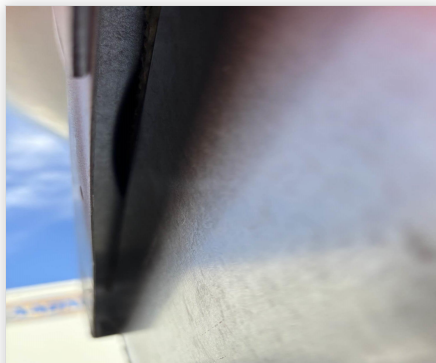
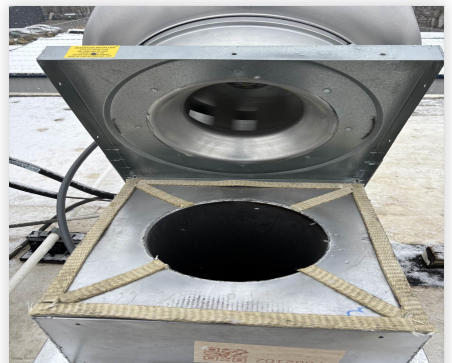
**Issue Name :** EF-2: Air Leakage  
**Description :** There is air leakage at the base of EF2. The inlet of the fan slightly overhangs the curb cap. This is affecting fan performance and efficiency. Recommend reworking curb or installing new curb cap to properly seal fan base.  
**Created By :** National TAB                      **Assigned To :** National TAB - Dan Hertenstein  
**Status :** Open  
**Priority :** High                                      **Asset Tag :** EF2  
**Originated Date :** 03/10/2026 - Kalen Kemp - National TAB

There is minor leakage at the base of the fan. Causing the fan speed to be set higher to achieve design airflow.

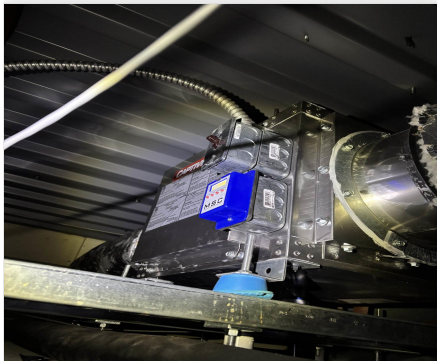
**Issue Name :** EF-3: Voltage/Amperage  
**Description :** Could not safely access amperage/voltage measurements for EF-3. We do not anticipate any amperage issues based on fan speed set point and performance on similar fans. Noting for clarity and awareness.  
**Created By :** National TAB                      **Assigned To :** National TAB - Dan Hertenstein  
**Status :** Open  
**Priority :** InfoOnly                              **Asset Tag :** EF3  
**Originated Date :** 03/11/2026 - Kalen Kemp - National TAB

Notes:  
 -COULD NOT ACCESS MOTOR. MOTOR DATA RETRIEVED FROM UNIT TAG.  
 -COULD NOT SAFELY ACCESS VOLTAGE/AMPERAGE READING. WE DO NOT ANTICIPATE ANY AMPERAGE ISSUES BASED ON THE MOTOR SPEED SET POINT.

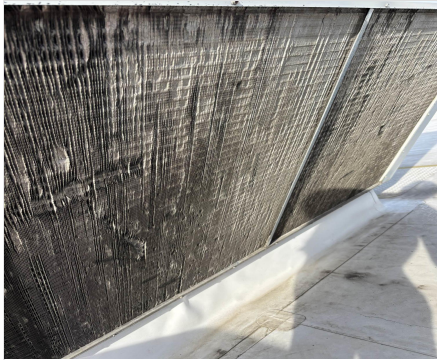
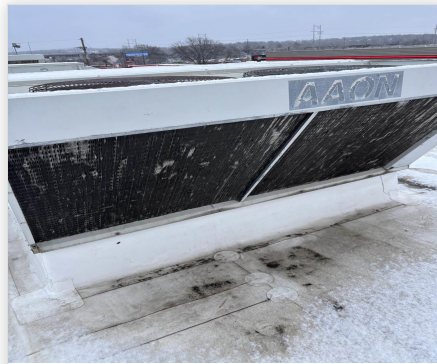
**Issue Name :** RT-1 and RT-2: Condenser Coil  
**Description :** The condenser coils for RT-1 and RT-2 are damaged. Recommend service.  
**Created By :** National TAB                      **Assigned To :** National TAB - Dan Hertenstein  
**Status :** Open  
**Priority :** Medium                                      **Asset Tag :**  
**Originated Date :** 03/11/2026 - Kalen Kemp - National TAB

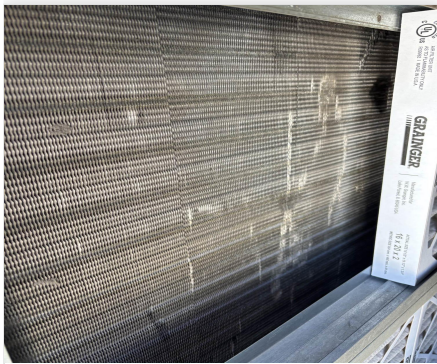
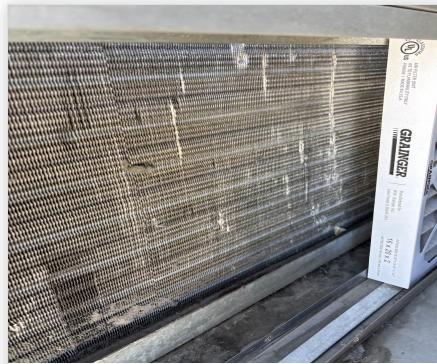
**Issue Name :** RT-1: Coil  
**Description :** The evaporator coil for RT-1 has minor damage.  
**Created By :** National TAB                      **Assigned To :** National TAB - Dan Hertenstein  
**Status :** Open  
**Priority :** Low                                      **Asset Tag :** RT-1  
**Originated Date :** 03/10/2026 - Kalen Kemp - National TAB

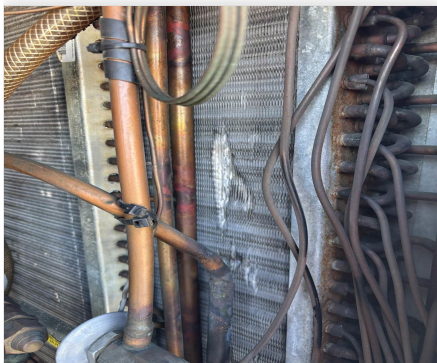
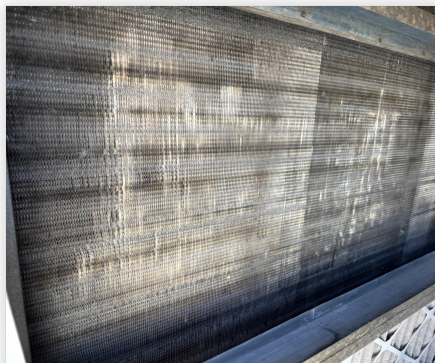
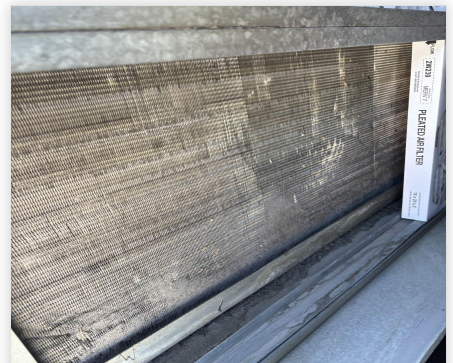
**Issue Name :** RT-2: Evaporator Coil  
**Description :** The evaporator coil is dirty on the filter side. There is also some damage on the fan side of this coil. This is affecting unit performance and efficiency. Recommend service.  
**Created By :** National TAB                      **Assigned To :** National TAB - Dan Hertenstein  
**Status :** Open  
**Priority :** Medium                                      **Asset Tag :** RT-2  
**Originated Date :** 03/10/2026 - Kalen Kemp - National TAB

- DIRTY EVAPORATOR COIL. RECOMMEND CLEANING.
- DISCONNECT SWITCH IS BYPASSED.

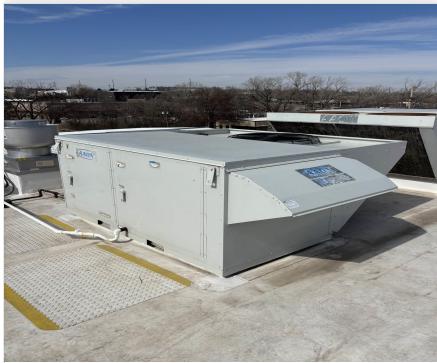
**Issue Name :** RT-3: No Heat  
**Description :** RT-3 is not going into heating. The RTU is designed for 100% outside air. This is causing the RTU to dump cold air from the outside down into the space making it uncomfortable for workers and food to get cold quicker. Recommend service.  
**Created By :** National TAB                      **Assigned To :** National TAB - Dan Hertenstein  
**Status :** Open  
**Priority :** High                                      **Asset Tag :** RT-3  
**Originated Date :** 03/11/2026 - Kalen Kemp - National TAB

- EMERSON DOES NOT CONTROL OA DAMPER POSITION. OA DAMPER POSITION SET MANUALLY. LEFT IN HOOD ON POSITION (100% OPEN)
- UNIT IS NOT ACTIVATING HEAT MODE. SET TO OFF ON EMERSON. RECOMMEND SERVICE.
