**National TAB
1329 E. KEMPER ROAD
SUITE 4210
CINCINNATI, OH 45246**

**Report: TAB REPORT
Function: Test, Adjust, & Balance
Date: 06/26/2023**

**PROJECT
06-19-23 CULVERS - COLUMBUS, GA**

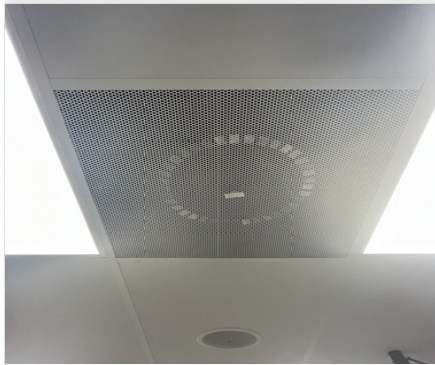
LineDiffusers
06/22/2023

Issue Name : Hood Capture
Description : With Hoods and Cookline diffusers at design flow, hood smoke capture is failing. Technician verified with kitchen units off the hoods captured correctly. Cookline diffuser ductwork is not installed per design. See MSET page m201 detail c6. Diffusers are missing rigid 90 and 12" rigid duct run. Return style diffusers are installed instead of supply.
Created By : National TAB **Assigned To :** National TAB - William Patton
Status : Open
Originated Date : 06/22/2023 - William Patton - National TAB

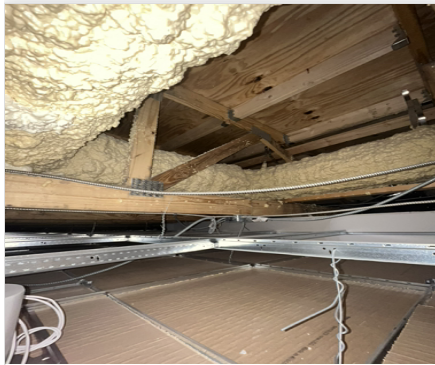
SprayFoamInsulation.j..
06/21/2023

Issue Name : Incorrect Dampers Installed
Description : MSET calls for volume dampers at supply takeoffs, instead dampers were installed at faces of diffusers. See MSET M201 detail C6. The existence of branch dampers could not be verified due to spray foam insulation on the duct. The face dampers are causing excessive noise at several diffusers.
Created By : National TAB **Assigned To :** National TAB - William Patton
Status : Open
Originated Date : 06/21/2023 - William Patton - National TAB

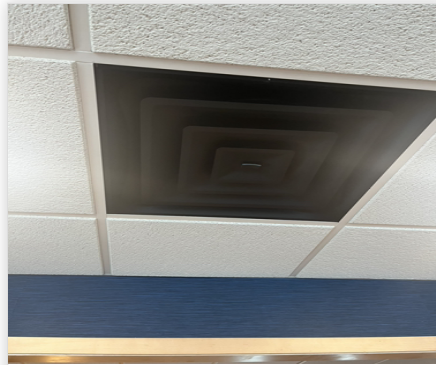
InNeckFaceDamper
06/21/2023

NO. EXCESSIVE NOISE CAN BE HEARD FROM DIFFUSERS POST BALANCE. (CAUSED BY INCORRECT DAMPER TYPE)

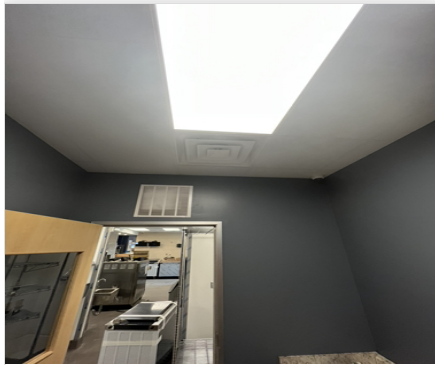
OfficeDiffuser
06/21/2023

Issue Name : Office Diffuser Ductwork
Description : Office supply diffuser is ducted to rtu2 instead of rtu1. MSET M101 calls for that diffuser to be ducted to rtu1. Per the MC the truss work makes ducting to rtu1 impossible. This may lead to uncomfortable temperatures in the office as the kitchen has a different demand for heat/cool than the office.
Created By : National TAB **Assigned To :** National TAB - William Patton
Status : Open
Originated Date : 06/21/2023 - William Patton - National TAB

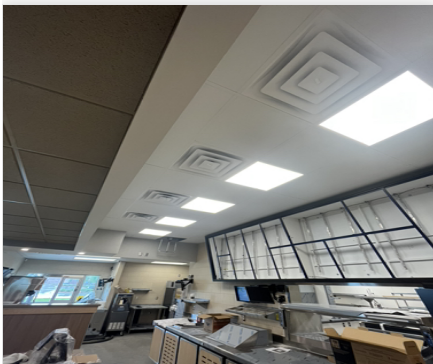
LowLineDiffusers
06/21/2023

Issue Name : RTU 1 Low Diffusers
Description : As a result of incorrect dampers being installed and the ductwork layout differing from that shown on the MSET there are 4 diffusers that are below design. Several full passes were made to attempt to resolve this but were unsuccessful. Space is comfortable as is.
Created By : National TAB **Assigned To :** National TAB - William Patton
Status : Open
Originated Date : 06/21/2023 - William Patton - National TAB

- **06/22/2023 National TAB - William Patton**
 - RECOMMENDED TO INSTALL VOLUME DAMPERS FOR THE DIFFUSERS AT THE TAKEOFFS. IT IS ALSO RECOMMENDED TO INSTALL BRANCH DAMPERS. NTAB WAS UNABLE TO SEE OR USE ANY BRANCH DAMPERS DUE TO SPRAY INSULATION ON THE DUCTWORK.

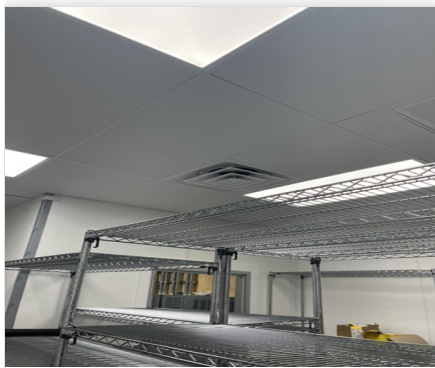
**LowFlowDiffuser
06/22/2023**

Issue Name : RTU 2 Diffuser 15 Low Flow
Description : Diffuser 15 (dry goods) is 351/600cfm. After several full passes, total increase in flow to this diffuser was 63 cfm, with all other diffusers falling within design. After inspection technician could not diagnose what is causing restriction. Recommend mechanical contractor investigates ductwork and volume damper for any issues.
Created By : National TAB **Assigned To :** National TAB - William Patton
Status : Open
Originated Date : 06/22/2023 - William Patton - National TAB
