Report: TAB Report
Function: Test, Adjust, & Balance
Date: 05/31/2024

PROJECT
06-03-24 WAWA #5434 PALATKA, FL

Project: 06-03-24 WAWA #5434 PALATKA, FL

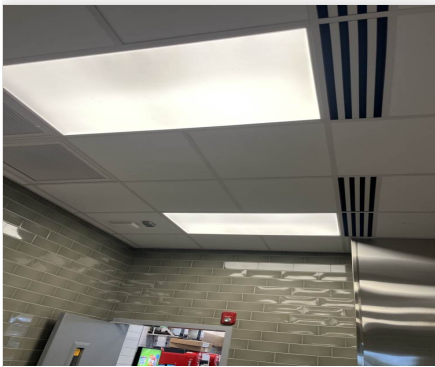
EF1_MissingGrille
06/13/2024

Issue Name : EF 1 Grille 4 Not Installed
Description : EF 1 Grille 4 was found to not be installed. There is no duct ran to this area either. Airflow was redistributed to the other two exhaust grilles in the Food Service #2 room.
Created By : National TAB **Assigned To :** National TAB - Will Turnbough
Status : Open
Priority : High **Asset Tag :**
Originated Date : 06/13/2024 - Stephen Tassinaro - National TAB

Asset	Notes	Date	Written By
EGRD4	NOT INSTALLED. AIRFLOW REDISTRIBUTED TO GRILLES 5 & 6.	06/13/2024	Stephen Tassinaro

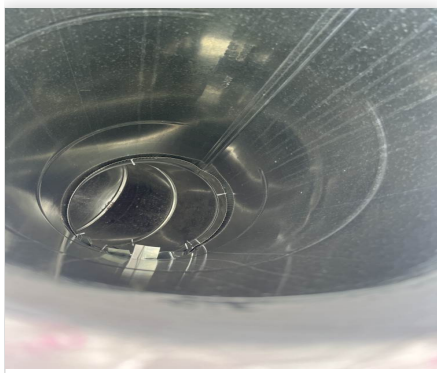
EF1_MissingBackdraft...
06/13/2024

Issue Name : EF 1 No Backdraft Damper
Description : There is no backdraft damper installed in the EF 1 ductwork. See note on HVAC EXHAUST FAN SCHEDULE.
Created By : National TAB **Assigned To :** National TAB - Will Turnbough
Status : Open
Priority : Medium **Asset Tag :**
Originated Date : 06/13/2024 - Stephen Tassinaro - National TAB

NO BACKDRAFT DAMPERS LOCATED

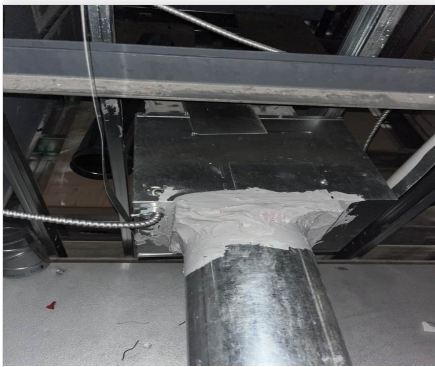
EF_2
06/13/2024

Issue Name : EF 2 Not Running
Description : EF 2 serving the Water Service Room, was not running at the time of balance. This fan was not balanced. The operation of this fan will not effect the balance or comfort of the rest of the store.
Created By : National TAB **Assigned To :** National TAB - Will Turnbough
Status : Open
Priority : High **Asset Tag :**
Originated Date : 06/13/2024 - Stephen Tassinaro - National TAB

NO SPEED CONTROLLER ON EF-2

EF-2 NOT OPERATIONAL. EF-1 BALANCED WITHIN 5%.

Notes:
FAN NOT RUNNING - NO SPEED CONTROLLER LOCATED.

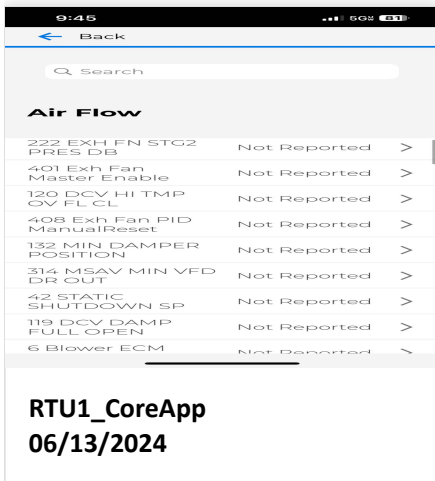
Issue Name : RTU 1 Core Freezing & Disconnecting
Description : RTU 1 Core app is consistently freezing and disconnecting. This repetitive disconnect prevented NTi from setting all unit parameters. Supply total and outside are were able to be set successfully.
Created By : National TAB **Assigned To :** National TAB - Will Turnbough
Status : Open
Priority : High **Asset Tag :**
Originated Date : 06/06/2024 - Stephen Tassinaro - National TAB

RTU 1 - CORE APP NOT RESPONSIVE RTU 2 - EAT 70F - LAT 59F RTU 3 - FAIL - Comp 1 Low Pressure - EAT 77F - LAT 68F

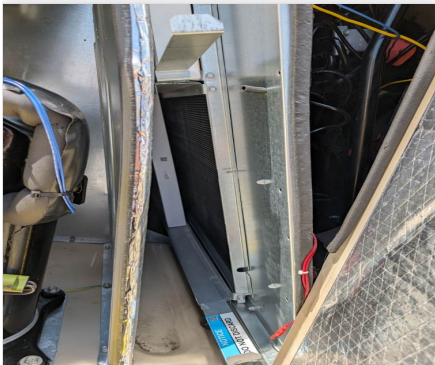
**MissingFilter
06/05/2024**

Issue Name : RTU 2 Missing One Final Filter
Description : RTU 2 is missing one of the final filters. Recommend replacing.
Created By : National TAB **Assigned To :** National TAB - Will Turnbough
Status : Open
Priority : Medium **Asset Tag :**
Originated Date : 06/05/2024 - Stephen Tassinaro - National TAB

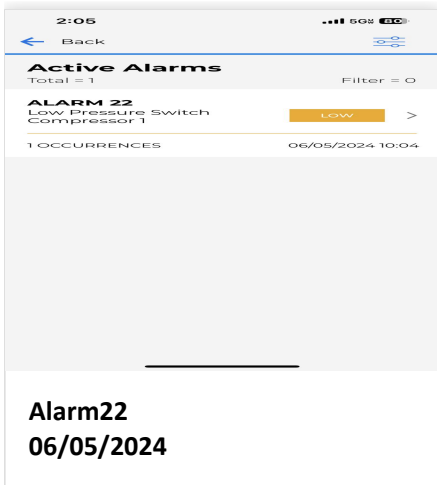
Issue Name : RTU 3 Alarm 22
Description : RTU 3 - Alarm 22 (Low Pressure Switch Compressor 1)
Created By : National TAB **Assigned To :** National TAB - Will Turnbough
Status : Open
Priority : High **Asset Tag :**
Originated Date : 06/05/2024 - Stephen Tassinaro - National TAB

RTU 3 - ALARM 22
