Report: TAB Report
Function: Test, Adjust, & Balance
Date: 05/31/2024

PROJECT
06-03-24 WAWA #5434 PALATKA, FL

Project: 06-03-24 WAWA #5434 PALATKA, FL

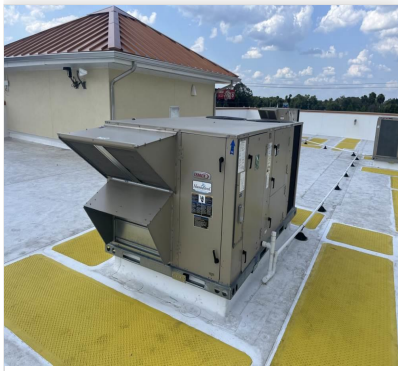
RTU_1
06/13/2024

Issue Name : RTU 1 Core Freezing & Disconnecting
Description : RTU 1 Core app is consistently freezing and disconnecting. This repetitive disconnect is preventing NTi from setting all unit parameters including outside air.
Created By : National TAB **Assigned To :** National TAB - Will Turnbough
Status : Open
Priority : High **Asset Tag :**
Originated Date : 06/06/2024 - Stephen Tassinaro - National TAB

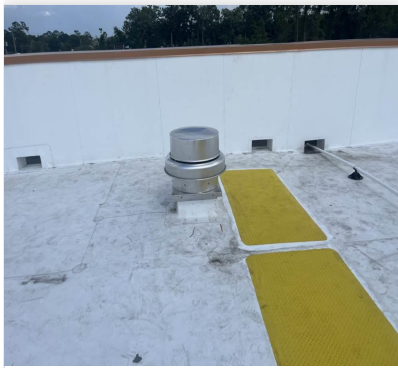
EF_1
06/13/2024

Issue Name : EF 1 Grille 4 Not Installed
Description : EF 1 Grille 4 was found to not be installed. There is no duct ran to this area either. Airflow was redistributed to the other two exhaust grilles in the Food Service #2 room.
Created By : National TAB **Assigned To :** National TAB - Will Turnbough
Status : Open
Priority : High **Asset Tag :**
Originated Date : 06/13/2024 - Stephen Tassinaro - National TAB

Issue Name : EF 1 No Backdraft Damper
Description : There is no backdraft damper installed in the EF 1 ductwork. See note on HVAC EXHAUST FAN SCHEDULE.
Created By : National TAB **Assigned To :** National TAB - Will Turnbough
Status : Open
Priority : [Medium](#) **Asset Tag :**
Originated Date : 06/13/2024 - Stephen Tassinaro - National TAB

Asset	Notes	Date	Written By
EGRD4	NOT INSTALLED. AIRFLOW REDISTRIBUTED TO GRILLES 5 & 6.	06/13/2024	Stephen Tassinaro

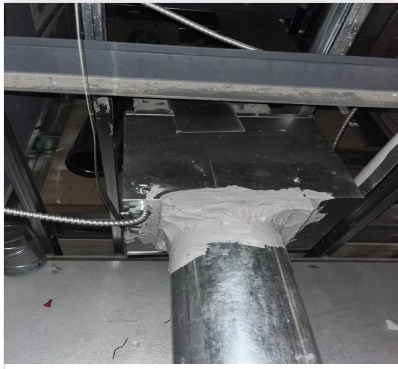
EF_2
06/13/2024

Issue Name : EF 2 Not Running
Description : EF 2 serving the Water Service Room, was not running at the time of balance. This fan was not balanced. The operation of this fan will not effect the balance or comfort of the rest of the store.
Created By : National TAB **Assigned To :** National TAB - Will Turnbough
Status : Open
Priority : High **Asset Tag :**
Originated Date : 06/13/2024 - Stephen Tassinaro - National TAB

NO SPEED CONTROLLER ON EF-2

Notes:
FAN NOT RUNNING - NO SPEED CONTROLLER LOCATED.
