Report: Test and Balance

Date: 4/28/2021

PROJECT
ARBYS #1191 FORT SMITH, AR (TOWSON)

4915 TOWSON
FT SMITH, AR

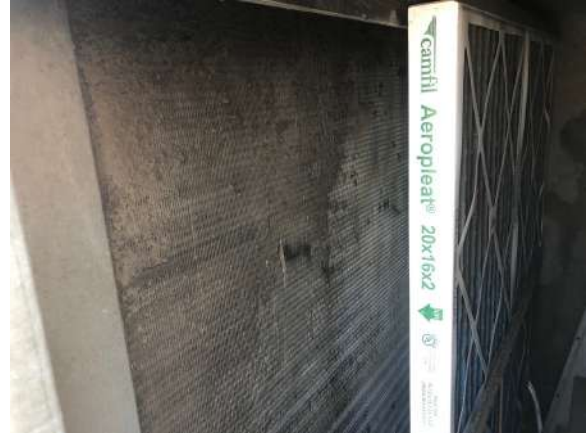
RTU1 Evap Coil

- Notes:
- [1] Supply duct is 42x24
 - [2] There are holes in the bottom of the discharge near the duct that is allowing loss of airflow
 - [3] Motor pulley is bound up and cannot be adjusted
 - [4] Evaporator coil and fan wheel are dirty and needs to be cleaned

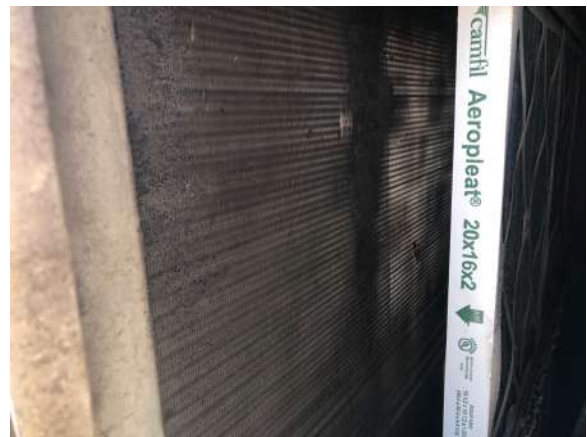
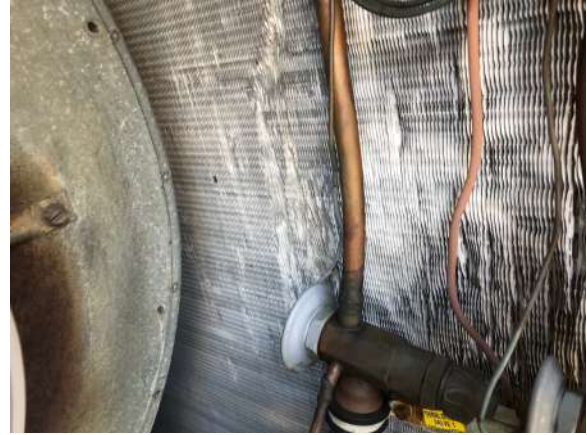
RTU2 Evap Coil

RTU-2 (KITCHEN)	
HIGH	Evaporator coil is very dirty and needs to be cleaned.
HIGH	Blower is very dirty and needs to be cleaned.
HIGH	The motor pulley is bound up and cannot be adjusted. Recommend breaking pulley free and the closing (maximizing) the pulley to increase airflow. Ensure that the amperage to the motor does not exceed the full load rating.
LOW	Unit has noticeable vibration and appears to be coming from motor compartment. Not audible from inside space but recommend monitoring/resolving.
LOW	Evaporator coil has damage to the fans which is likely impacting airflow. Recommend straightening if possible.
INFO ONLY	Airflow is currently 230 CFM/ton (3788 CFM). After making changes above it is anticipated that airflow should increase significantly. If airflow remains low a pulley change may be feasible since there is a large amount of amperage left on the motor.
EF-1 (FRYERS)/FRYER HOOD

- Notes:
- [1] Evap coil is damaged on the motor side
 - [2] Discharge duct is 35x25
 - [3] Dirt buildup on the fan blades and evaporator coil
 - [4] Unable to adjust motor pulley without pulling motor out of compartment
 - [5] Unit is noticeably vibrating, seems to be coming from the motor compartment. Sound does not carry to space

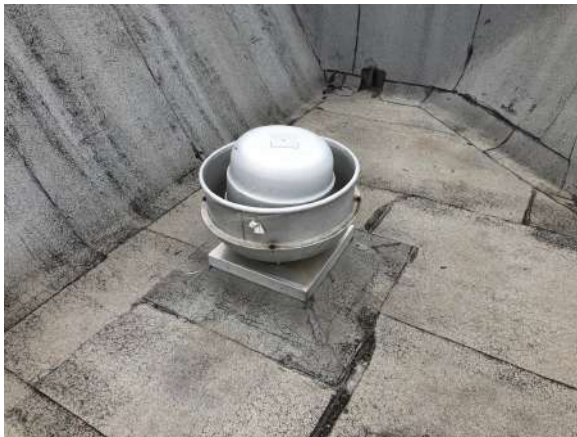
EF2

- Notes:
- [1] Belt has no size
 - [2] Unable to safely take volts and amps
 - [3] Unable to lower speed any further, motor is tensioned as much as possible

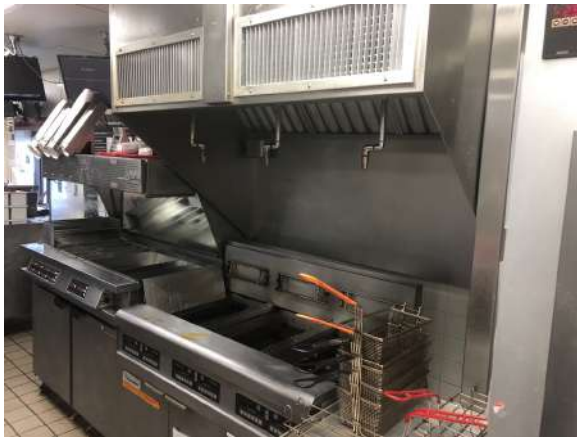
HD1

Notes: [1] Upon arrival filters are very dirty, very little airflow is able to pass through
 [2] Exhaust duct has 2 90s to top of hood

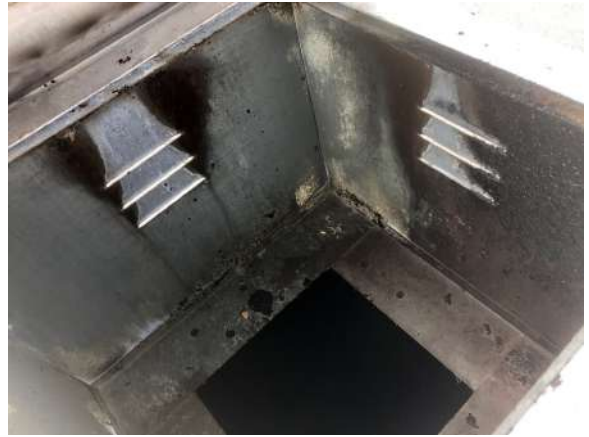
Initial EF1 Vents

HIGH	Fan sits on vented curb and the grease duct is not run all the way up to the fan. The current arrangement allows for leakage through the curb. It also allows for a ledge for grease to pool which is a fire hazard. Recommend running the grease duct all the way up to the base of the fan. During testing, the vents were temporarily taped.
INFO ONLY	Airflow is currently 687 CFM which is lower than recommended for this size hood. However with the vents taped off, the hood was performing well. Not recommended to change fans at this time. If fan change is performed in future, recommend larger fan
INFO ONLY	Filters were initially dirty. Had Operations clean.
EF-2 (OVEN HOOD)/OVEN HOOD	
HIGH	Fan sits on vented curb and the grease duct is not run all the way up to the fan. The current arrangement allows for leakage through the curb. It also allows for a ledge for grease to pool which is a fire hazard. Recommend running the grease duct all the way up to the base of the fan. During testing, the vents were temporarily taped.

- Notes:
- [1] No Belt size listed
 - [2] Unable to safely take volts and amps
 - [3] Grease duct does not come all the way to the curb, taped off vents from curb extension.

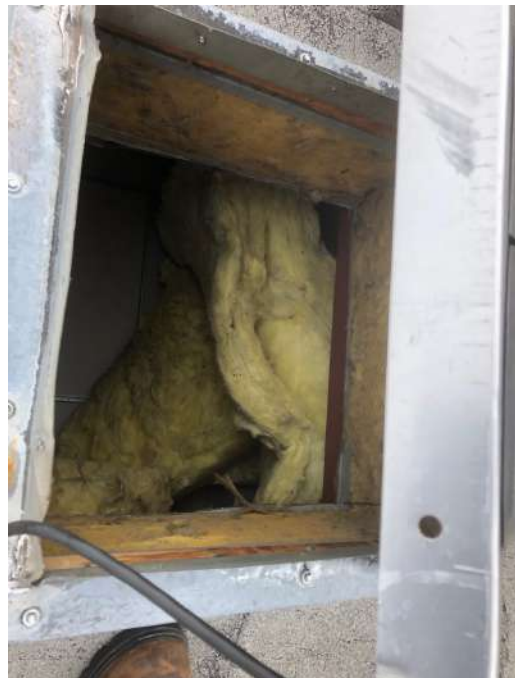
EF3 No Duct

EF-3 (RESTROOM)	
HIGH	Ductwork is not run from the fan to the grilles in the space. The fan pulls from the ceiling space. The airflow at the grilles was around 200 CFM total but based on a fan curve, the total airflow for the fan is around 1000 CFM. Recommend running ductwork to this fan. The fan is currently wired for high speed and once ductwork is connected it is recommended to wire the fan for low speed.
MUA (FRYER HOOD)	
HIGH	MUA outlet at hood is a front face discharge style. This style of MUA is not recommended as it discharges unconditioned outside air into the kitchen space. If supply air can be increased on both RTU's, then it is possible to completely turn off the MUA. This should have a significant impact on space comfort.

- Notes:
- [1] Unit is not attached to any ductwork
 - [2] Unit total CFM taken from fan curve.
 - [3] Unit needs to be wired for low speed, currently wired for high speed.
