Report: TAB Report
Function: Test, Adjust, & Balance
Date: 07/31/2025
Completed By: National TAB

07-28-25 CHIPOTLE #5480 FREDERICK, CO

Chipotle Mexican Grill
610 Newport Center Drive, Suite 1100
Newport Beach, CA 92660

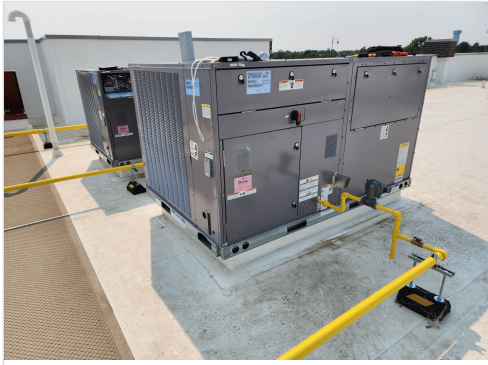
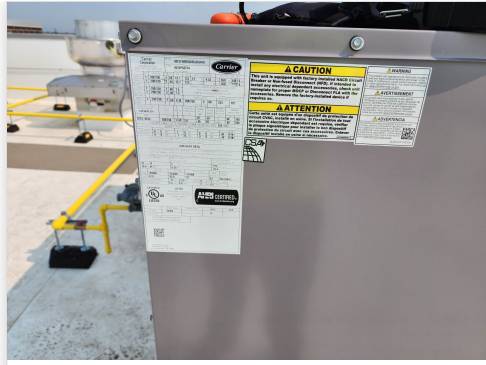
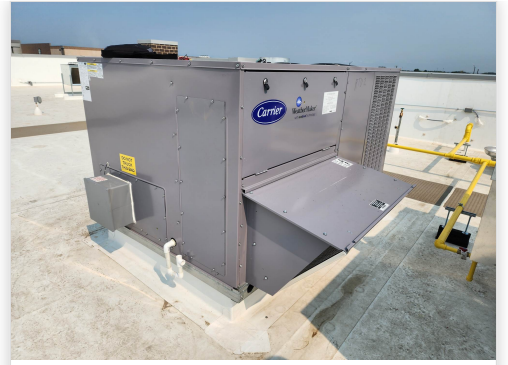
Unit Data - PHOTO LOG

Asset: RTU2

AREA:DINING

Unit Data		
	Design	Actual
MFG	CARRIER	CARRIER
Serial Num	-	0524P63214
Model Num	48FCFN09	48FCFN09
Type	RTU	RTU
Configuration	VERTICAL	VERTICAL
Num OA Filters 1	-	1
OA Filter Size 1	-	19"X35.5"
Num Final Filter 1	-	4
Final Filter Size 1	-	19.5"X19.5"

Test Data		
	Design	Actual
SF CFM	3400	3351
SF RPM	-	1443
RA CFM	2650	2540
OA CFM	750	811
RL Voltage	-	215, 215, 214
RL Amperage	-	2.5, 2.4, 2.5
SF Rotation	-	COUNTERCLOCKWISE
SF System SetPt	-	A60
Min OA Damper Position	-	4.4V
OA Enthalpy Setpt	-	ES5

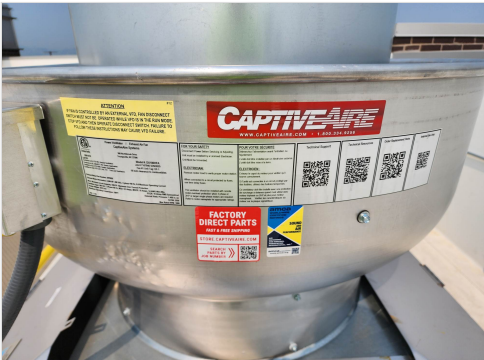
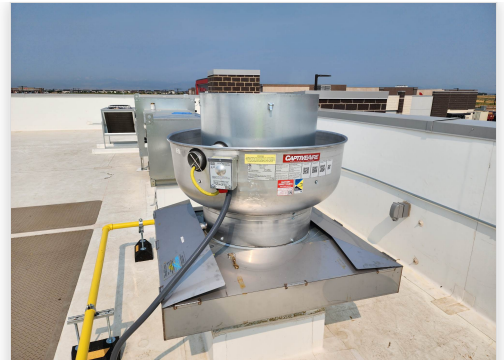
Unit Data - PHOTO LOG

Asset: EF1

AREA: KITCHEN HD

Unit Data		
	Design	Actual
MFG	CAPTIVE-AIRE	CAPTIVE-AIRE
Model Num	DU180HFA	DU180HFA
Serial Num	-	7167846
Type	UPBLAST	UPBLAST
Configuration	VERTICAL	VERTICAL

Test Data		
	Design	Actual
CFM	2550	2609
Fan RPM	1304	1034
Fan Rotation	-	COUNTERCLOCKWISE
Motor RPM	-	1034
System SetPt	-	53Hz
RL Voltage	-	96
RL Amperage	-	4.8
Total ESP	1.450"	0.76"
Fan Inlet SP	-	-0.76"
Fan Discharge SP	-	ATM

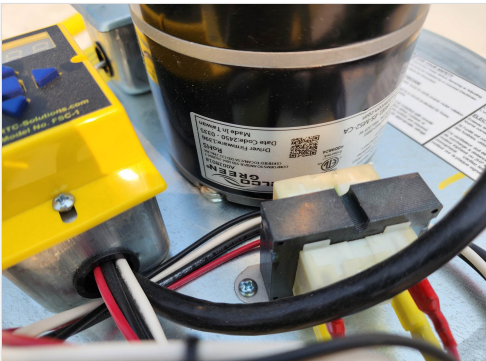
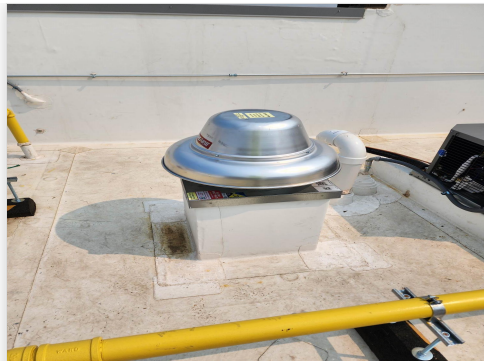
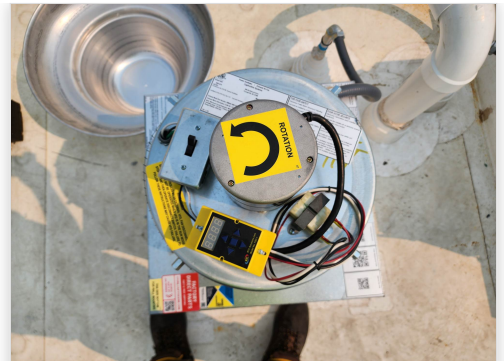
Unit Data - PHOTO LOG

Asset: EF2

AREA:RESTROOM

Unit Data		
	Design	Actual
MFG	CAPTIVE-AIRE	CAPTIVE-AIRE
Model Num	DR12HFA	DR12HFA
Serial Num	-	7167846
Type	DOWNBLAST	DOWNBLAST
Configuration	VERTICAL	VERTICAL

Test Data		
	Design	Actual
CFM	150	150
Fan RPM	1402	1329
Fan Rotation	-	COUNTERCLOCKWISE
Motor RPM	-	1329
System SetPt	-	68%

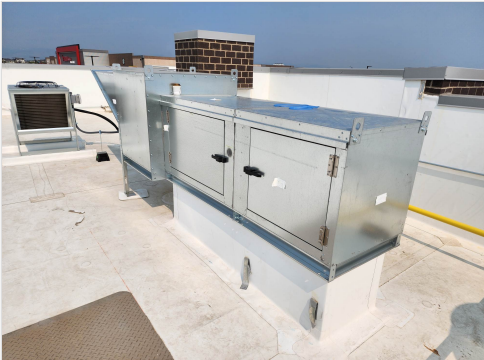
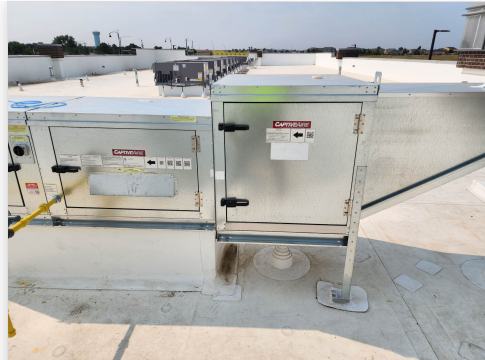
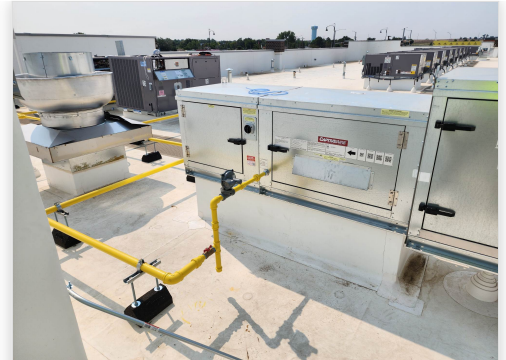
Unit Data - PHOTO LOG

Asset: MAU1

AREA: KITCHEN HD

Unit Data		
	Design	Actual
MFG	CAPTIVE-AIRE	CAPTIVE-AIRE
Model Num	A1-D.250-15D	A1-D.250-15D
Serial Num	-	7167664
Type	MAU	MAU
Configuration	VERTICAL	VERTICAL

Test Data		
	Design	Actual
CFM	1300	1319
SF RPM	1667	1531
Motor RPM	-	1531
SF System SetPt	-	50.2Hz
RL Voltage	-	128
RL Amperage	-	2.4

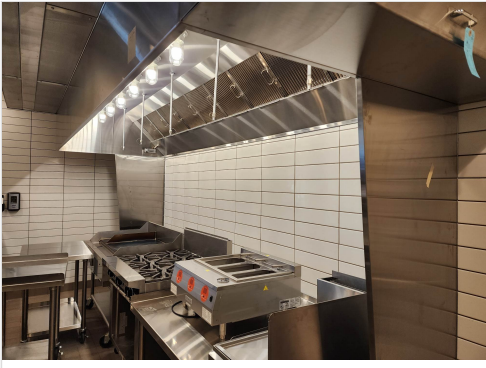
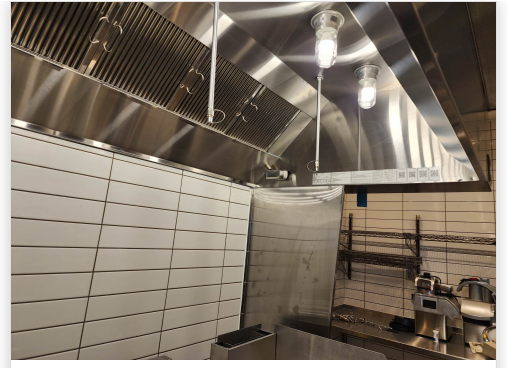
Unit Data - PHOTO LOG

Asset: HD1

AREA:KITCHEN

Unit Data		
	Design	Actual
MFG	CAPTIVE-AIRE	CAPTIVE-AIRE
Model Num	5424 ND-2-ACPSP-F	5424 ND-2-ACPSP-F
Job / Serial Num	-	7167846
Type	TYPE 1 CANOPY	TYPE 1
Hood length	153"	153"
Hood Width	54"	54"
Supply Plenum Type	-	AC-PSP
Supply Plenum Width	9"	9"
Supply Plenum Length	165"	165"

Test Data Exhaust		
	Design	Actual
Filter Type	CAPTRATE SOLO FILTER	CAPTRATE SOLO FILTER
Filter Size 1	16X16	16X16
Filter Qty 1	9	9
Filter AK factor size 1	1.62	1.62
Filter Total AK Area	14.58	14.58
Filter1 FPM	-	156
Filter2 FPM	-	169
Filter3 FPM	-	197
Filter4 FPM	-	219
Filter5 FPM	-	167
Filter6 FPM	-	204
Filter7 FPM	-	166
Filter8 FPM	-	169
Filter9 FPM	-	165
Filter Ave FPM(corr)	-	179
CFM	2550	2609

Test Data Supply		
	Design	Actual
Total Area	10.31	10.31
Kv factor (Vel)	0.81	0.81
Num of Readings	-	9
Reading1 FPM	-	229
Reading2 FPM	-	132
Reading3 FPM	-	137
Reading4 FPM	-	176
Reading5 FPM	-	142
Reading6 FPM	-	145
Reading7 FPM	-	112
Reading8 FPM	-	192
Reading9 FPM	-	159
Ave FPM(corr)	-	128
CFM	1300	1319
