Report: TAB REPORT
Function: Test, Adjust, & Balance
Date: 01/19/2026
Completed By: National TAB

PROJECT
01-19-26 CHIPOTLE #5286 TAYLORS, SC

Project: 01-19-26 CHIPOTLE #5286 TAYLORS, SC

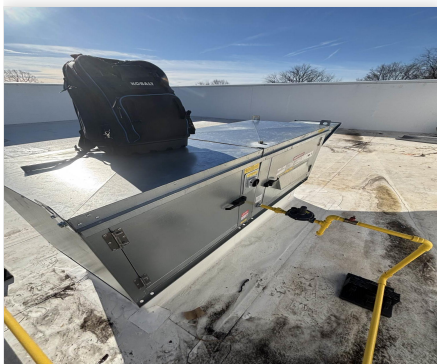
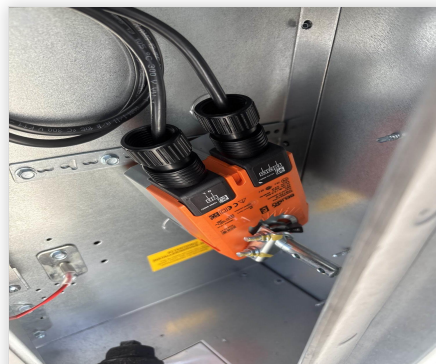
Issue Name : Damper will not open
Description : The OA damper for the MAU does not open when the unit is powered on. For balancing it was manually opened to 100%, and shut back to its original position once balanced. Unit was left OFF.
Created By : National TAB **Assigned To :** National TAB - Dan Hertenstein
Status : Open
Priority : **Urgent** **Asset Tag :** MAU1
Originated Date : 01/20/2026 - Christian Moller - National TAB

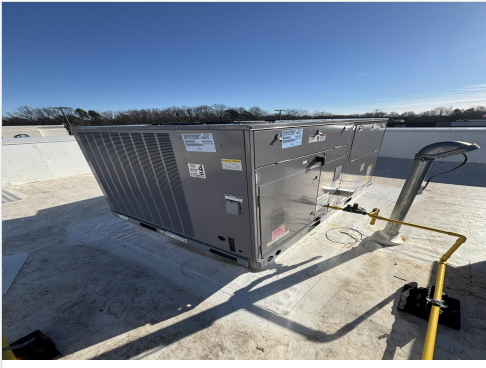
Unit Data - PHOTO LOG

Asset: RTU1

Test Data		
	Design	Actual
SF CFM	4000	3859
SF RPM	-	DD
RA CFM	3500	3318
OA CFM	500	541
RL Voltage	-	209/210/211
RL Amperage	-	5.1/5.4/5.8
SF Rotation	-	CCW
SF System SetPt	-	8.2DCV
RA Damper Position	-	5.6V
Min OA Damper Position	-	4.4V
Min OA Damper Type	-	ECON

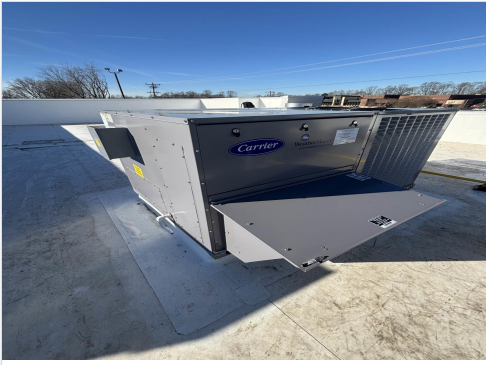
Unit Data - PHOTO LOG

Asset: RTU2

Test Data		
	Design	Actual
SF CFM	4000	4215
SF RPM	-	DD
RA CFM	3000	3141
OA CFM	1000	1074
RL Voltage	-	209/210/211
RL Amperage	-	6.0/6.2/6.4
SF Rotation	-	CCW
SF System SetPt	-	8.6DCV
RA Damper Position	-	4.9V
Min OA Damper Position	-	5.1V
Min OA Damper Type	-	ECON

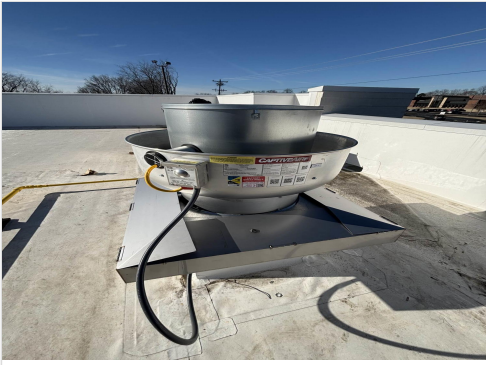
Unit Data - PHOTO LOG

Asset: EF1

Test Data		
	Design	Actual
CFM	2550	2347
Fan RPM	1232	DD
Fan Rotation	-	CCW
Motor RPM	-	DD
System SetPt	-	HMI/52.3Hz
RL Voltage	-	210
RL Amperage	-	3.7
Total ESP	1.450"	1.13"
Fan Inlet SP	-	-1.13"
Fan Discharge SP	-	ATM

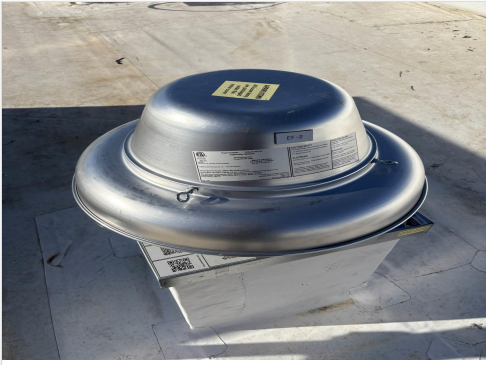
Unit Data - PHOTO LOG

Asset: EF2

Test Data		
	Design	Actual
CFM	150	152
Fan RPM	1304	DD/994
Fan Rotation	-	CCW
Motor RPM	-	DD
System SetPt	-	52P
RL Voltage	-	211
RL Amperage	-	1.2
Total ESP	0.60"	0.33"
Fan Inlet SP	-	-0.33"
Fan Discharge SP	-	ATM

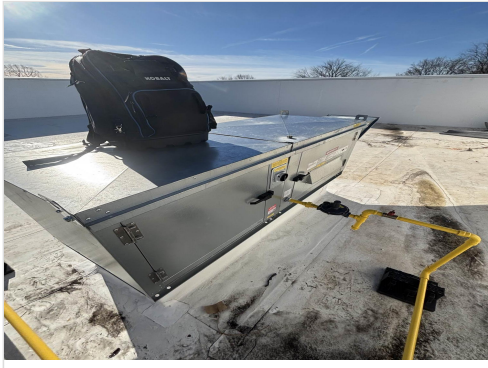
Unit Data - PHOTO LOG

Asset: MAU1

Test Data		
	Design	Actual
CFM	1300	1356
SF RPM	1557	DD
Motor RPM	-	DD
SF System SetPt	-	HMI/31.4Hz
RL Voltage	-	212/211/210
RL Amperage	-	2.3/2.6/2.1
Total ESP	-	0.81"
Fan Discharge SP	-	0.74"

Notes:
See issue (1)
