**Report: TAB**

**Function: Test, Adjust, & Balance**

**Date: 10/14/2025**

**09-29-25 CHIPOTLE #5401 OAKLEY, CA  
(LAUREL & OHARA)**

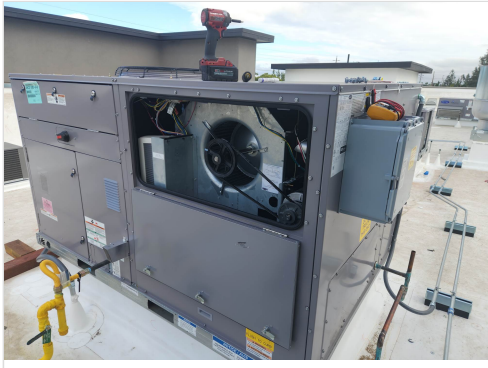
## Unit Data - PHOTO LOG

Asset: RTU1

AREA: KITCHEN

Unit Data		
	Design	Actual
MFG	CARRIER	CARRIER
Serial Num	-	4422P67317
Model Num	48FCNF12	48HCFD11A2M5A6F4J0
Type	RTU	RTU
Configuration	VERTICAL	VERTICAL
Num OA Filters 1	-	1
OA Filter Size 1	-	35X19
Num Final Filter 1	-	4
Final Filter Size 1	-	20X20X2
Num Final Filter 2	-	
Final Filter Size 2	-

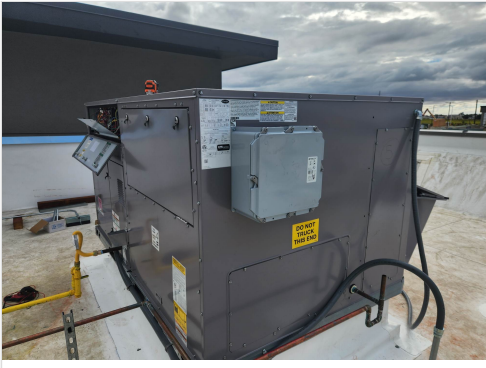
## Unit Data - PHOTO LOG

Asset: RTU2

AREA: DINING

Unit Data		
	Design	Actual
MFG	CARRIER	CARRIER
Serial Num	-	4422P67488
Model Num	48FCNF12	48HCDD11A2M5A6F4J0
Type	RTU	RTU
Configuration	VERTICAL	VERTICAL
Num OA Filters 1	-	1
OA Filter Size 1	-	35X19
Num Final Filter 1	-	4
Final Filter Size 1	-	20X20X2
Num Final Filter 2	-	
Final Filter Size 2	-

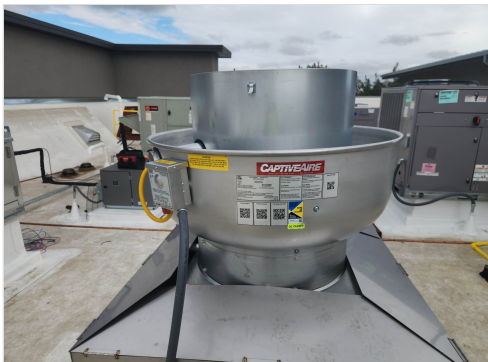
### Unit Data - PHOTO LOG

Asset: EF1

AREA: KITCHEN

Unit Data		
	Design	Actual
MFG	CAPTIVEAIRE	CAPTIVEAIRE
Model Num	DU180HFA	DU180HFA
Serial Num	-	7416016
Type	UPBLAST	UPBLAST
Configuration	VERTICAL	VERTICAL

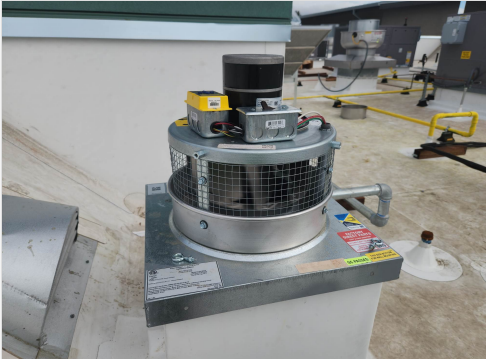
### Unit Data - PHOTO LOG

Asset: EF2

AREA:RESTROOM

Unit Data		
	Design	Actual
MFG	CAPTIVEAIRE	CAPTIVEAIRE
Model Num	DR12HFA	DR12HFA
Serial Num	-	7416016
Type	DOWNBLAST	DOWNBLAST
Configuration	VERTICAL	VERTICAL

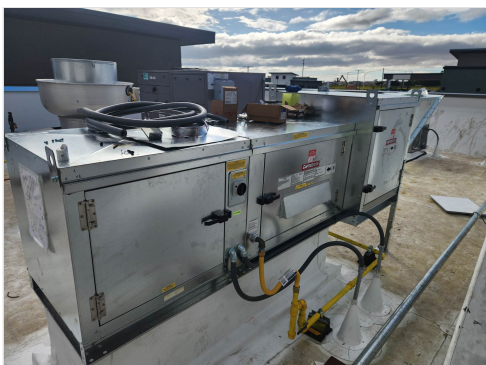
### Unit Data - PHOTO LOG

Asset: MAU1

AREA:HOOD

Unit Data		
	Design	Actual
MFG	CAPTIVEAIRE	CAPTIVEAIRE
Model Num	A1-D.250-15D	A1-D.250-15D
Serial Num	-	7416016
Type	MAU	MAU
Configuration	VERTICAL	VERTICAL

Gas Heat		
	Design	Actual
Heater Operates (y/n)	-	NO
Flame Status (pass/fail)	-	FAIL
Inlet Air Temp SetPt	55	55
Discharge Air Temp SetPt	60	60
Air Flow Switch SP Actual	-	0.45"

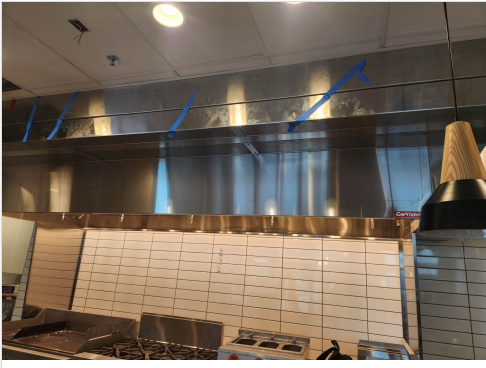
**Unit Data - PHOTO LOG**

Asset: HD1

AREA: COOK LINE

Unit Data		
	Design	Actual
MFG	CAPTIVEAIRE	CAPTIVEAIRE
Model Num	5424 ND-2-ACPSP-F	5424 ND-2-ACPSP-F
Job / Serial Num	-	7416016
Type	TYPE 1 CANOPY	TYPE I CANOPY
Hood length	153"	153"
Hood Width	54"	54"
Supply Plenum Type	-	PERFORATED
Supply Plenum Width	9"	9"
Supply Plenum Length	165"	165"
