Report: Test and Balance

PROJECT
FREDDY'S - OVERLAND PARK, KS (BLUHAWK)

7831 W 159TH ST
OVERLAND PARK, KS 66223

Project: FREDDY'S - OVERLAND PARK, KS (BLUHAWK)

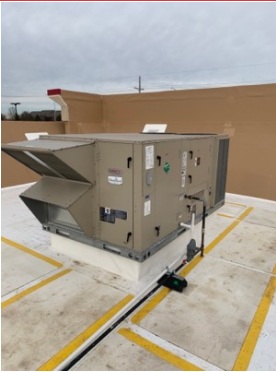
RTU-1 (DINING)

(1)The unit was balanced to total flow and to ensure no drafting. Diffusers 1-7 and 1-5 caused the unit to be unable to get each diffuser within design.

(2) Condensate drain has no p-trap

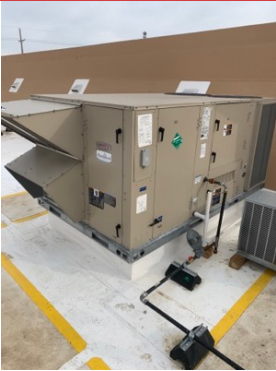
RTU-2 (KITCHEN)

- Notes:
- (1) The unit was balance to total flow, hood capture, and comfort. The diffuser that are below design was caused by restrictions in the duct work. They had one or multiple of the following issues: 90 deg turn after takeoff, flex is partial smash trying to go around obstructions, to long of a duct run, to many turns to go around obstructions, and/or flex duct coming into the top of the diffuser at a bad angle.
 - (2) Condensate drain has no p-trap

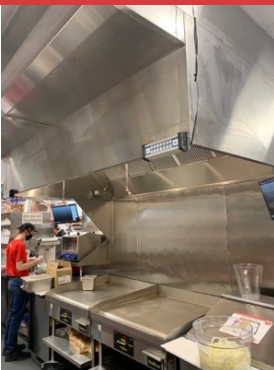
KEH-1 (GRIDDLE)

- Notes:
- (1) The right quarter end panel was removed and the monitor for orders was put in place. The monitor is half way in the hood.
 - (2) If the quarter end panel was installed their would be 100% hood capture. it currently at 95-98% hood capture.

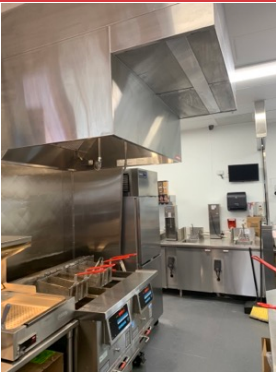
KEH-2 (FRYER)

PRIORITY (HIGH/LOW/INFO ONLY)	
INFO ONLY	(3) Hood capture is 90%. Dampers to the ACPSP and PSP are not accessible. When the kitchen RTU was turned off the hood had 100%. The smoke want to rise into the fryer warmer on the left side of the hood. Then roll out. The high velocity from the ACPSP is disrupting the airflow pattern. A branch damper needs to be installed on the duct run to the hoods, so this airflow pattern can be modified to improve hood capture.
INFO ONLY	I PUT THE NOTE ABOVE HEAR SINCE IT WOULD NOT FIT IN THE REPORT.
INFO ONLY	
INFO ONLY
