**Report: TAB REPORT
Function: Test, Adjust, & Balance
Date: 05/05/2023**

**PROJECT
04-17-23 IHOP - COCKEYSVILLE, MD**

Project: 04-17-23 IHOP - COCKEYSVILLE, MD

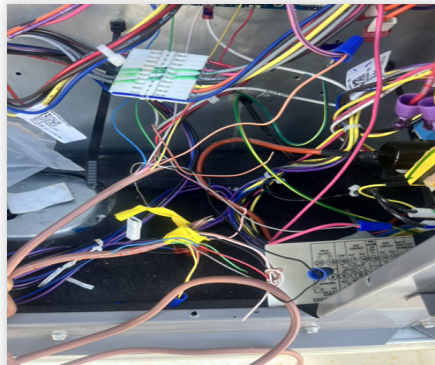
Thermostat
05/17/2023

Issue Name : RTU-4 is always running
Description : RTU-4 is always running with stage 2 cooling being active and does not look like it is controlled by the thermostat. Recommend having Mechanical contractor to troubleshoot thermostat wiring.
Created By : National TAB **Assigned To :** National TAB - David Annan
Status : Open
Originated Date : 05/17/2023 - David Annan - National TAB

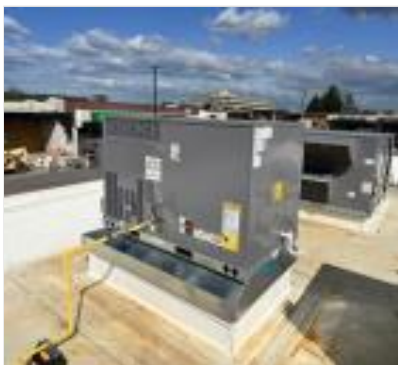
RTU-3
05/03/2023

OA intake for RTU-1 and RTU-2 were increased to compensate missing OA from RTU-3

Economizers are assembled and functional?	RTU-3 (Temporary) does not have an economizer.
DCV Max damper opening position is set to minimum?	Yes
Free cooling enthalpy set point set for lowest setting (Typically "D")	Yes
Motors are all operating below the FLA rating?	Yes
Are belts tight?	Yes
If direct drive unit is the speed controller working.	Yes
Is gas piping installed and valves turned on?	Yes
Unit free of noticeable noise and vibration	Yes

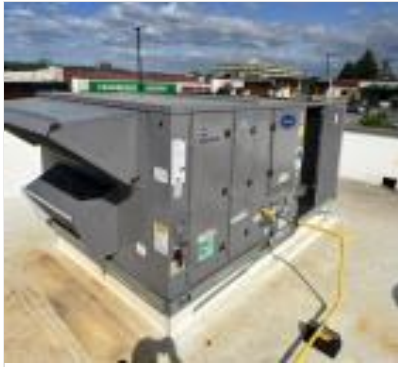
RTU-4
05/03/2023

- RTU-4 is always running

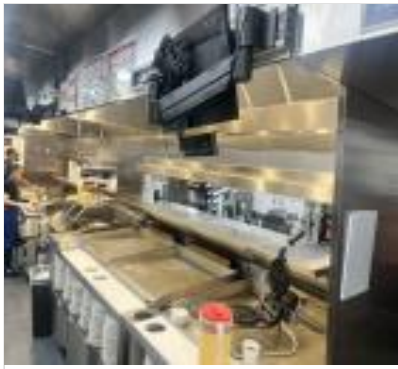
Hood-1
05/03/2023

Notes: Readings at the perforated PSP were turbulent and inaccurate. Total was read at the MUA intake.
