**Report: TAB REPORT
Function: Test, Adjust, & Balance
Date: 05/05/2023**

**PROJECT
04-17-23 IHOP - COCKEYSVILLE, MD**

Project: 04-17-23 IHOP - COCKEYSVILLE, MD

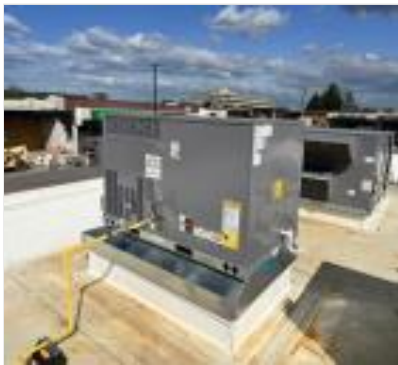
RTU-3
04/12/2023

OA intake for RTU-1 and RTU-2 were increased to compensate missing OA from RTU-3
