**Report: TAB REPORT
Function: Test, Adjust, & Balance
Date: 05/05/2023**

**PROJECT
04-17-23 IHOP - COCKEYSVILLE, MD**

150 CRANBROOK RD
COCKEYSVILLE, MD 21030

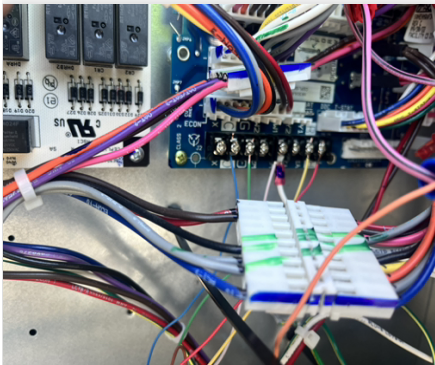
Thermostat
05/17/2023

Issue Name : RTU-4 is always running
Description : RTU-4 is always running with stage 2 cooling being active and does not look like it is controlled by the thermostat. Recommend having Mechanical contractor to troubleshoot thermostat wiring.
Created By : National TAB **Assigned To :** National TAB - David Annan
Status : Open
Originated Date : 05/17/2023 - David Annan - National TAB
