**Report: TAB REPORT**  
**Function: Test, Adjust, & Balance**  
**Date: 07/11/2025**  
**Completed By: National TAB**

**PROJECT**  
**06-23-25 CHIPOTLE #4676 UPPER**  
**MARLBORO, MD**

Project: 06-23-25 CHIPOTLE #4676 UPPER MARLBORO, MD

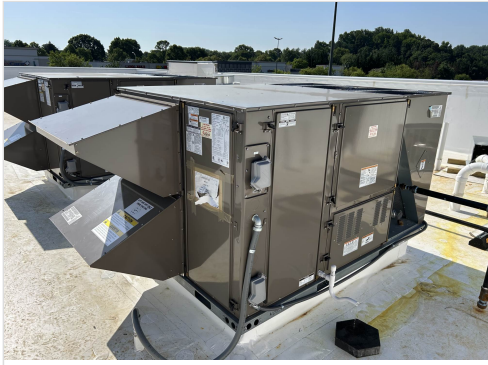
## Unit Data - PHOTO LOG

Asset: RTU1

AREA:KITCHEN

Unit Data		
	Design	Actual
MFG	YORK	YORK
Serial Num	-	N2B3471946
Model Num	ZJ120	ZJ120N18R2B5EAA2A3
Type	RTU	RTU
Configuration	VERTICAL	VERTICAL
Num OA Filters 1	-	1
OA Filter Size 1	-	29x20.5
Num Final Filter 1	-	4
Final Filter Size 1	-	20x24x2

Test Data		
	Design	Actual
SF CFM	3800	3592
SF RPM	-	972
RA CFM	3200	3018
OA CFM	600	574
RL Voltage	-	280 VFD
RL Amperage	-	7.89 VFD
SF Rotation	-	CW
SF System SetPt	-	60 HZ
RA Damper Position	-	86%
Min OA Damper Position	-	14%
Min OA Damper Type	-	ECONOMIZER

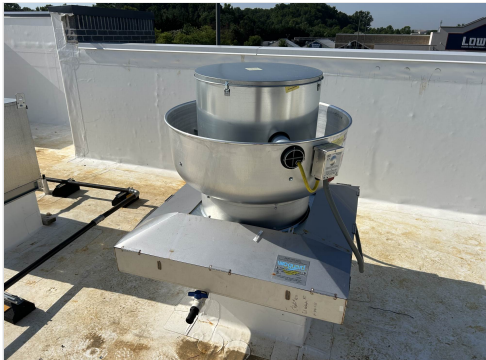
### Unit Data - PHOTO LOG

Asset: EF1

AREA:HOOD #1

Unit Data		
	Design	Actual
MFG	CAPTIVEAIRE	CAPTIVEAIRE
Model Num	DU180HFA	DU180HFA
Serial Num	-	6150612
Type	UPBLAST/CEILING	UPBLAST
Configuration	VERTICAL	VERTICAL

Test Data		
	Design	Actual
CFM	2550	2552
Fan RPM	-	1082
Fan Rotation	-	CCW
Motor RPM	-	1082
System SetPt	-	55.7 HZ
RL Voltage	-	128 VFD
RL Amperage	-	5.3 VFD
Total ESP	1.45"	0.67"
Fan Inlet SP	-	-0.67"
Fan Discharge SP	-	ATM

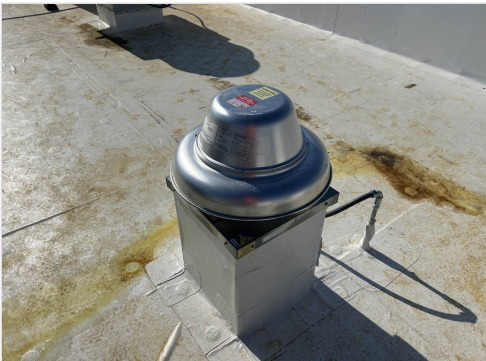
## Unit Data - PHOTO LOG

Asset: EF2

AREA:RESTROOMS

Unit Data		
	Design	Actual
MFG	CAPTIVEAIRE	CAPTIVEAIRE
Model Num	DR12HFA	DR12HFA
Serial Num	-	6150612
Type	DOWNBLAST	DOWNBLAST
Configuration	VERTICAL	VERTICAL

Test Data		
	Design	Actual
CFM	260	263
Fan RPM	-	1131
Fan Rotation	-	CCW
Motor RPM	-	1131
System SetPt	-	59%
RL Voltage	-	121
RL Amperage	-	0.7
Total ESP	0.60"	0.12"
Fan Inlet SP	-	-0.12"
Fan Discharge SP	-	ATM

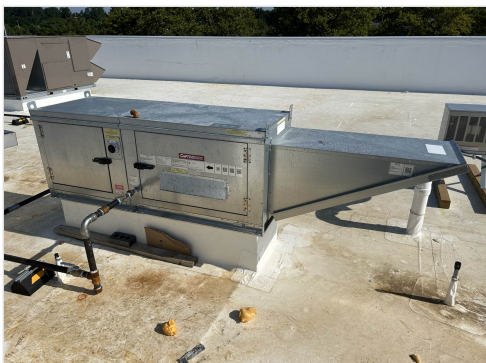
### Unit Data - PHOTO LOG

Asset: MAU1

AREA:HOOD #1

Unit Data		
	Design	Actual
MFG	CAPTIVEAIRE	CAPTIVEAIRE
Model Num	A1-D.250-15D	A1-D.250-15D
Serial Num	-	6150612
Type	MAU	MAU
Configuration	VERTICAL	VERTICAL

Test Data		
	Design	Actual
CFM	1300	1303
SF RPM	-	1569
Motor RPM	-	1569
SF System SetPt	-	54.1 HZ
RL Voltage	-	158 VFD
RL Amperage	-	2.5 VFD

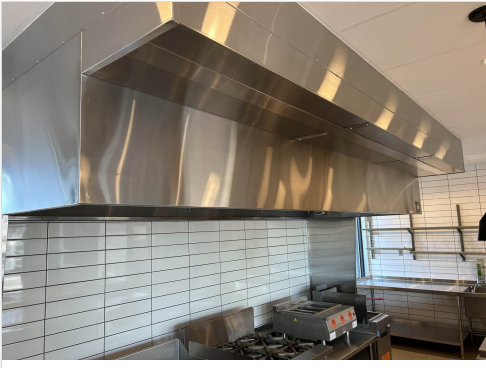
**Unit Data - PHOTO LOG**

Asset: HD1

AREA:KITCHEN

Unit Data		
	Design	Actual
MFG	CAPTIVEAIRE	CAPTIVEAIRE
Model Num	5424 ND-2-ACPSP-F	5424 ND-2-ACPSP-F
Job / Serial Num	-	6150612
Type	TYPE I CANOPY	TYPE I CANOPY
Hood length	153"	153"
Hood Width	54"	54"
Supply Plenum Type	-	ACPSP
Supply Plenum Width	9"	9"
Supply Plenum Length	165"	165"

Test Data Exhaust		
	Design	Actual
Filter Type	CAPTRATE SOLO FILTERS	CAPTRATE SOLO
Filter Size 1	16X16"	16X16
Filter Qty 1	9	9
Filter AK factor size 1	1.62	1.62
Filter Total AK Area	14.58	14.58
Filter1 FPM	-	166
Filter2 FPM	-	163
Filter3 FPM	-	161
Filter4 FPM	-	199
Filter5 FPM	-	203
Filter6 FPM	-	199
Filter7 FPM	-	181
Filter8 FPM	-	159
Filter9 FPM	-	151
Filter Ave FPM(corr)	-	175
CFM	2550	2552
