Report: TAB Report
Function: Test, Adjust, & Balance
Date: 10/22/2025
Completed By: National TAB

PROJECT
10-20-25 QT #1129 SPARTANBURG, SC

Project: 10-20-25 QT #1129 SPARTANBURG, SC

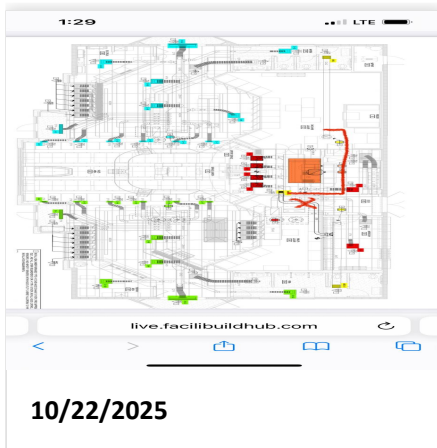
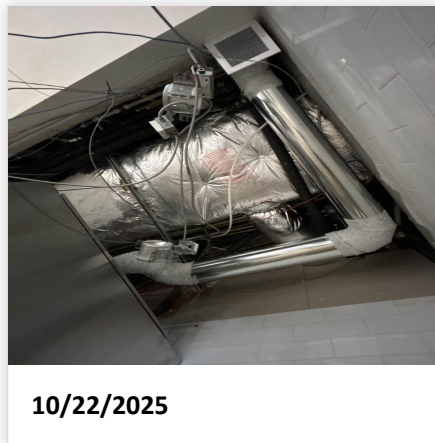
Issue Name : EF-1 AND EF-2 Routing does not Match Plans
Description : Per GC, exhaust was tapped into women's restroom instead of men's due to confined space issue. The Combi-Oven grille is now on EF-1 when plans called for it to be installed on EF-2.
Created By : National TAB **Assigned To :** National TAB - Dan Hertenstein
Status : Open
Priority : InfoOnly **Asset Tag :** EF2
Originated Date : 10/22/2025 - Jearod Ferrette - National TAB
