Report: TAB Report
Function: Test, Adjust, & Balance
Date: 10/22/2025
Completed By: National TAB

PROJECT
10-20-25 QT #1129 SPARTANBURG, SC

Project: 10-20-25 QT #1129 SPARTANBURG, SC

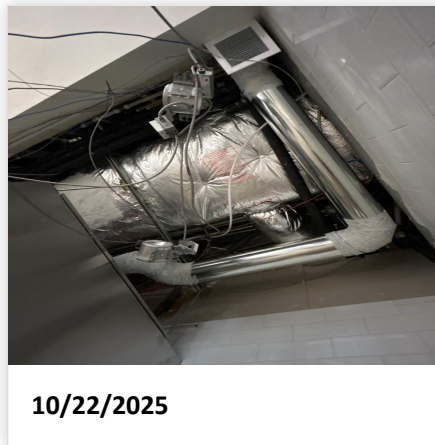
Issue Name : EF-1 AND EF-2 Routing does not Match Plans
Description : Per GC, exhaust was tapped into women's restroom instead of men's due to confined space issue. The Combi-Oven grille is now on EF-1 when plans called for it to be installed on EF-2.
Created By : National TAB **Assigned To :** National TAB - Dan Hertenstein
Status : Open
Priority : InfoOnly **Asset Tag :** EF2
Originated Date : 10/22/2025 - Jearod Ferrette - National TAB

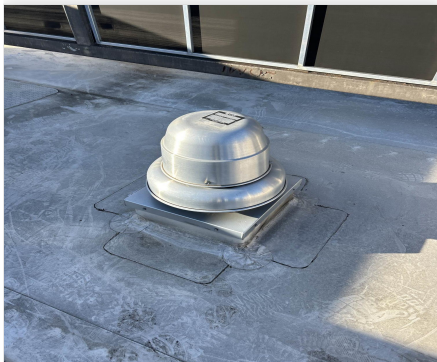
Issue Name : EF-1 not operational
Description : EF-1 not operational. The motor is just humming.
Created By : National TAB **Assigned To :** National TAB - Dan Hertenstein
Status : Open
Priority : High **Asset Tag :** EF1
Originated Date : 10/23/2025 - Jearod Ferrette - National TAB

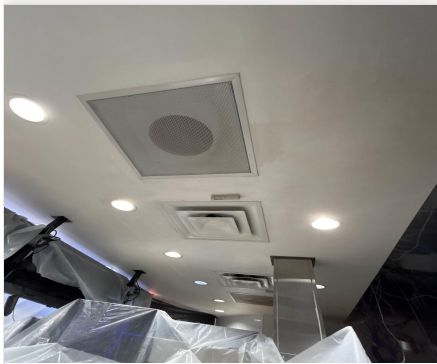
Issue Name : Kitchen diffusers on back order
Description : Kitchen diffusers on backorder
Created By : National TAB **Assigned To :** National TAB - Dan Hertenstein
Status : Open
Priority : Low **Asset Tag :** RT-3
Originated Date : 10/23/2025 - Jearod Ferrette - National TAB

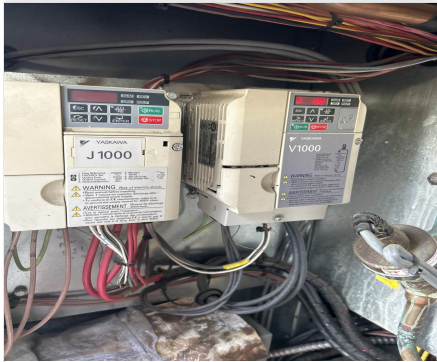
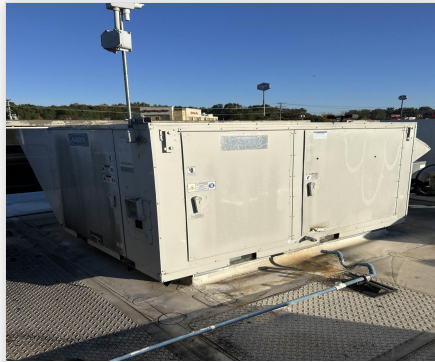
Issue Name : RTU 3 not operational
Description : RTU-3 not operational. Unit has power, but the VFD doesn't appear functional. Attempted to power cycle but no change to the unit.
Created By : National TAB **Assigned To :** National TAB - Dan Hertenstein
Status : Open
Priority : Urgent **Asset Tag :** RT-3
Originated Date : 10/23/2025 - Jearod Ferrette - National TAB

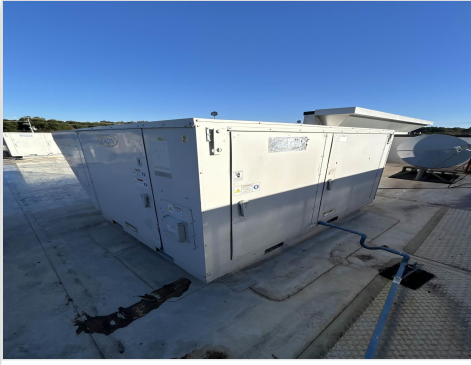
Unit Data - PHOTO LOG

Test Data		
	Design	Actual
SF CFM	4200	4352
SF RPM	-	DD/ 43HZ
OA CFM (Hoods On)	800	877
OA CFM (Hoods Off)	350	367
RL Voltage	-	143.3vfd
RL Amperage	-	9.5vfd
VFD Max SetPt	-	43HZ
OA Damper Position (Hoods On)	-	
OA Damper Position (Hoods Off)	-

Performance Data		
	Design	Actual
MA Plenum SP	-	-1.37"
Fan Suction SP	-	-1.47"
Fan Discharge SP	-	0.28"
Total ESP	-	2.84"
Fan Total SP	-	1.75"

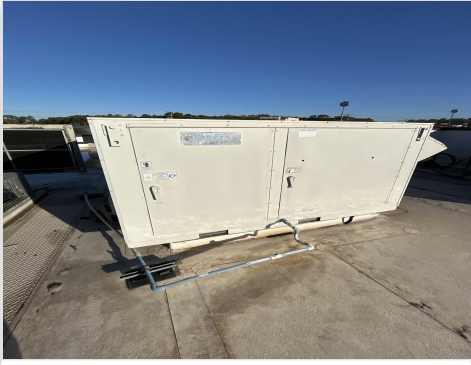
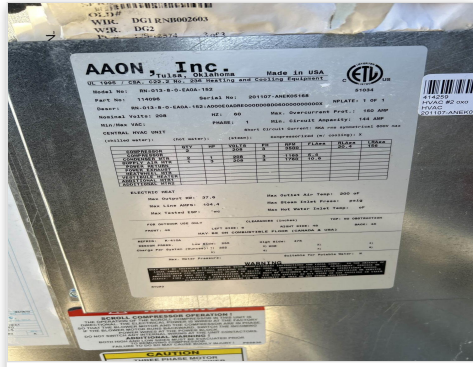
Unit Data - PHOTO LOG

Test Data		
	Design	Actual
SF CFM	4200	4563
SF RPM	-	DD/ 43HZ
OA CFM (Hoods On)	800	869
OA CFM (Hoods Off)	350	380
RL Voltage	-	143.5vfd
RL Amperage	-	9.5vfd
VFD Max SetPt	-	43hz
OA Damper Position (Hoods On)	-	46%
OA Damper Position (Hoods Off)	-	26%

Performance Data		
	Design	Actual
MA Plenum SP	-	-0.52"
Fan Suction SP	-	-0.68"
Fan Discharge SP	-	1.30"
Total ESP	-	1.20"
Fan Total SP	-	1.98"

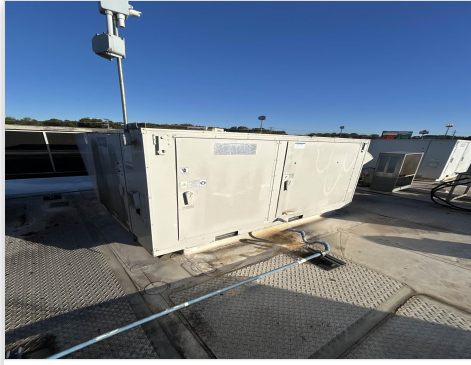
Unit Data - PHOTO LOG

Test Data		
	Design	Actual
SF CFM	4200	[1]
SF RPM	-	[1]

[1] UNIT NOT OPERATIONAL AT TIME OF TAB. NEEDS SERVICE.

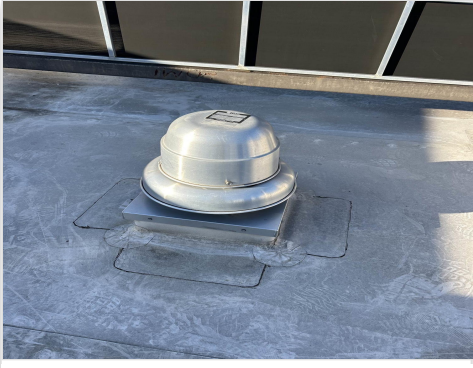
Unit Data - PHOTO LOG

Test Data		
	Design	Actual
CFM	525	0 [1]

[1] DEVIATION FROM PLANS, EF-1 DUCTED TO COMB-OVEN GRILLE INSTEAD OF EF-2. FAN (EF-1) IS NOT OPERATIONAL. SEE ISSUE.

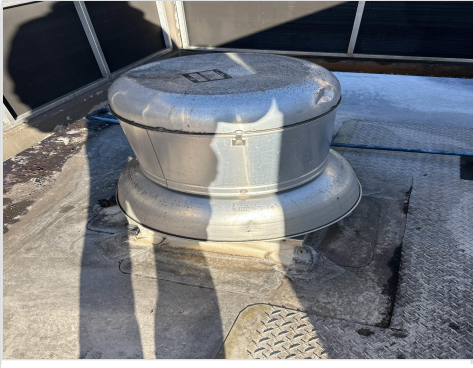
Unit Data - PHOTO LOG

Test Data		
	Design	Actual
CFM	375	356
Fan RPM	-	DD
Fan Rotation	-	CCW
Motor RPM	-	DD
System SetPt	-	MAX ON DAIL
RL Voltage	-	NA
RL Amperage	-	NA
Total ESP	-	0.21"
Fan Inlet SP	-	-0.21"
Fan Discharge SP	-	ATMO

Notes:
 [1] OVEN GRILLE INTENDED FOR THIS FAN ADDED TO EF-1 INSTEAD; SEE ISSUE.

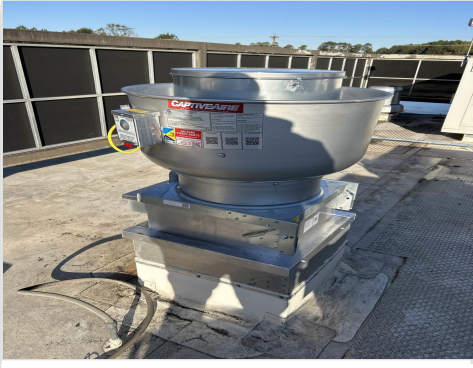
Unit Data - PHOTO LOG

Test Data		
	Design	Actual
CFM	1350	1460
Fan RPM	-	DD/
Fan Rotation	-	CCW
Motor RPM	-	1243
System SetPt	-	54.8 Hz
RL Voltage	-	211
RL Amperage	-	2.0/1.8
Total ESP	-	0.33"
Fan Inlet SP	-	-0.33"
Fan Discharge SP	-	ATMO

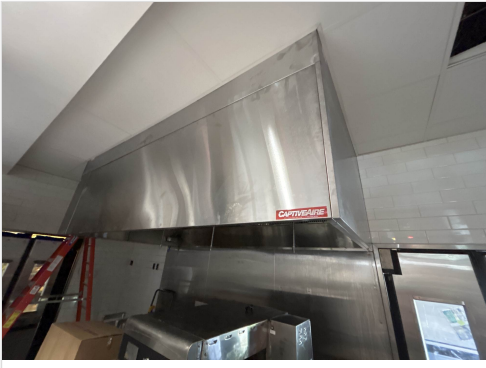
Unit Data - PHOTO LOG

Unit Data		
	Design	Actual
MFG	CAPTIVEAIRE	CAPTIVEAIRE
Model Num	6030ND-2-F	6030ND-2-F
Job / Serial Num	-	7644870
Type	-	TYPE I CANOPY
Hood length	-	121"
Hood Width	-	60"

Test Data Exhaust		
	Design	Actual
Filter Type	-	CAPTRATE
Filter Size 1	-	16X20
Filter Qty 1	-	6
Filter AK factor size 1	-	2.08
Filter Total AK Area	-	12.48
Filter1 FPM	-	118
Filter2 FPM	-	115
Filter3 FPM	-	112
Filter4 FPM	-	123
Filter5 FPM	-	119
Filter6 FPM	-	117
Filter Ave FPM(corr)	-	117
CFM	1350	1460
