Report: TAB Report
Function: Test, Adjust, & Balance
Date: 10/22/2025
Completed By: National TAB

PROJECT
10-20-25 QT #1129 SPARTANBURG, SC

Project: 10-20-25 QT #1129 SPARTANBURG, SC

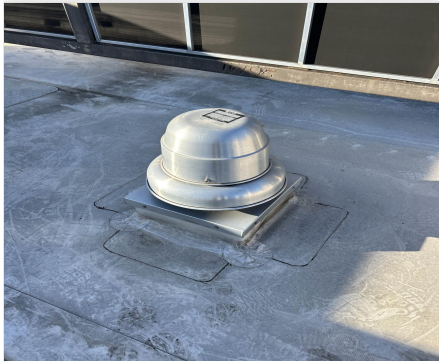
Issue Name : EF-1 not operational
Description : EF-1 not operational. The motor is just humming.
Created By : National TAB **Assigned To :** National TAB - Dan Hertenstein
Status : Open
Priority : High **Asset Tag :** EF1
Originated Date : 10/23/2025 - Jearod Ferrette - National TAB

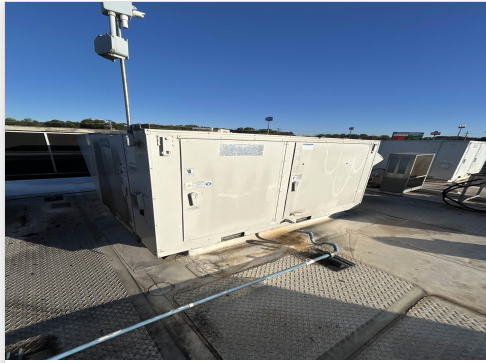
Asset: RT-3

Unit Data	
	Actual
MFG	AAON
Serial Num	201107ANEK05167
Model Num	RN01380EA0A152
Num OA Filters 1	1
OA Filter Size 1	44.5X22.5

Test Data		
	Design	Actual
SF CFM	4200	
SF RPM	-	
OA CFM (Hoods On)	800	
OA CFM (Hoods Off)	350	
RL Voltage	-	
RL Amperage	-	
VFD Max SetPt	-	
VFD Min SetPt	-	
OA Damper Position (Hoods On)	-	
OA Damper Position (Hoods Off)	-
