Report: TAB Report
Function: Test, Adjust, & Balance
Date: 10/22/2025
Completed By: National TAB

PROJECT
10-20-25 QT #1129 SPARTANBURG, SC

Project: 10-20-25 QT #1129 SPARTANBURG, SC

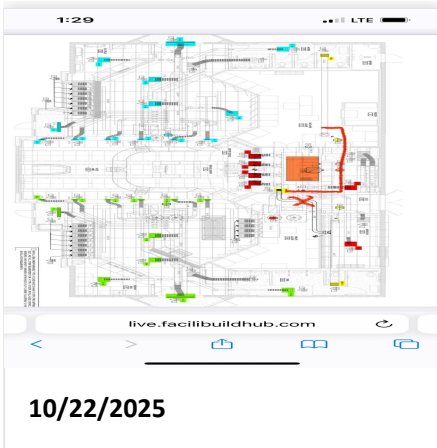
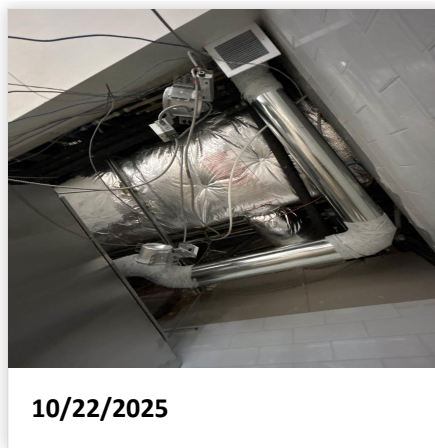
Issue Name : EF-1 doesn't match drawings
Description : Per GC exhaust was tapped into women's restroom instead of men's. confined space issue, unable to pipe ductwork to men's restroom. This will provide low flow for exhausting kitchen.
Created By : National TAB **Assigned To :** National TAB - Dan Hertenstein
Status : Open
Priority : InfoOnly **Asset Tag :** EF2
Originated Date : 10/22/2025 - Jearod Ferrette - National TAB

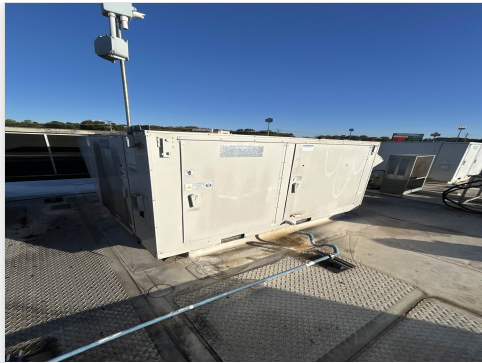
Asset: RT-3

Unit Data		
	Design	Actual
MFG	NA	AAON
Serial Num	-	201107ANEK05167
Model Num	NA	RN01380EA0A152
Num OA Filters 1	-	1
OA Filter Size 1	-	44.5X22.5

Test Data		
	Design	Actual
SF CFM	4200	
SF RPM	-	
OA CFM (Hoods On)	800	
OA CFM (Hoods Off)	350	
RL Voltage	-	
RL Amperage	-	
VFD Max SetPt	-	
VFD Min SetPt	-	
OA Damper Position (Hoods On)	-	
OA Damper Position (Hoods Off)	-

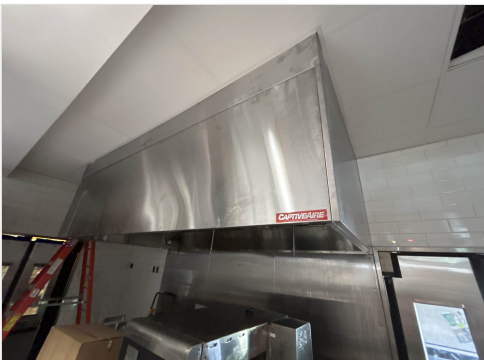
Asset: HD1

Unit Data		
	Design	Actual
MFG	CAPTIVEAIRE	CAPTIVEAIRE
Model Num	6030ND-2-F	6030ND-2-F
Job / Serial Num	-	7644870
Type	-	TYPE I CANOPY
Hood length	-	121"
Hood Width	-	60"

Test Data Exhaust		
	Design	Actual
Filter Type	-	CAPTRATE
Filter Size 1	-	16X20
Filter Qty 1	-	6
Filter AK factor size 1	-	2.08
Filter Total AK Area	-	12.48
Filter1 FPM	-	118
Filter2 FPM	-	115
Filter3 FPM	-	112
Filter4 FPM	-	123
Filter5 FPM	-	119
Filter6 FPM	-	117
Filter Ave FPM(corr)	-	117
CFM	1350	1460
