Report: TAB REPORT
Function: Test, Adjust, & Balance
Date: 11/30/2023

**10-23-23 LIFE STORAGE #657 WESTLAKE
OH**

1099 Bradley Road

Westlake, OH 44145

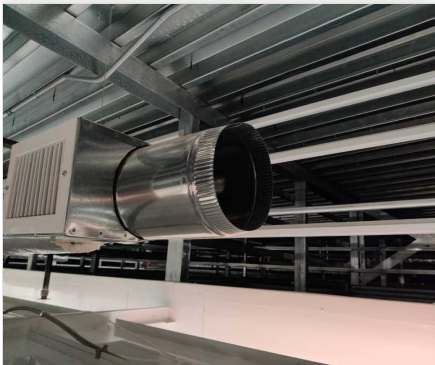
IMG_20231025_113422.j..
10/25/2023

Issue Name : FRU 6 missing End cap
Description : FRU 6 is missing End cap by diffusers 14/15 see pic
Created By : National TAB **Assigned To :** National TAB - Will Turnbough
Status : Open
Priority : **Asset Tag :**
Originated Date : 10/25/2023 - Mohammed Ouard - National TAB

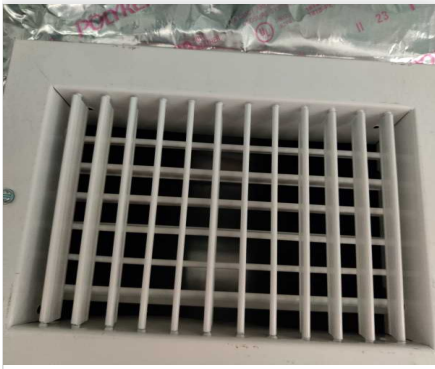
IMG_20231025_112635.j..
10/25/2023

Issue Name : Some diffusers don't have dampers to adjust air flow(see list)
Description : FUR 1 diff 14 FUR 2 diff 5 and 7 FUR 3 diff 6 FUR 5 diff 1 and 6 FUR 6 diff 9 and 10
Created By : National TAB **Assigned To :** National TAB - Will Turnbough
Status : Open
Priority : **Asset Tag :**
Originated Date : 10/25/2023 - Mohammed Ouard - National TAB

Grilles installed but missing dampers to adjust air flow .readings were very high.

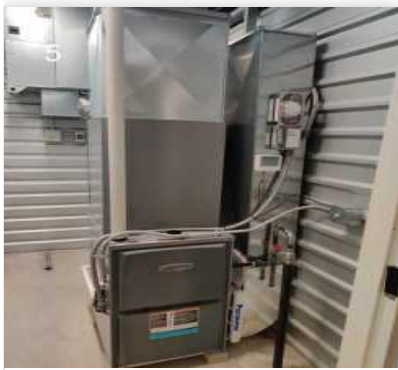
FUR 4

Diffuser 4-14 is at 71% .unable to push more air without compromising unit total .

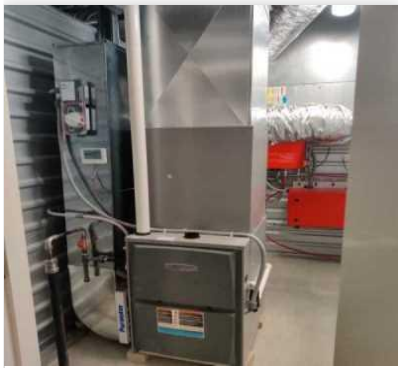
FUR-6

Unable to balance to 10% of design .Missing dampers on Grilles # 9,10 and 13.
