Report: TAB REPORT
Function: Test, Adjust, & Balance
Date: 09/11/2025
Completed By: National TAB

08-04-25 NIKE #202 CHESTERFIELD, MO

Project: 08-04-25 NIKE #202 CHESTERFIELD, MO

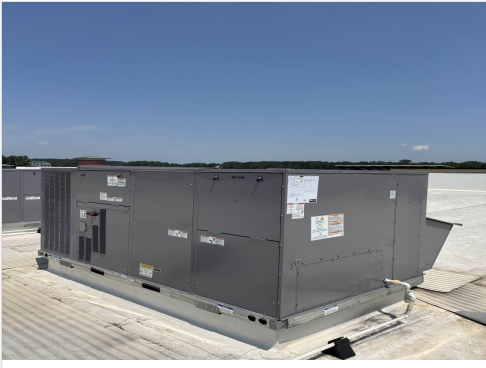
Unit Data - PHOTO LOG

Asset: RTU1

- Return Grilles Dirty/Clogged (RESOLVED 9/11/25). Balanced RTU with OA method. Put OA damper at 100% and adjusted fan speed accordingly. Set OA once fan speed was balanced.
- Initial Airflow Calculation: 2589

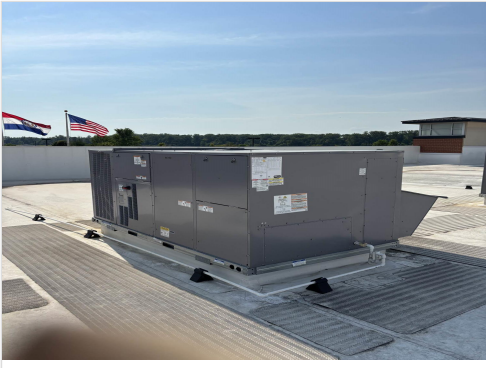
Unit Data - PHOTO LOG

Asset: RTU2

- Return Grilles Dirty/Clogged.(RESOLVED 9/11/25). Balanced RTU with OA method. Put OA damper at 100% and adjusted fan speed accordingly. Set OA once fan speed was balanced.
- Initial Airflow Calculation: 2999

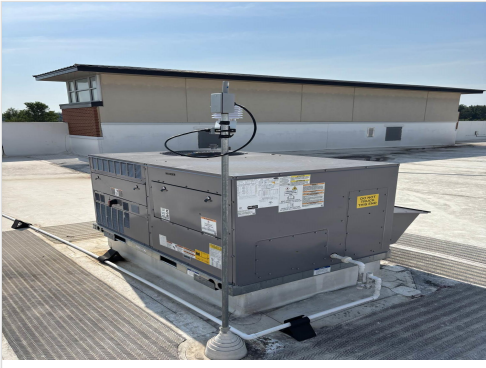
Unit Data - PHOTO LOG

Asset: RTU4

- Balanced RTU with OA method. Put OA damper at 100% and adjusted fan speed accordingly. Set OA once fan speed was balanced.
- Unable to access return Grilles to determine if they were clean/dirty

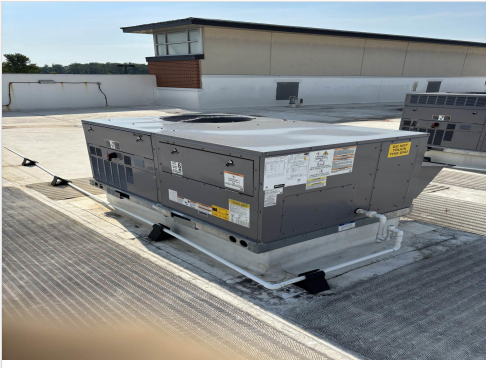
Unit Data - PHOTO LOG

Asset: RTU5

- Balanced RTU with OA method. Put OA damper at 100% and adjusted fan speed accordingly. Set OA once fan speed was balanced.
- Unable to access return Grilles to determine if they were clean/dirty
