Report: TAB Report
Function: Test, Adjust, & Balance
Date: 11/11/2025
Completed By: National TAB

11-10-25 WAWA #8700 FREEHOLD, NJ

275 MONMOUTH RD

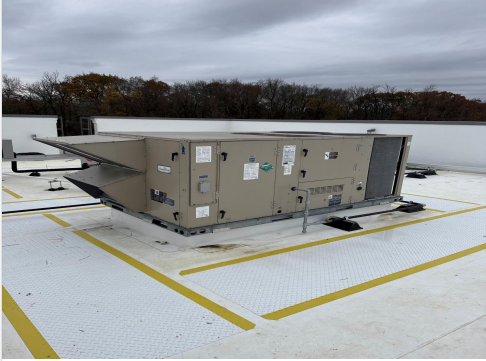
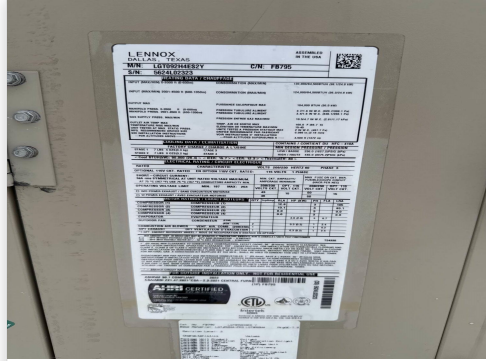
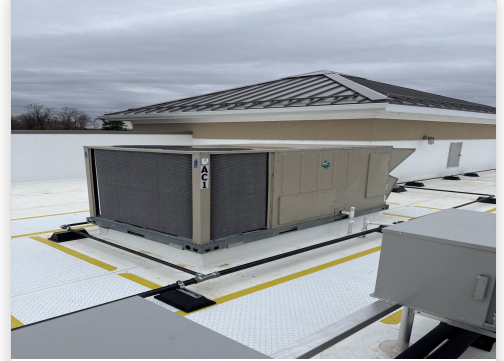
Unit Data - PHOTO LOG

Asset: RTU1

AREA:RETAIL

Unit Data		
	Design	Actual
MFG	LENNOX	LENNOX
Serial Num	-	5624L02323
Model Num	LGT092H4E	LGT092H4E
Type	RTU	RTU
Configuration	VERTICAL	VERTICAL
Num OA Filters 1	-	2
OA Filter Size 1	-	14X23
Num Final Filter 1	-	4
Final Filter Size 1	-	20X25X2

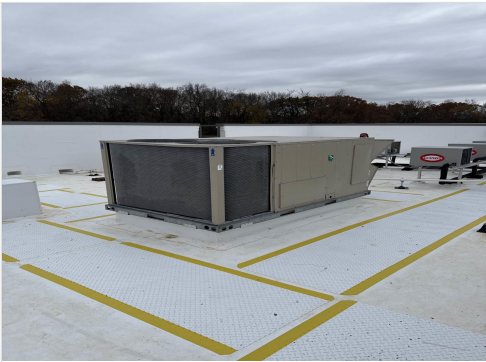
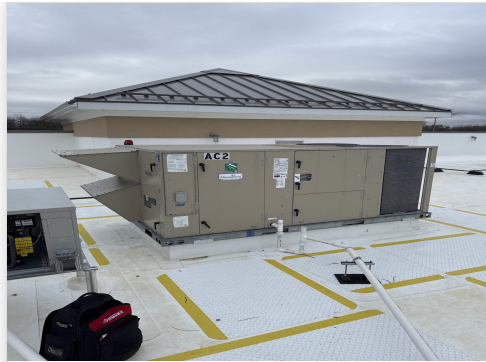
Unit Data - PHOTO LOG

Asset: RTU2

AREA:FOOD SERVICE

Unit Data		
	Design	Actual
MFG	LENNOX	LENNOX
Serial Num	-	5624L06686
Model Num	LCT150H4E	LCT150H4E
Type	RTU	RTU
Configuration	VERTICAL	VERTICAL
Num OA Filters 1	-	2
OA Filter Size 1	-	14X23
Num Final Filter 1	-	4
Final Filter Size 1	-	20X25X2

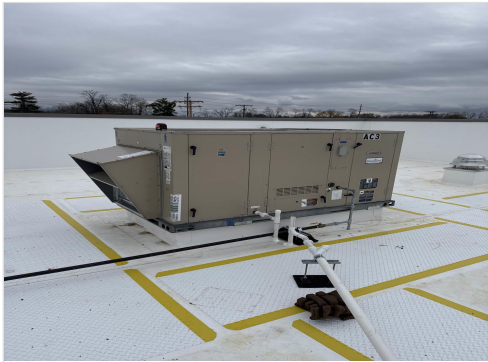
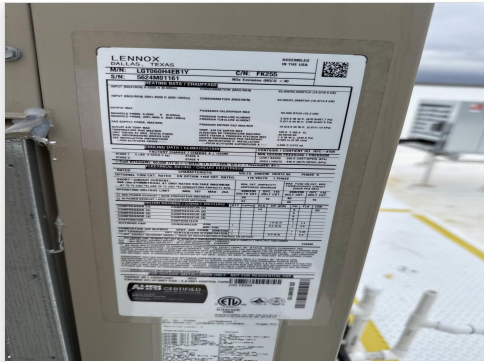
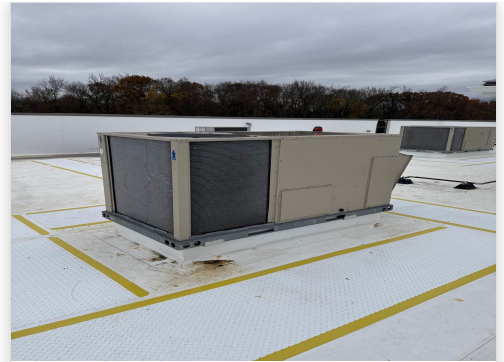
Unit Data - PHOTO LOG

Asset: RTU3

AREA:RETAIL

Unit Data		
	Design	Actual
MFG	LENNOX	LENNOX
Serial Num	-	5624M01161
Model Num	LGT060H4E	LGT060H4E
Type	RTU	RTU
Configuration	VERTICAL	VERTICAL
Num OA Filters 1	-	2
OA Filter Size 1	-	14X14
Num Final Filter 1	-	4
Final Filter Size 1	-	20X20X2

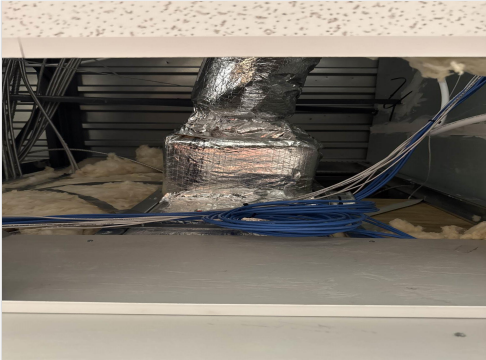
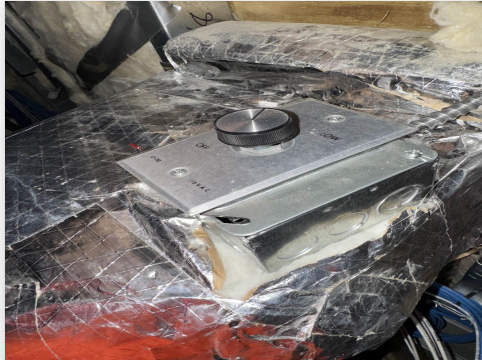
Unit Data - PHOTO LOG

Asset: EF3

AREA:ELECTRICAL ROOM

Unit Data		
	Design	Actual
MFG	PENNBARRY	PENNBARRY
Model Num	Z3H	Z3H
Type	INLINE	INLINE
Configuration	VERTICAL	VERTICAL

[1] Most Unit data including motor and electrical data was not accessible.
