Report: TAB Report
Function: Test, Adjust, & Balance
Date: 11/11/2025
Completed By: National TAB

11-10-25 WAWA #8700 FREEHOLD, NJ

Project: 11-10-25 WAWA #8700 FREEHOLD, NJ

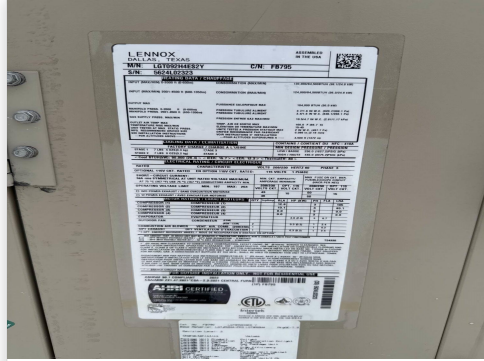
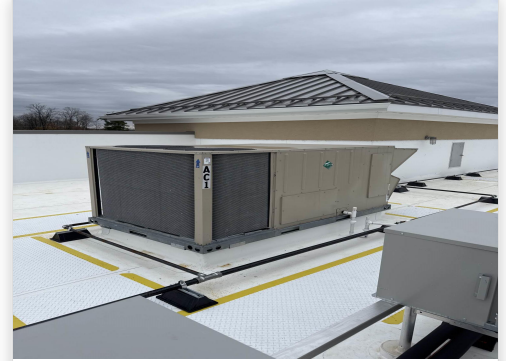
Unit Data - PHOTO LOG

Unit Data		
	Design	Actual
MFG	LENNOX	LENNOX
Serial Num	-	5624L02323
Model Num	LGT092H4E	LGT092H4E
Type	RTU	RTU
Configuration	VERTICAL	VERTICAL
Num OA Filters 1	-	2
OA Filter Size 1	-	14X23
Num Final Filter 1	-	4
Final Filter Size 1	-	20X25X2

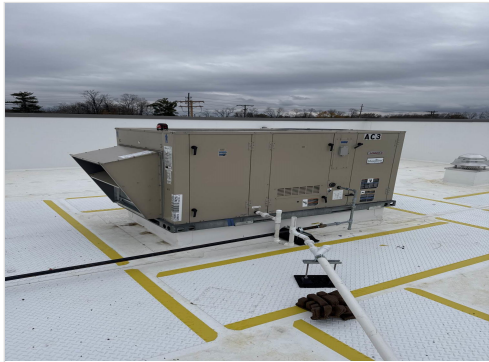
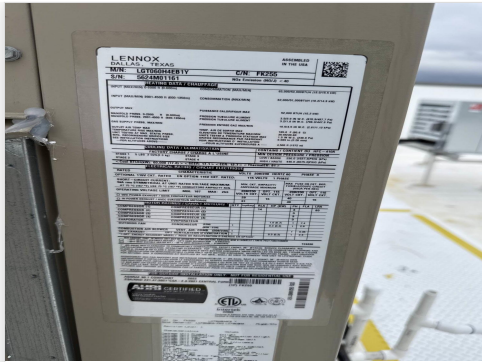
Unit Data - PHOTO LOG

Unit Data		
	Design	Actual
MFG	LENNOX	LENNOX
Serial Num	-	5624M01161
Model Num	LGT060H4E	LGT060H4E
Type	RTU	RTU
Configuration	VERTICAL	VERTICAL
Num OA Filters 1	-	2
OA Filter Size 1	-	14X14
Num Final Filter 1	-	4
Final Filter Size 1	-	20X20X2

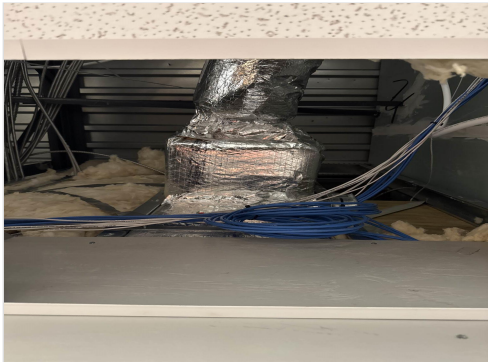
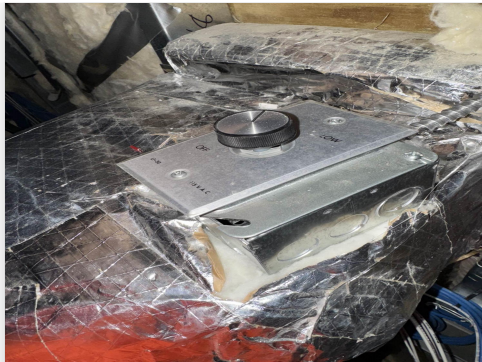
Unit Data - PHOTO LOG

Unit Data		
	Design	Actual
MFG	PENNBARRY	PENNBARRY
Model Num	Z3H	Z3H
Type	INLINE	INLINE
Configuration	VERTICAL	VERTICAL

[1] Most Unit data including motor and electrical data was not accessible.
