Report: FINAL TAB REPORT
Function: Test, Adjust, & Balance
Date: 07/21/2022

06-20 KROGER #024-292 - LOUISVILLE, KY

Project: 06-20 KROGER #024-292 - LOUISVILLE, KY

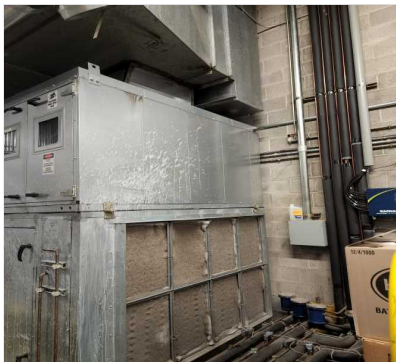
AHU-1

Unit Data		
	Design	Actual
MFG	AHU	Air Zone International
Serial Num	-	508180
Model Num	EXISTING	VDT-PL-2-40-I
Type	-	AHU
Configuration	-	VERTICAL
Num OA Filters 1	-	N/A
OA Filter Size 1	-	N/A
Num Final Filter 1	-	16
Final Filter Size 1	-	16X24X2
Num Final Filter 2	-	
Final Filter Size 2	-

Notes: 2 SUPPLY FAN MOTORS 50.7 HZ INITIAL

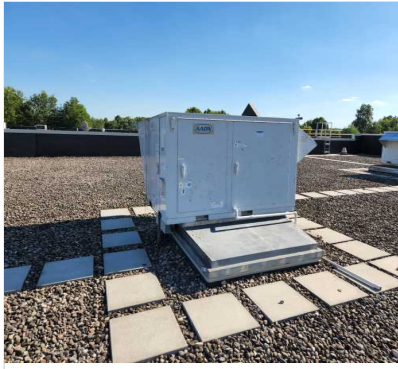
RTU-1

Description : RTU-1's pully is frozen and needs to be freed to be speed up to increase cfm

Test Data		
	Design	Actual
SF CFM	4550	3341
SF RPM	-	NA
RA CFM	-	2809
OA CFM	500	532
RL Voltage	-	206/205/204
RL Amperage	-	6.6/7.2/7.8
SF Rotation	-	Cw
RA Damper Position	-	80%
Min OA Damper Position	-	20%
Min OA Damper Type	-	Manual
OA Enthalpy Setpt	-	
Brake Horse Power	-

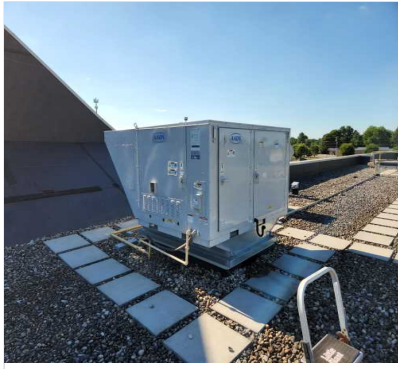
Issue Name : RTU-5 VFD is bypassed
Description : RTU-5 VFD is bypassed.
Created By : National TAB **Assigned To :** National TAB - Wendy Biggs
Status : Open
Originated Date : 06/23/2022 - Zack Eismin - National TAB
