**Report: Punchlist**

**Function: Test, Adjust, & Balance**

## 12-08-25 Freddys - Ada, OK

1000 Lonnie Abbott Blvd

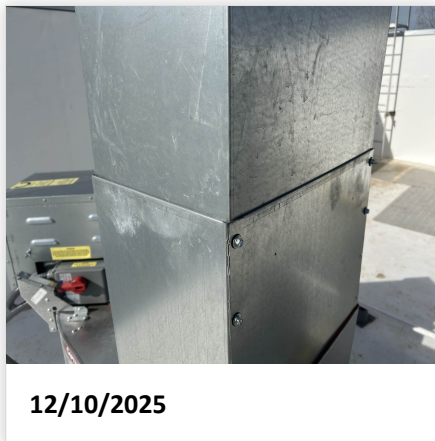
**Issue Name :** KEF-1 exhaust riser.  
**Description :** KEF-1 exhaust riser is not sealed. The exhaust riser should be installed the same as any other portion of duct and should be firmly in place and fully sealed from leakage. Install additional fasteners and apply caulking to joint seams.  
**Created By :** National TAB                      **Assigned To :** National TAB - Dan Hertenstein  
**Status :** Open  
**Priority :** Medium                                      **Asset Tag :**  
**Originated Date :** 12/10/2025 - Cody Collett - National TAB

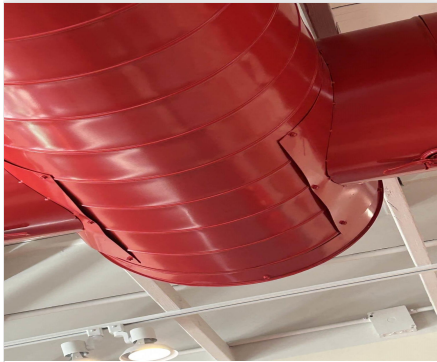
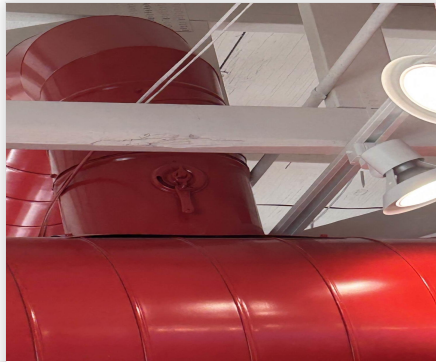
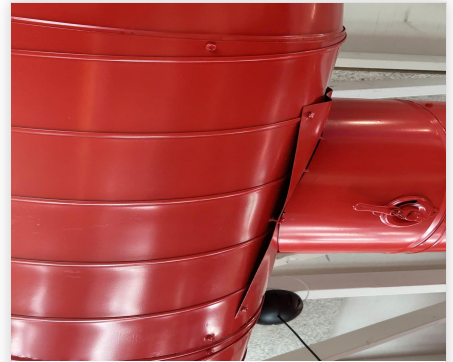
**Issue Name :** RTU-1 duct leakage at duct take offs.  
**Description :** RTU-1 duct leakage at duct take offs. Seal gaps with caulking of appropriate color for duct. (Duct is painted red.)  
**Created By :** National TAB                      **Assigned To :** National TAB - Dan Hertenstein  
**Status :** Open  
**Priority :** Urgent                                      **Asset Tag :**  
**Originated Date :** 12/10/2025 - Cody Collett - National TAB

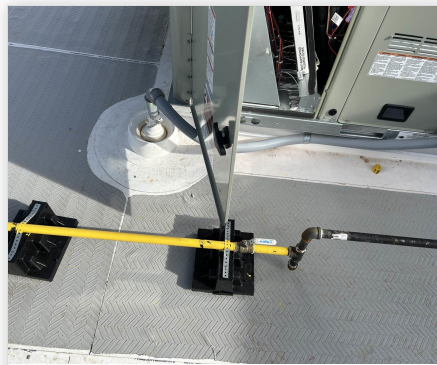
**Issue Name :** RTU-1 main power flex conduit.  
**Description :** RTU-1 main power flex conduit obstructs MA door of RTU-1 from fully opening. Additionally water collects at escutcheon at roof penetration.  
**Created By :** National TAB                      **Assigned To :** National TAB - Dan Hertenstein  
**Status :** Open  
**Priority :** Low                                      **Asset Tag :**  
**Originated Date :** 12/10/2025 - Cody Collett - National TAB
