Shake Shack (Chesterfield) - Commissioning

Name : (FIV) KEF- Above Ceiling **Status :** NotSubmitted
Assigned Organization : MULTIPLE **Asset :**
Requesting Organization : National TAB

KITCHEN HOOD EXHAUST FANS

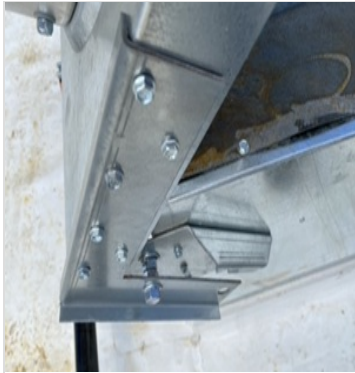
Bolttension.jpeg

Unit Tag matches the design and submittal MFG and Model	Yes
There is no noticeable physical damage to the fan	No damage
Fans are installed in the correct location and orientation	Yes
All packing, material and debris has been removed from the blower/wheel housing and the motor compartment	Yes
Fan wheels turn easily by hand (turn power off prior to testing)	Yes
Exhaust fans have external disconnects and are connected to allow full hinging of each exhaust fan	Yes
Fan is properly hinged and supported when hinged fully back for grease duct access	Fan is hinged but the lever arm is out side of the brace on some hinges. The bolts are tightened too tight, no allowing the fan to catch when opened on these braces. MC to bend lever arm so that it will catch on the brace and loosen the bolts to relieve some tension so that this functions as designed

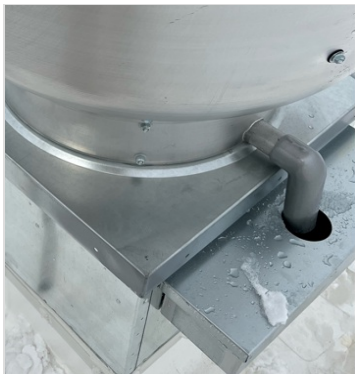
grease_cup.PNG

Grease cups are properly installed and connected to the fan base grease drain to prevent spilling outside of the grease cup

Yes

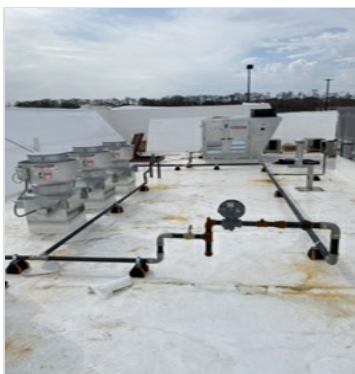
KEF.jpeg

Exhaust fans are located 5ft from parapet wall and 10ft from any fresh air intake.

Yes

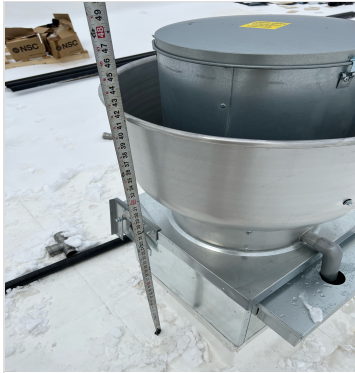
fandischarge42.jpg

Top of fan discharges a minimum 40" above the finished roof

Yes
