**Report: (FPT) - Electrical
Function: Commissioning
Date: 6/13/2022**

05-09 Shake Shack #1352 (Chesterfield, MO) COMMISSIONING

17312 Chesterfield Airport Road

Project: 05-09 Shake Shack #1352 (Chesterfield, MO) COMMISSIONING

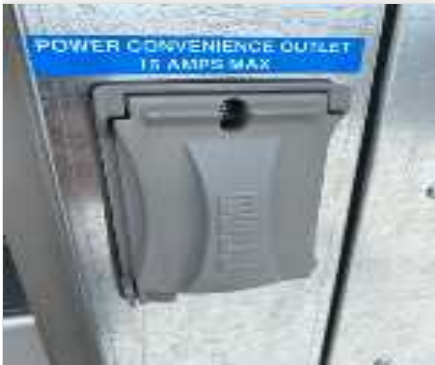
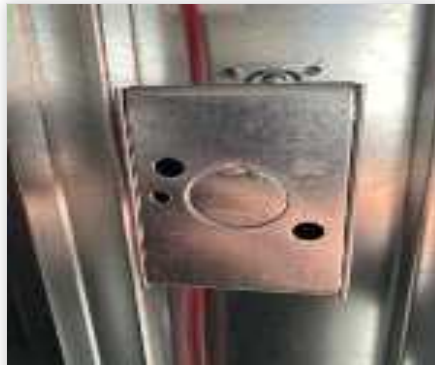
Issue Name : DOAS power convenience outlet not wired

Description : Power outlet for DOAS is not powered. This is not a integrated power supply provided by CAS, it requires a separate 20 amp/120v circuit. This circuit is not provided on the panel design label

Convenienceoutlet.jpeg

Nopowerconvoutlet.jpeg

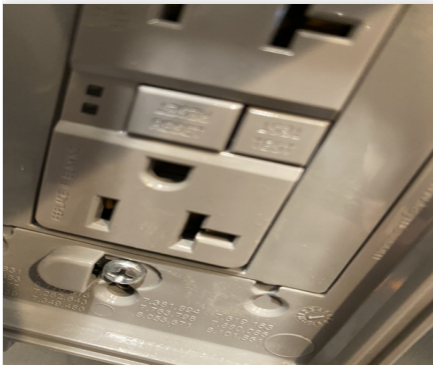
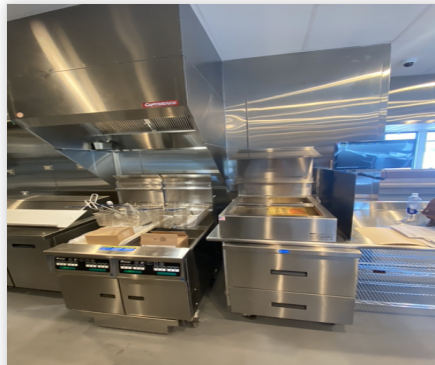
Issue Name : GFI not resetting
Description : GFI not resetting: FRYER line interior wall GFI not resetting after trip test. Repair and validate ALL cookline GFI's will reset properly
Created By : National TAB **Assigned To :** Akron Electric - Patrick Clancy
Status : Open
Originated Date : 05/23/2022 - Dan Hertenstein - National TAB

GFIoutlet.jpeg

Frylinelocation.jpeg

- **06/06/2022** National TAB - Travis Halter
 - GFI still does not reset, tested power as well in case. No power detected.

Fryer - Hood interior Wall: There are one GFCI outlet that will not reset noted on the open issues list Fryer - hood Exterior Wall: There is one Dead outlet that is noted on the open issues list

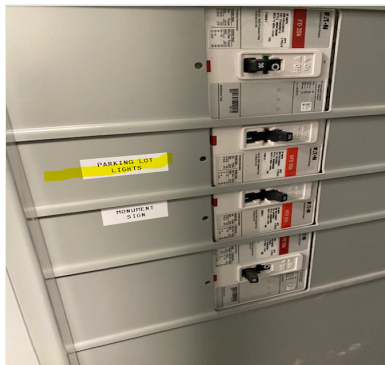
MP_parking_lot_breaker.PNG

Breaker Panel MP Phase Loading Matches Design

Panel layout deviation as shown on details. Phase balance remains the same, electrician eliminated multiple exterior/parking light individual circuits and replaced with a single breaker. Electrician to validate VA of this circuit to confirm the updated panel installation

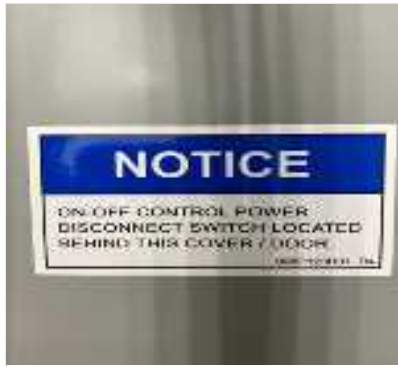
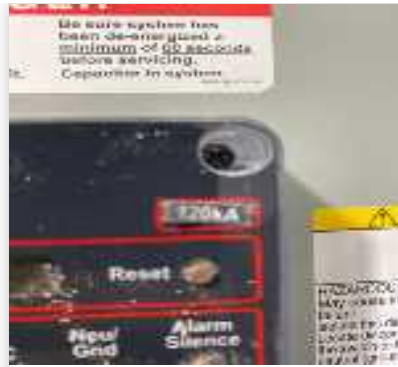
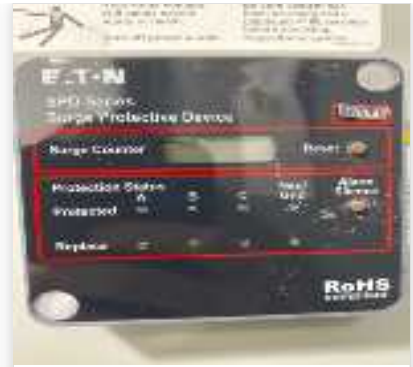
(SPD) Surge protector device is installed with maximum surge current capability: Service entrance switch boards, switchgear: 240 KA; Distribution panels, panelboards used for service entrance & MCC: 120 KA; branch panel boards: 80KA **Yes**

Onoffsirgectrlnote.jpeg

120KA.jpeg

Surgeprotector.jpeg
